Archaeological Survey
Ballintober Castle
Ballintober, Co. Roscommon
Ireland

RO027-048002-

Niall Brady

Castle Studies Trust
2014 Grant award

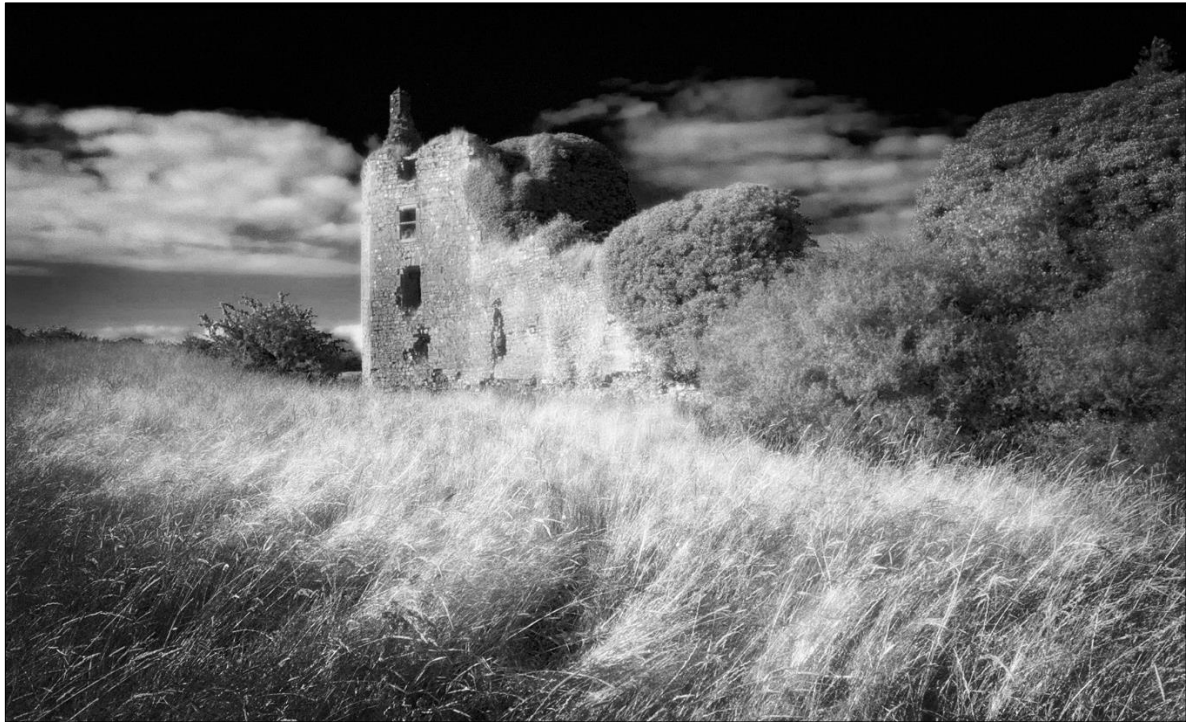
Plate 1: Ballintober Castle, from the Southwest.

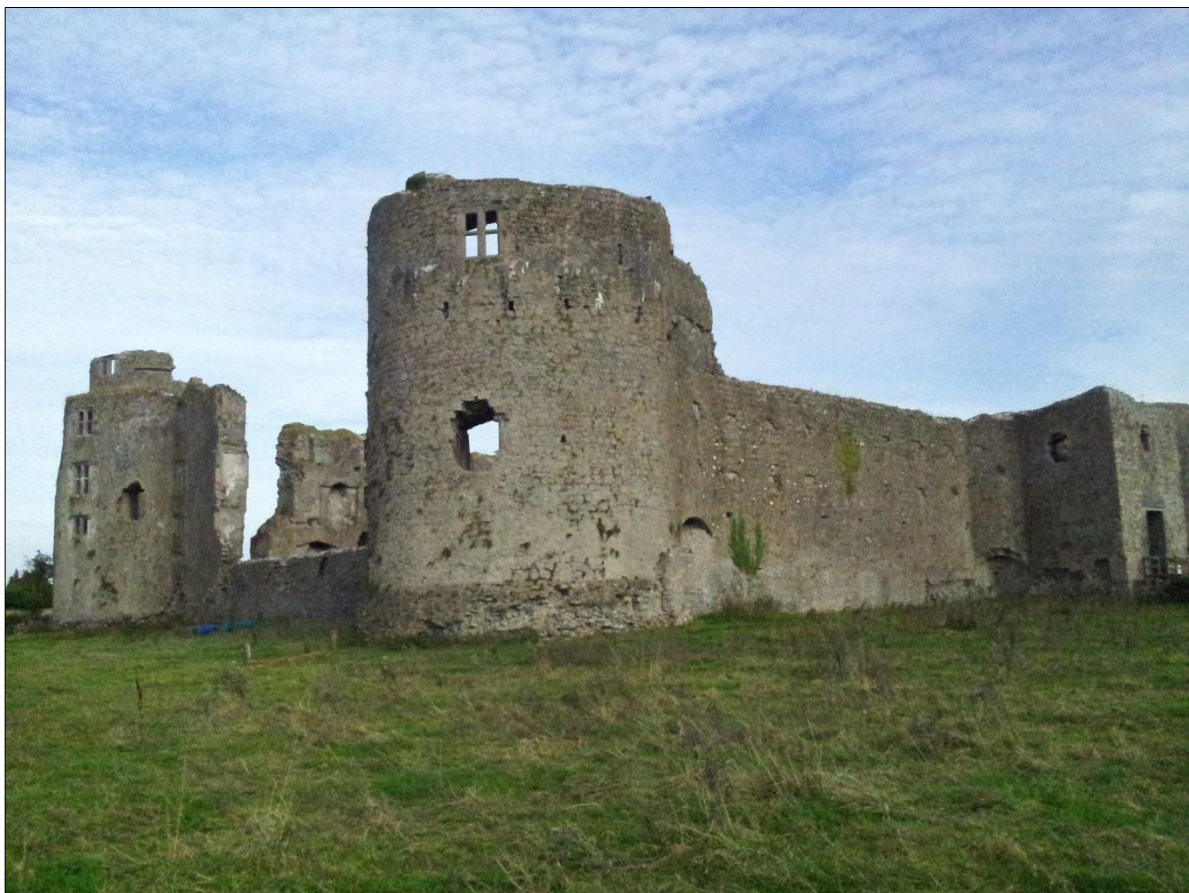
Plate 2: Roscommon Castle, from the Southwest, looking at Southwest corner tower in central area, and postern gate to the right

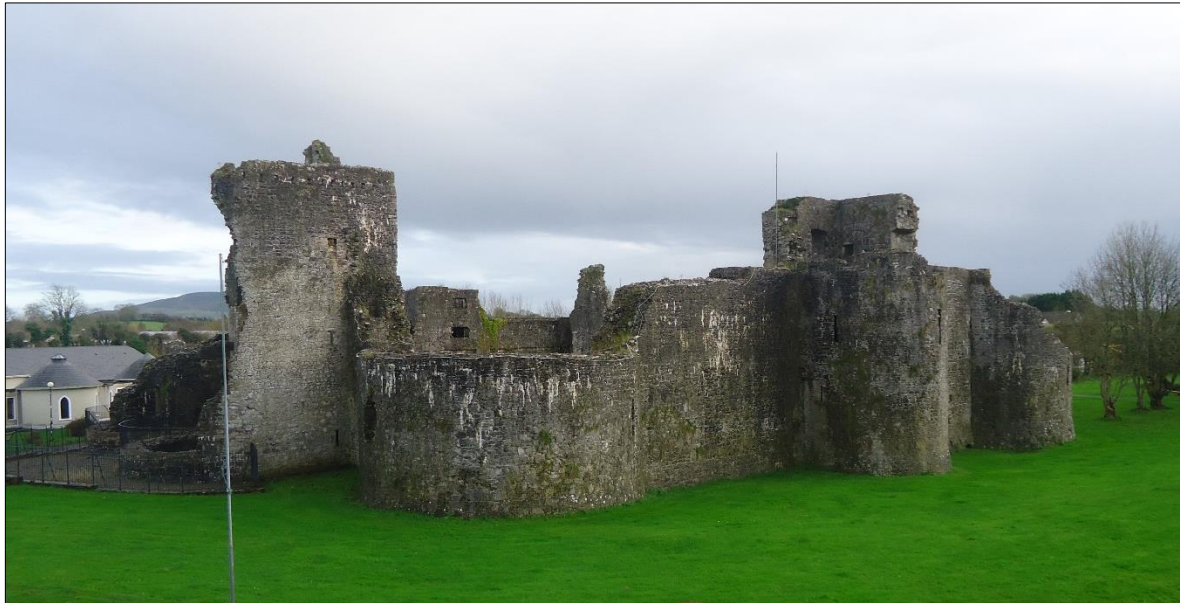
Plate 3: Ballymote Castle, from Northwest. View shows the western tower of the castle's entrance on the left side, with the northwest corner tower in the centre

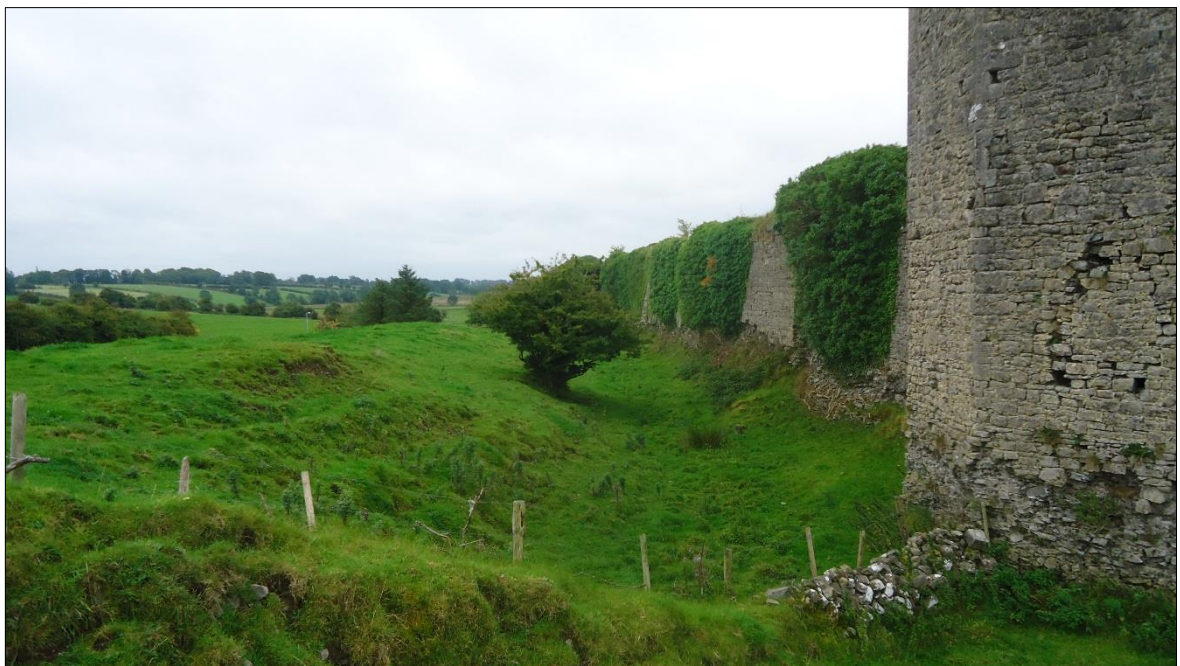
Plate 4: Ballintober Castle, view looking East of the fosse on the north side

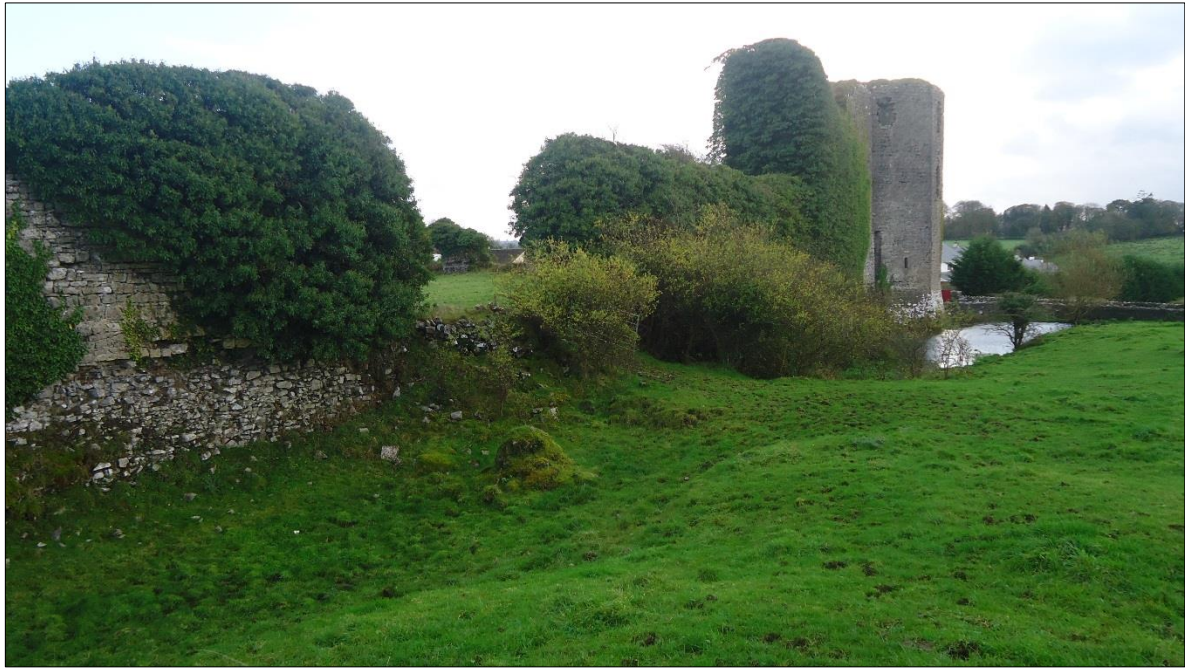
Plate 5: Ballintober Castle, view looking South of the fosse on the west side

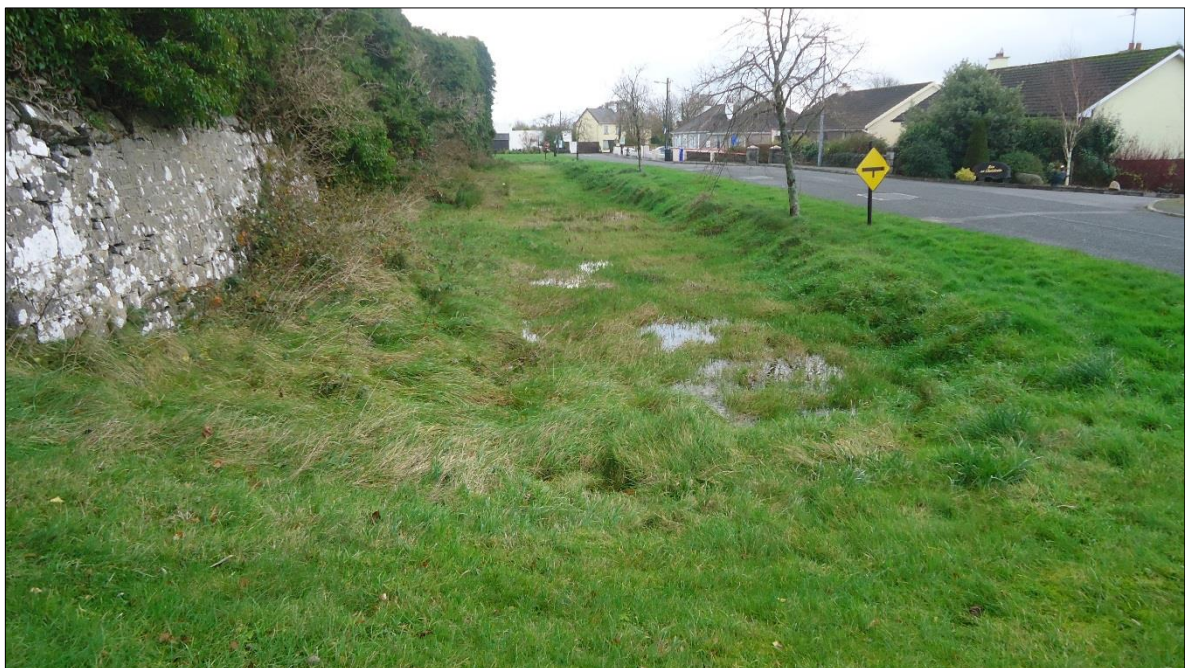
Plate 6: Ballintober Castle, view looking East of the fosse on the south side

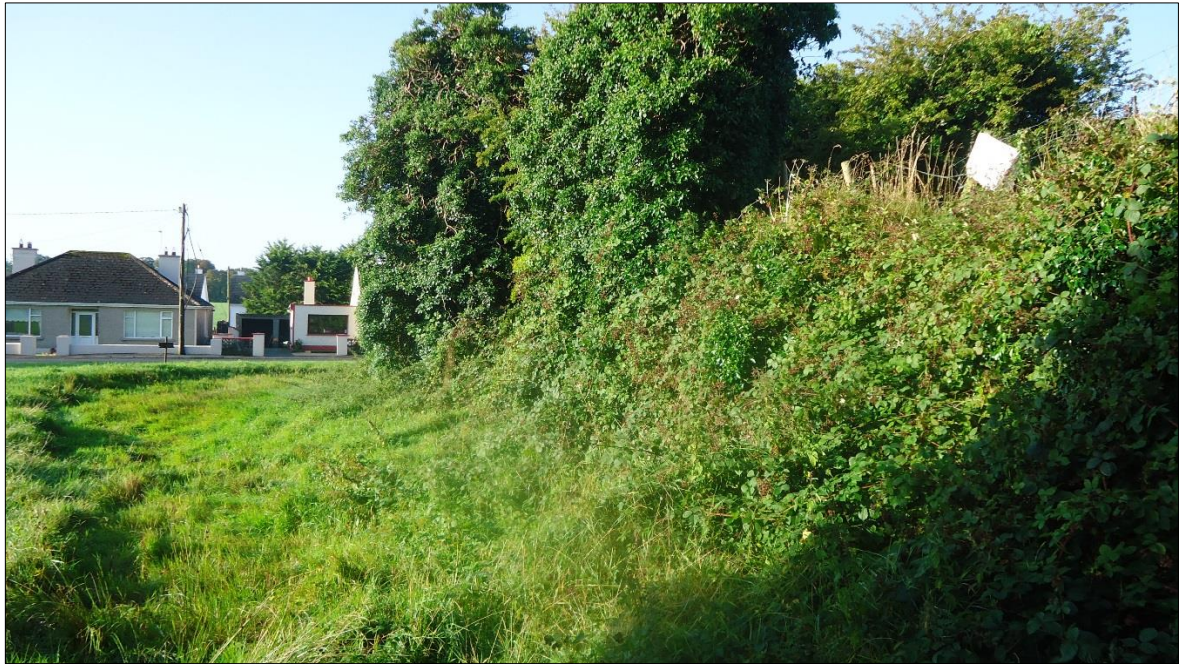
Plate 7: Ballintober Castle, view looking South of the fosse on the south side at the southeast corner

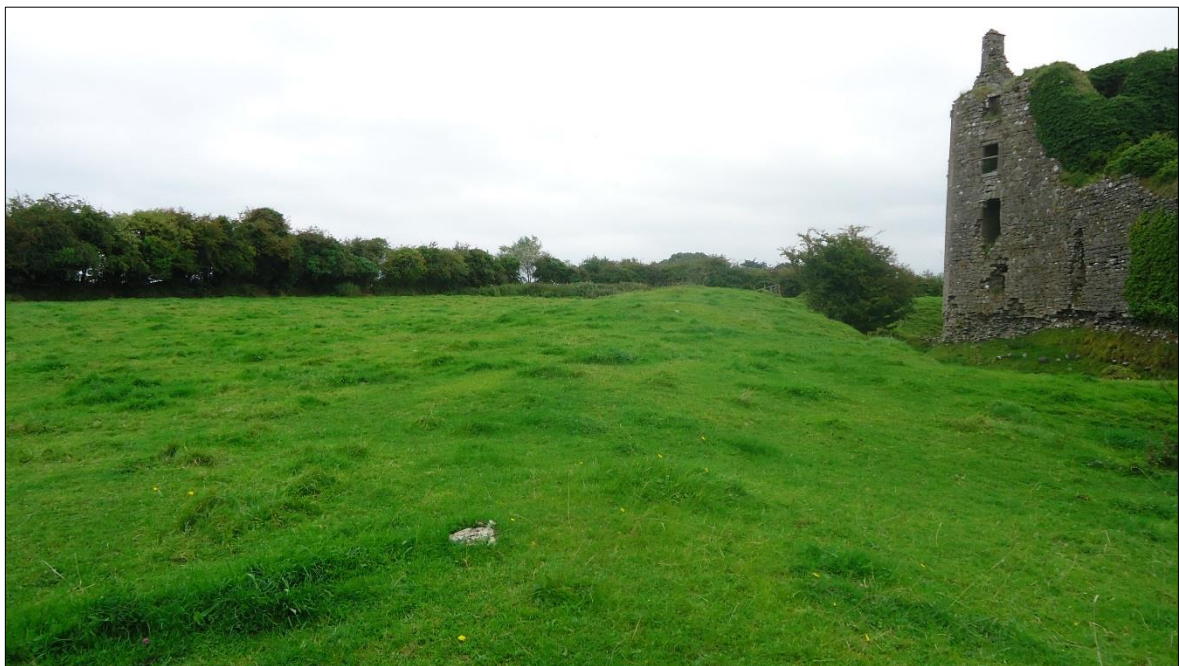
Plate 8: Ballintober Castle, view looking North showing the counterscarp bank on the west side

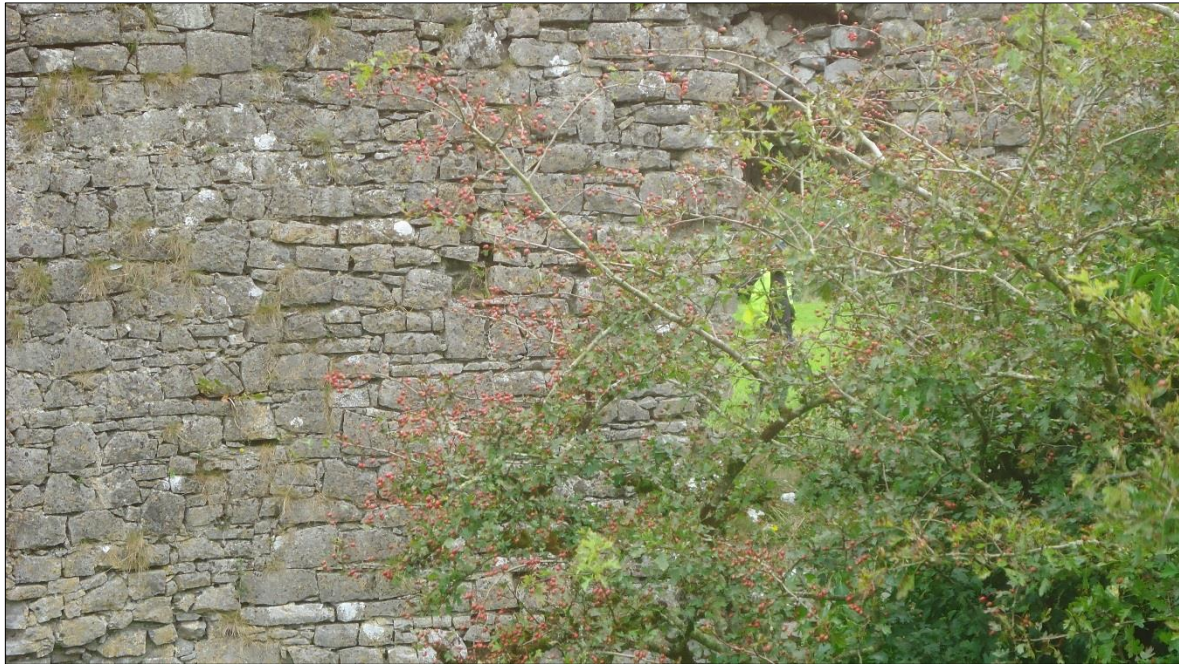
Plate 9: Ballintober Castle, view looking at the stonework on the exterior of the west wall

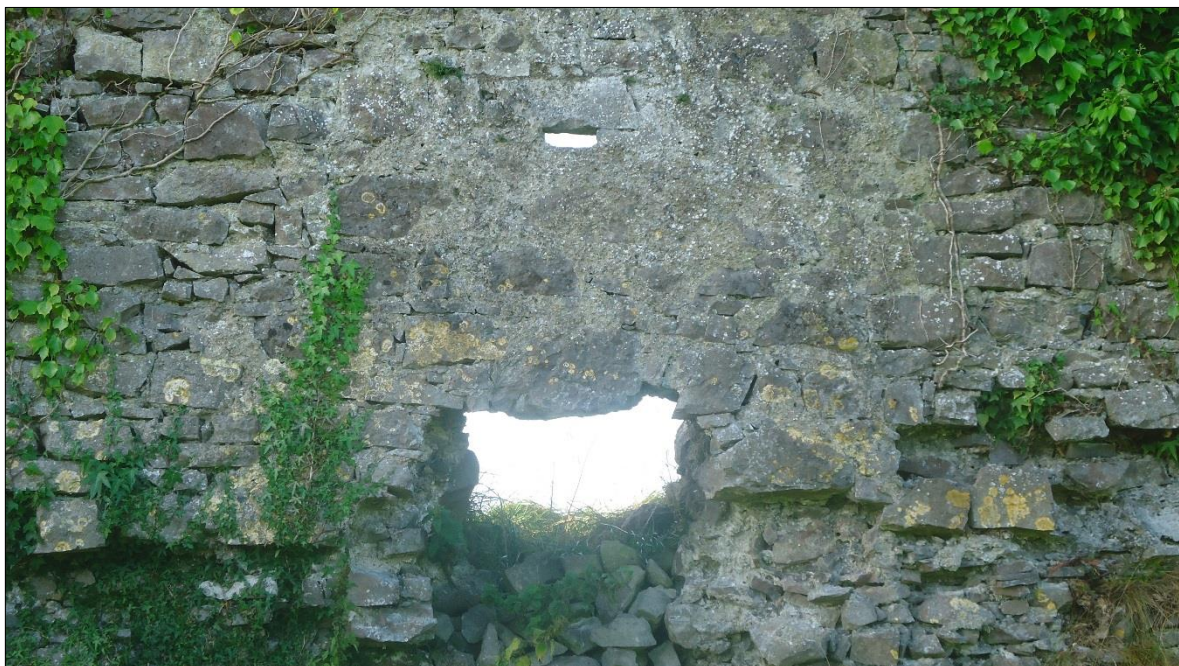
Plate 10: Ballintober Castle, view looking at the exterior of one of the gun loops on the north wall, showing render surviving around the opening in contrast to the wall fabric away from it, indicative of the inserted nature of this opening

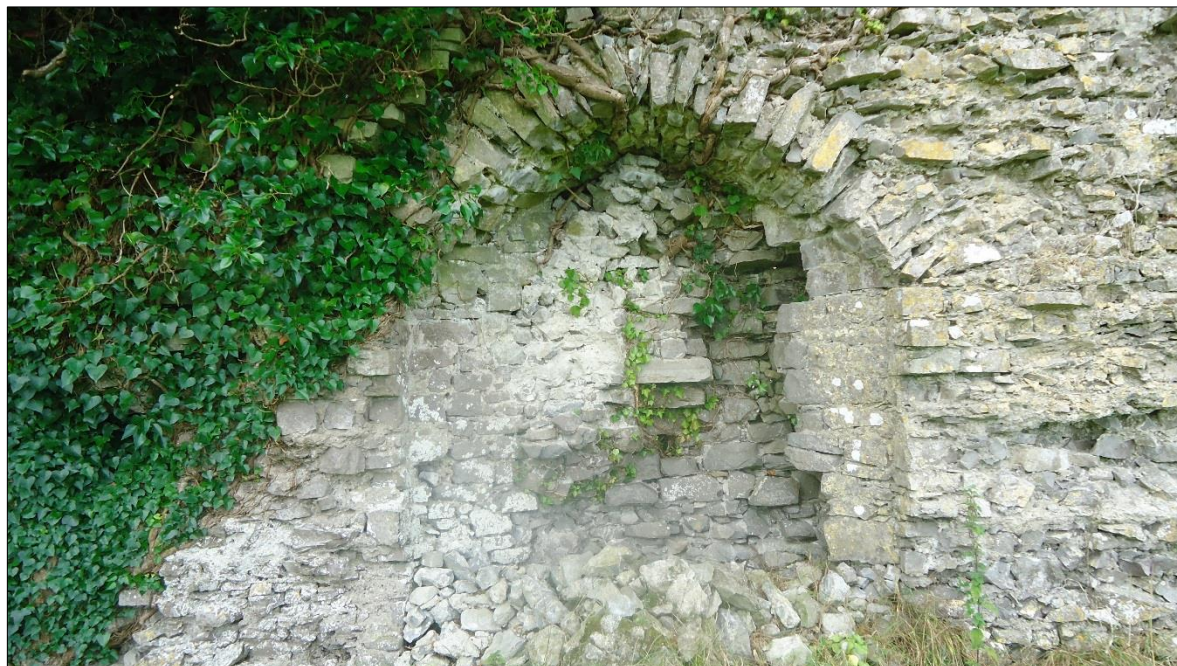
Plate 11: Ballintober Castle, view looking at interior of west wall on the south side showing window opening under arch

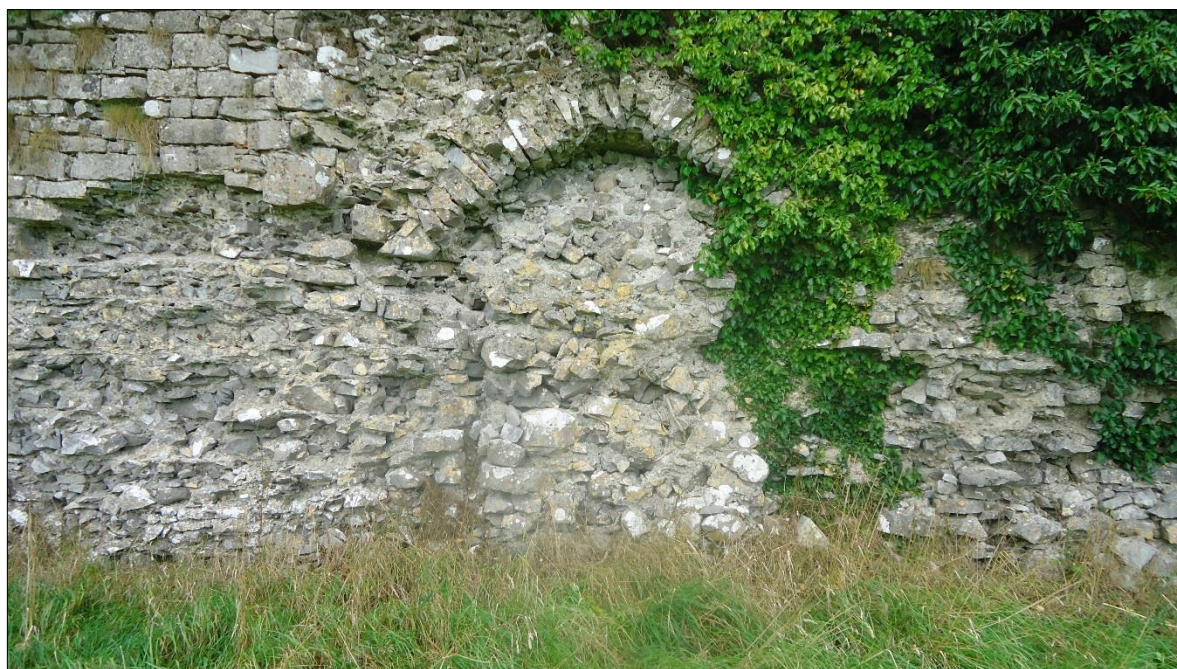
Plate 12: Ballintober Castle, view looking view at interior of west wall showing blocked-up window opening under arch

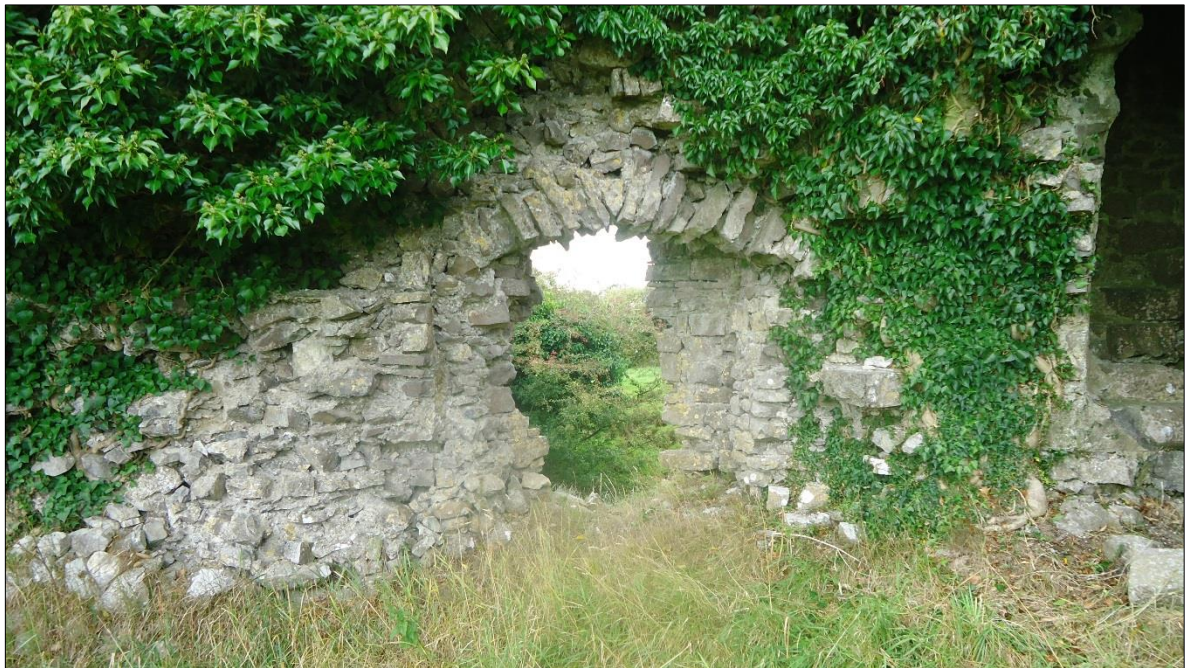
Plate 13: Ballintober Castle, view looking at interior of west wall on the north side showing remnant of window opening under arch

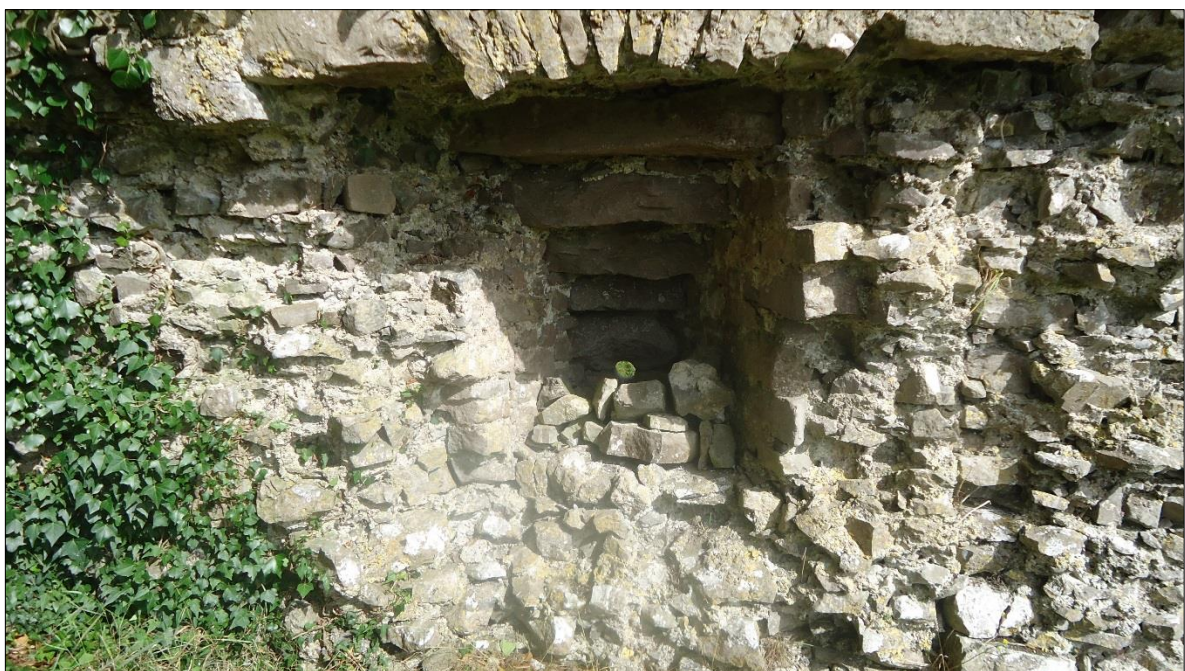
Plate 14: Ballintober Castle, view looking at interior of north wall showing gun loop with round hole, next to northwest corner tower

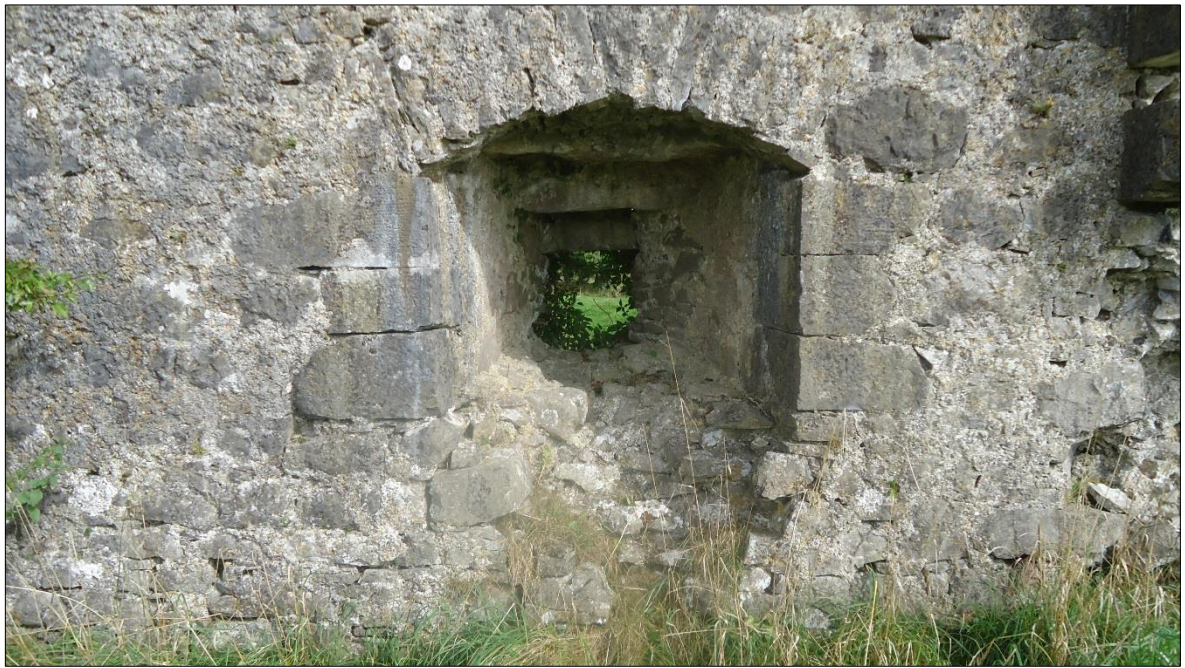
Plate 15: Ballintober Castle, view looking at interior of north wall showing gun loop next to mural stairs

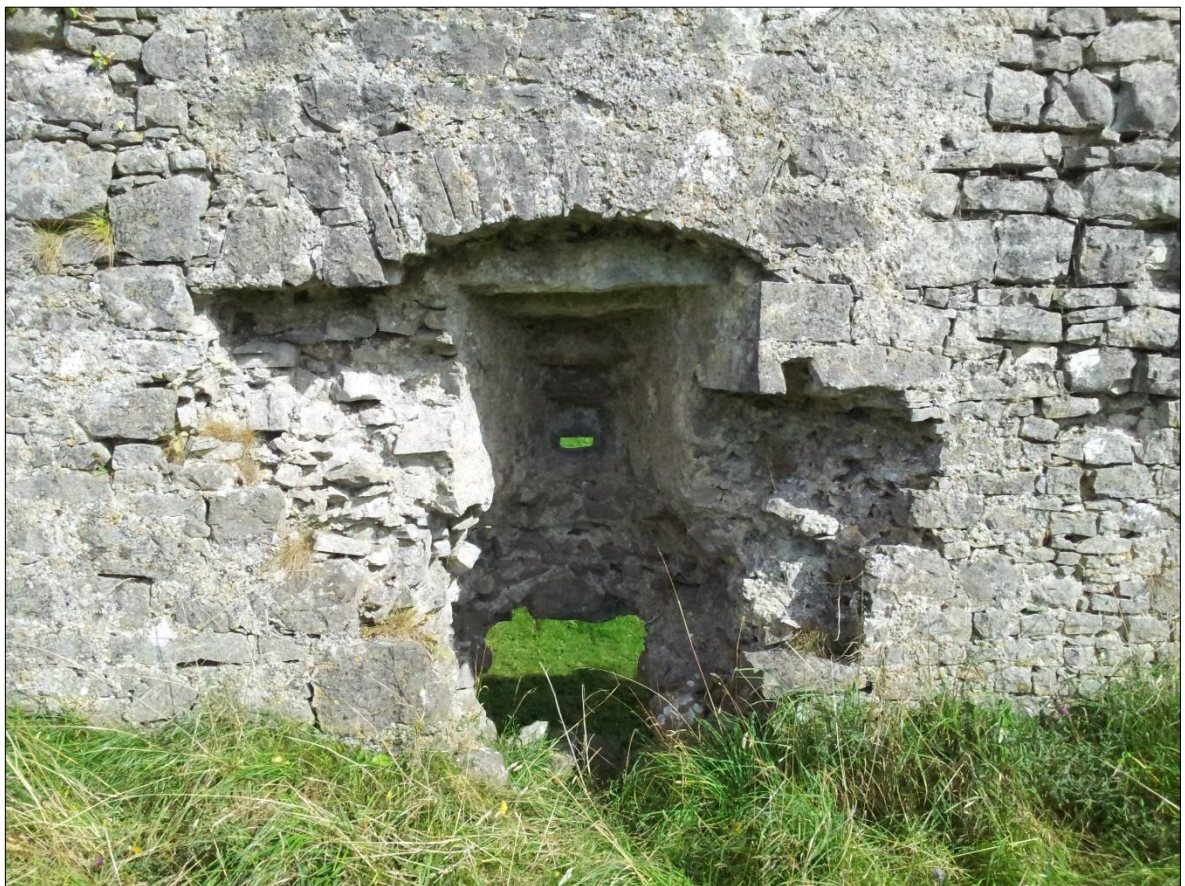
Plate 16: Ballintober Castle, view looking at interior of north wall showing gun loop with narrow rectangular hole, west of the mural stairs

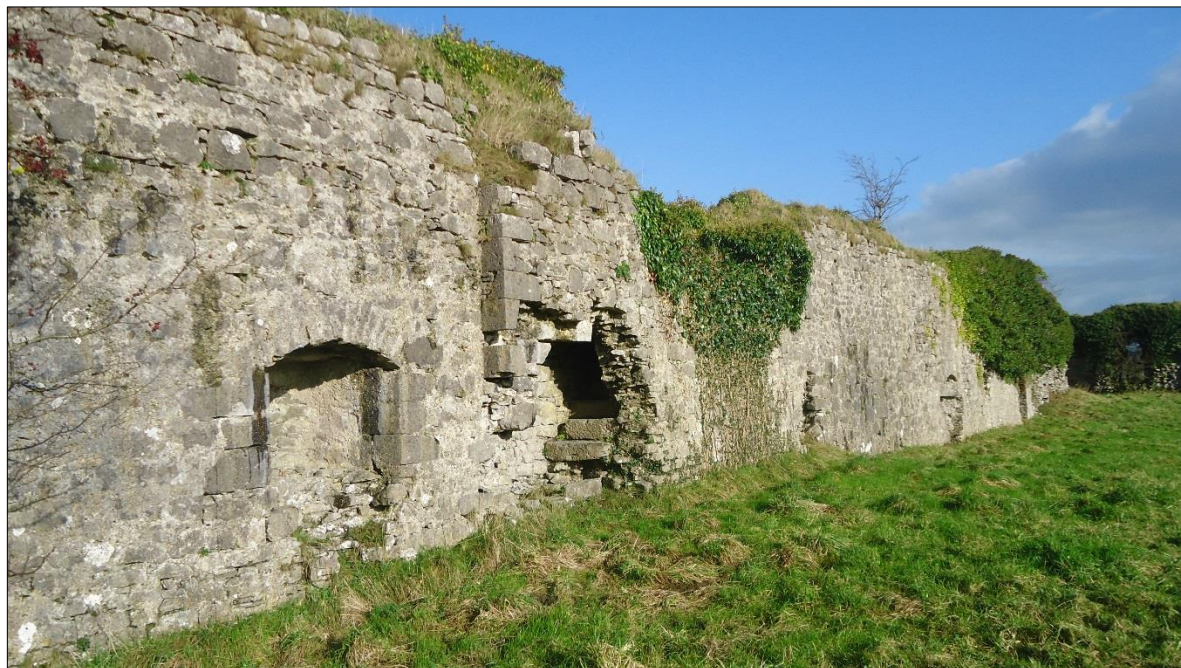
Plate 17: Ballintober Castle, view looking northeast showing the entrance to the mural stairs

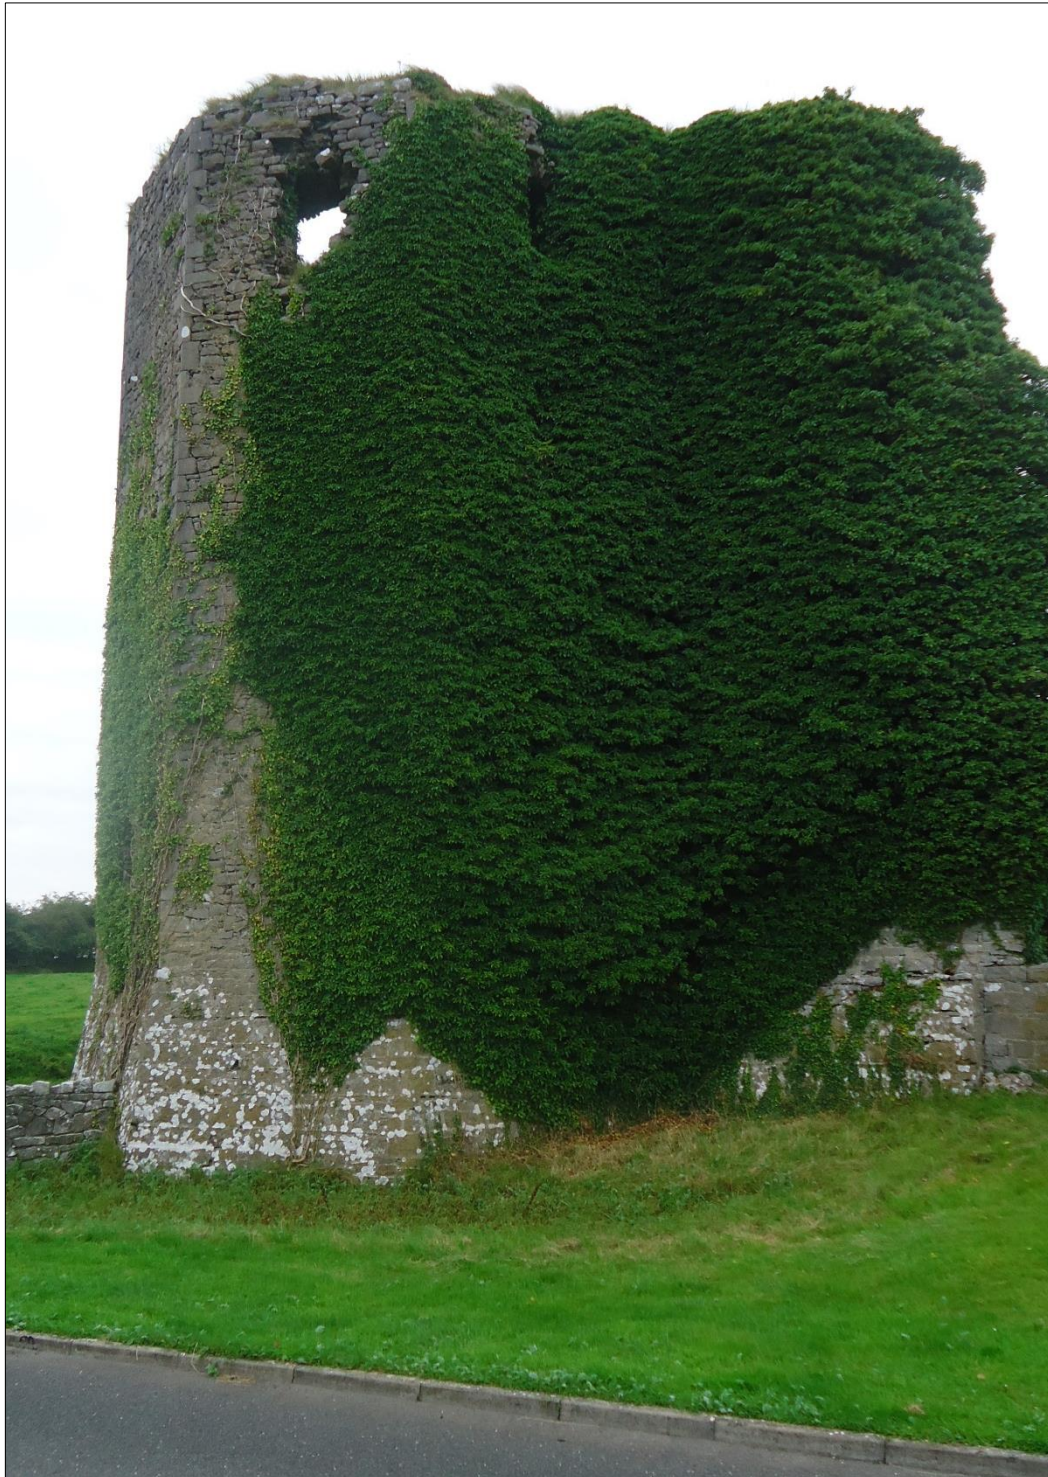
Plate 18: Ballintober Castle, view looking at the exterior of the southwest corner tower from the South

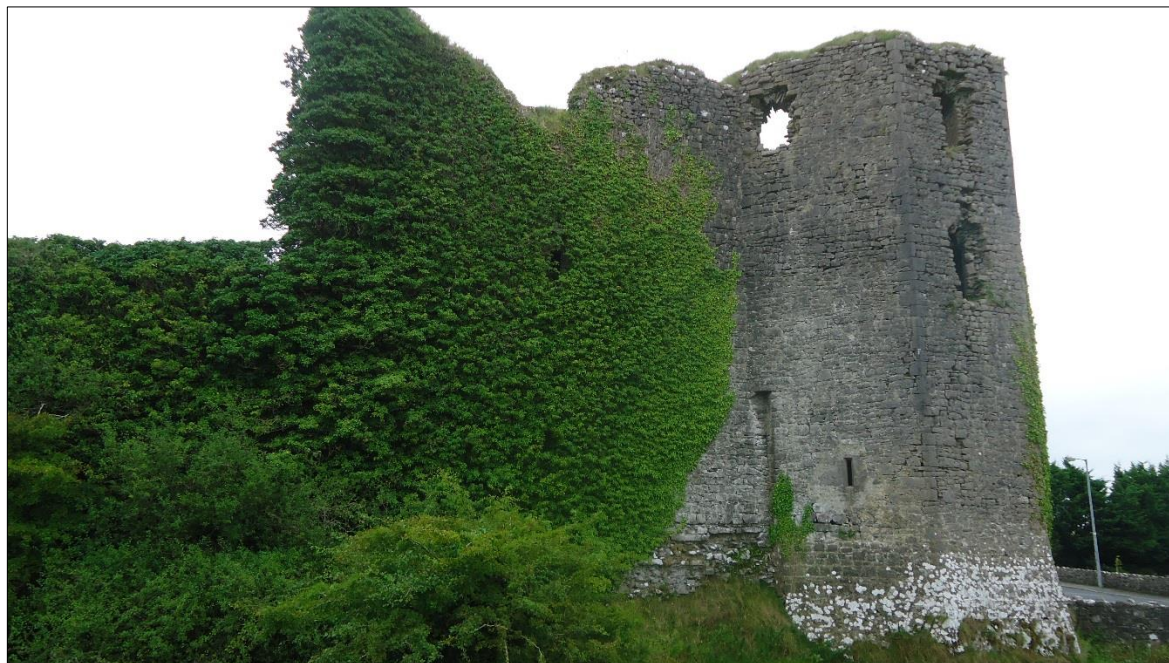
Plate 19: Ballintober Castle, view looking at the exterior of the southwest corner tower from the West

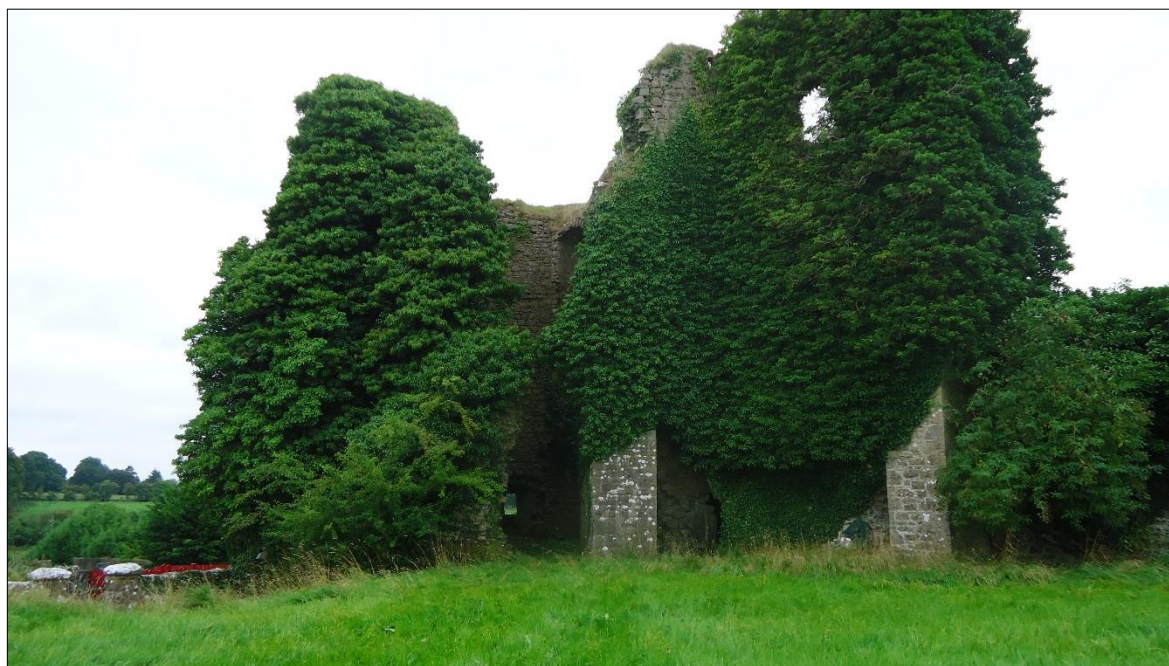
Plate 20: Ballintober Castle, view looking South at exterior of the southwest corner tower, showing the presence of two buttresses inserted to support the tower and the residential chamber to its north

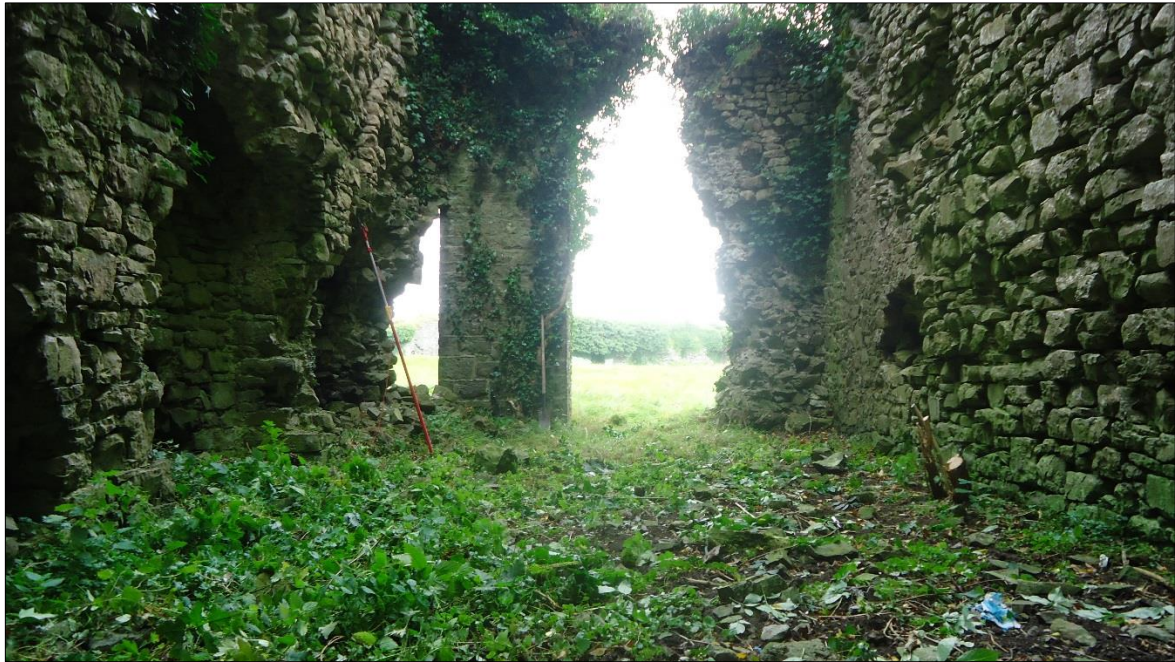
Plate 21: Ballintober Castle, view looking North from interior of the southwest corner tower, showing the ruined nature of the north wall and the presence of the buttress inserted to support the tower

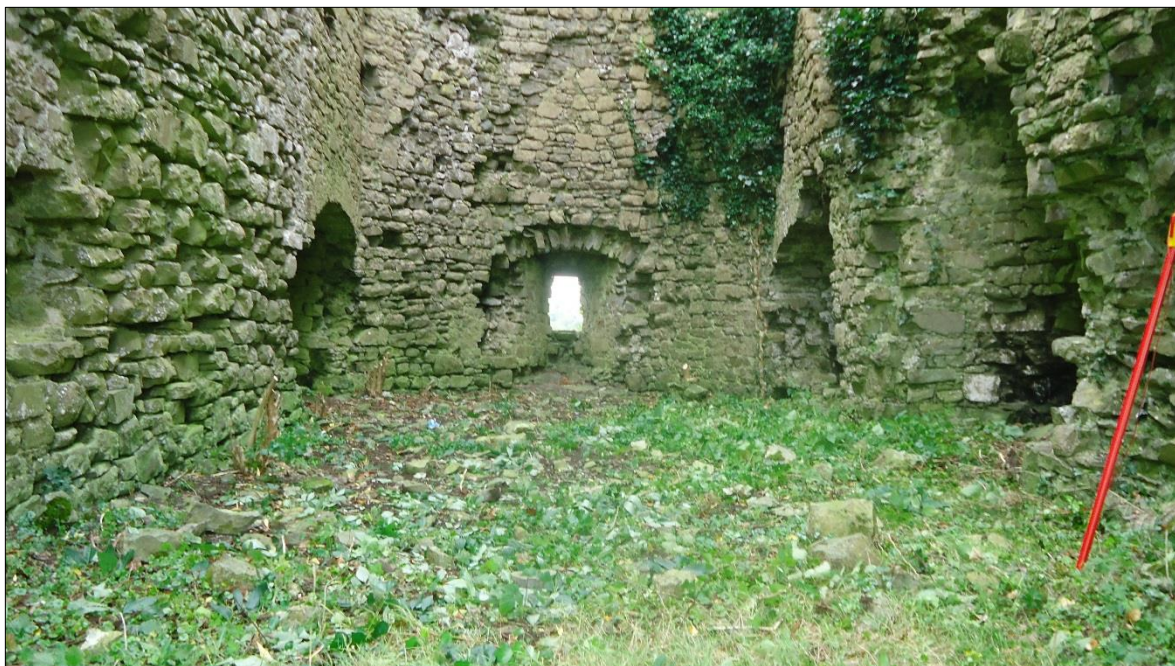
Plate 22: Ballintober Castle, southwest corner tower, view looking at ground floor window in south wall. Note too the arch-shaped feature above the window, which is related to the ceiling structure of this level

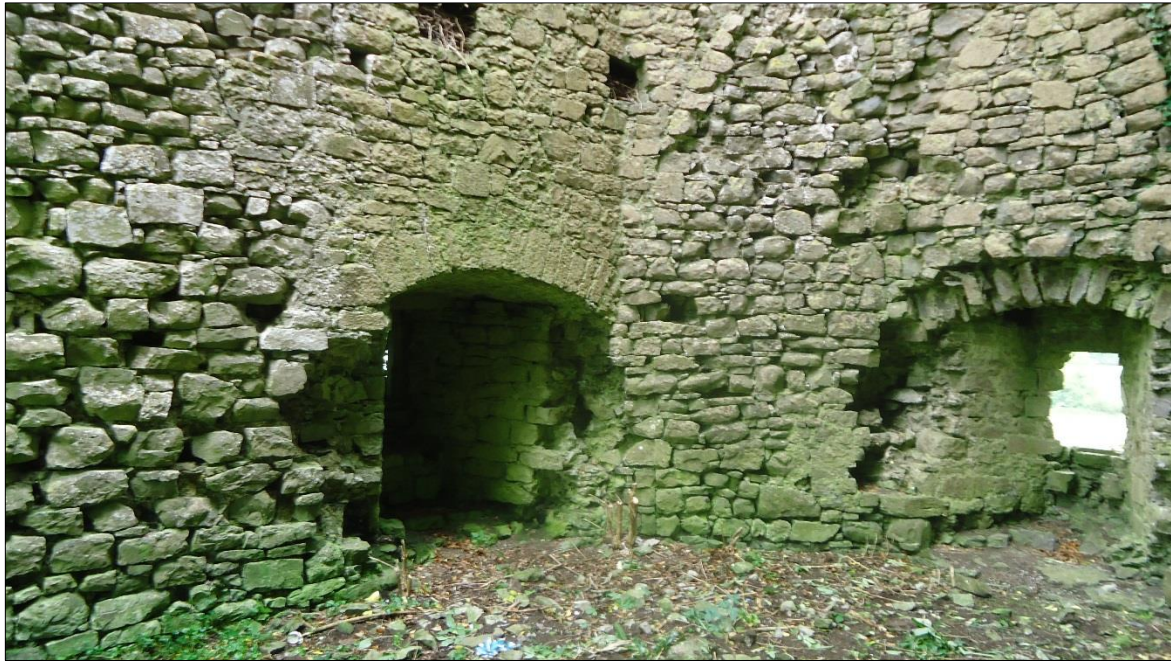
Plate 23: Ballintober Castle, southwest corner tower, view looking at ground floor window in east wall

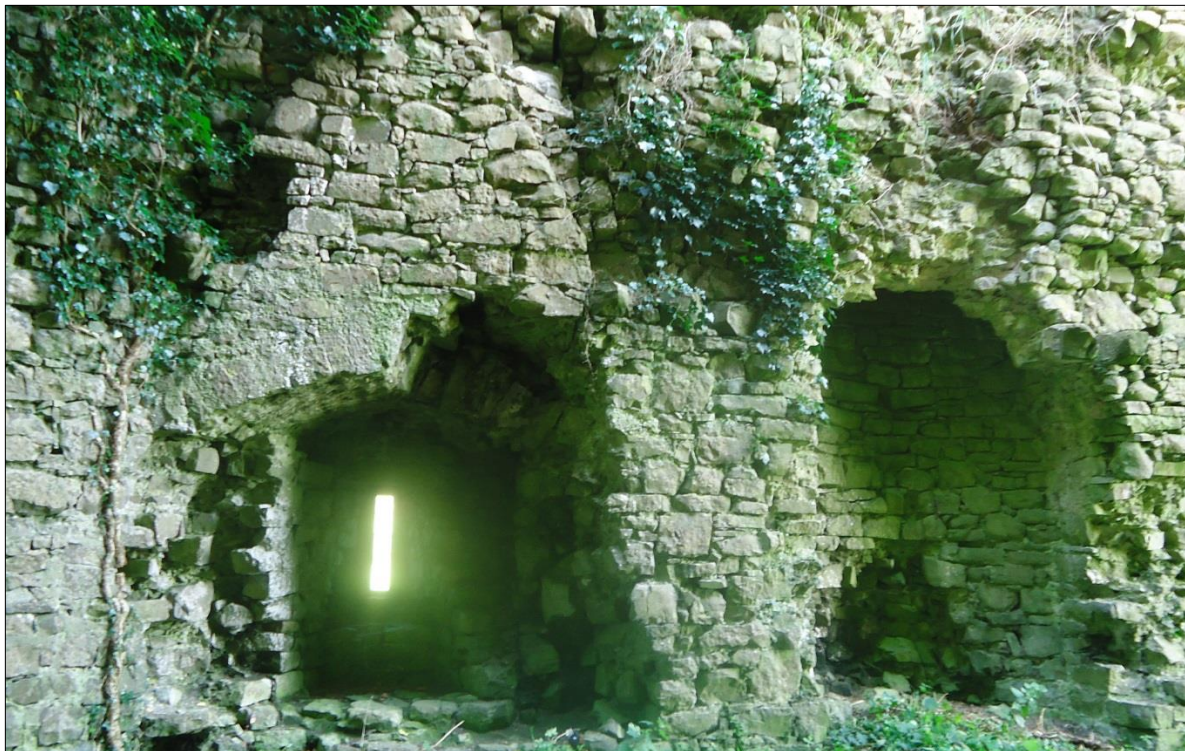
Plate 24: Ballintober Castle, southwest corner tower, view looking at ground floor window and fireplace in west wall

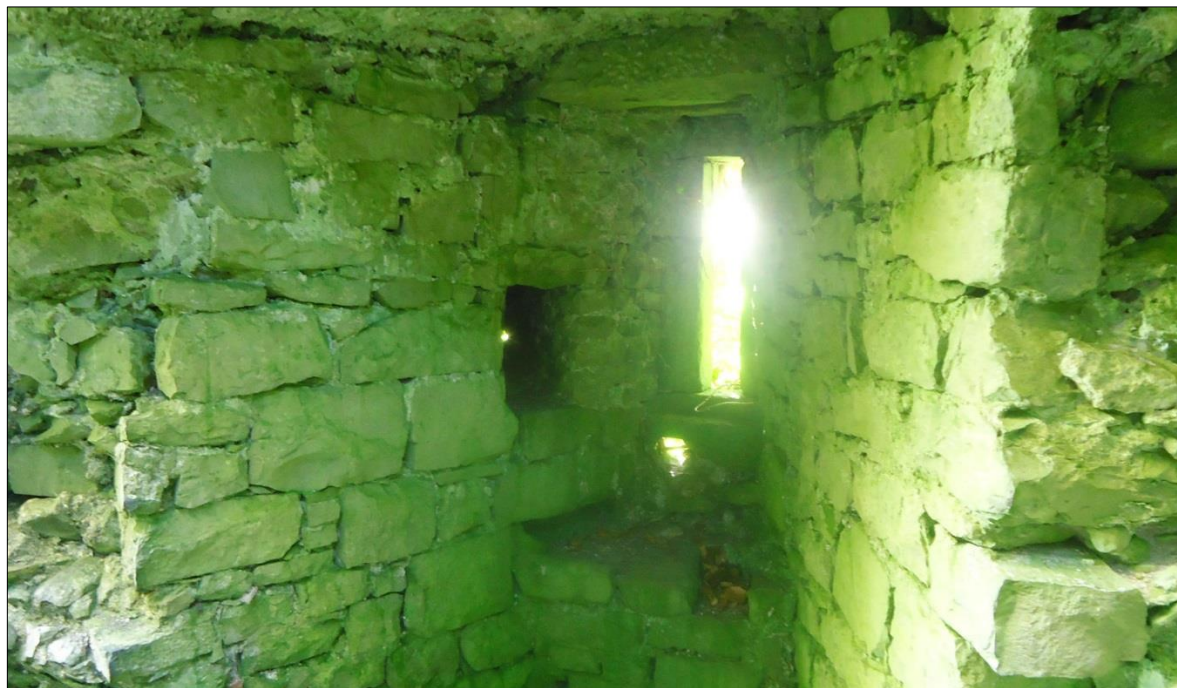
Plate 25: Ballintober Castle, southwest corner tower, view of the east window, showing second gun loop added on its north side

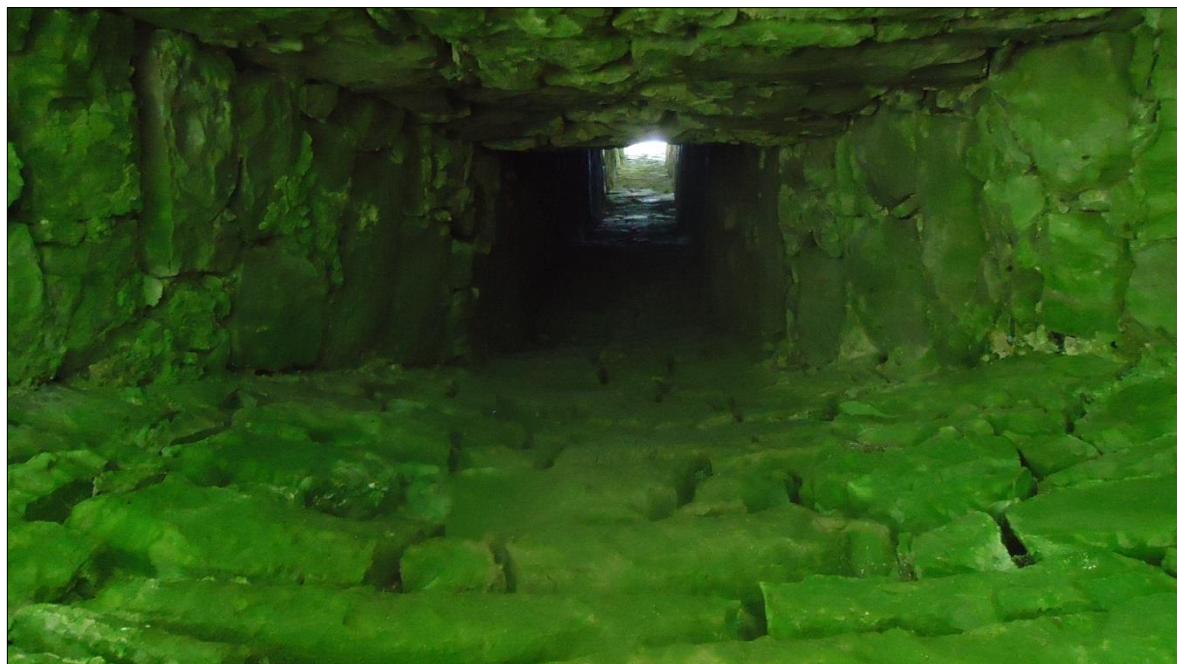
Plate 26: Ballintober Castle, southwest corner tower, view looking up the ground-floor chimney flue
