Archaeological Survey
Ballintober Castle
Ballintober, Co. Roscommon
Ireland

RO027-048002-

Niall Brady

Castle Studies Trust
2014 Grant award

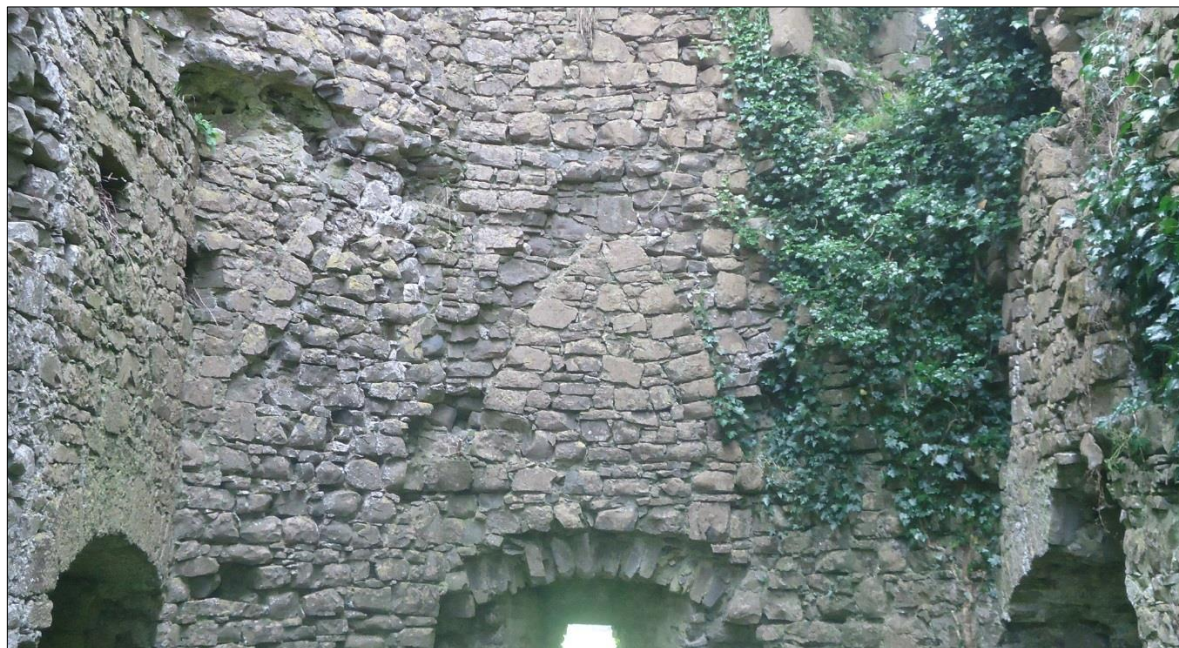
Plate 27: Ballintober Castle, southwest corner tower, view looking at the steeply-pitch arched recess above the south window, which served as one of several such arches to support a complex ceiling. Similar arched-recesses exist to the left and to right on the angled facades of the tower

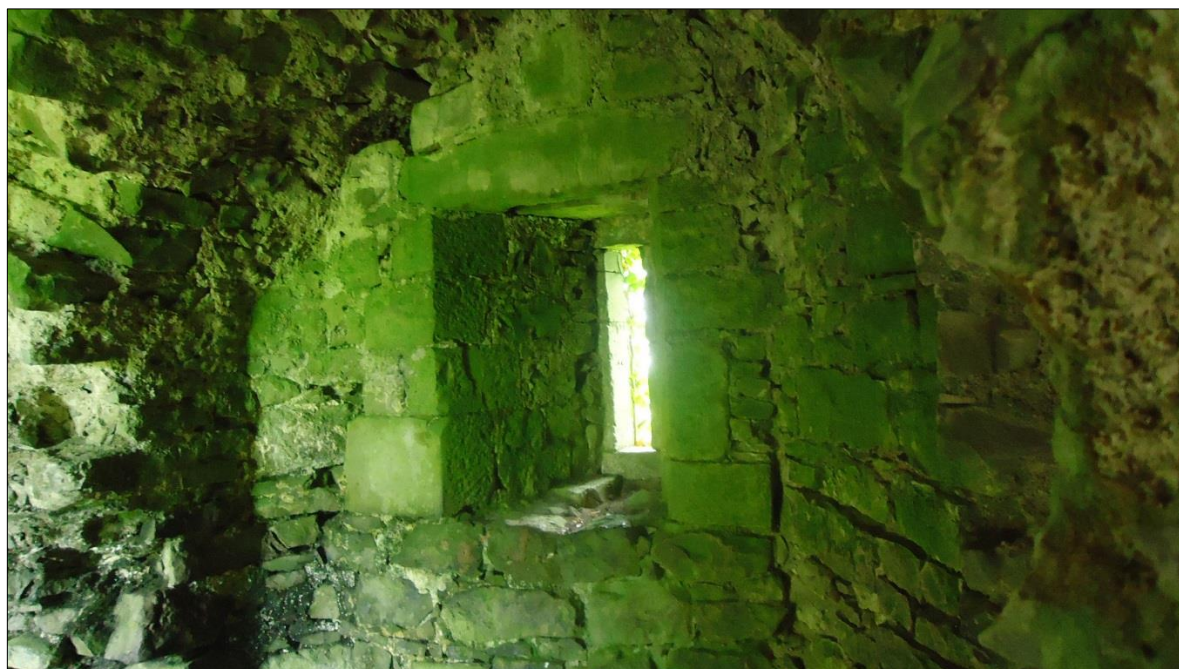
Plate 28: Ballintober Castle, north chamber in southwest corner tower, view looking at west-facing window

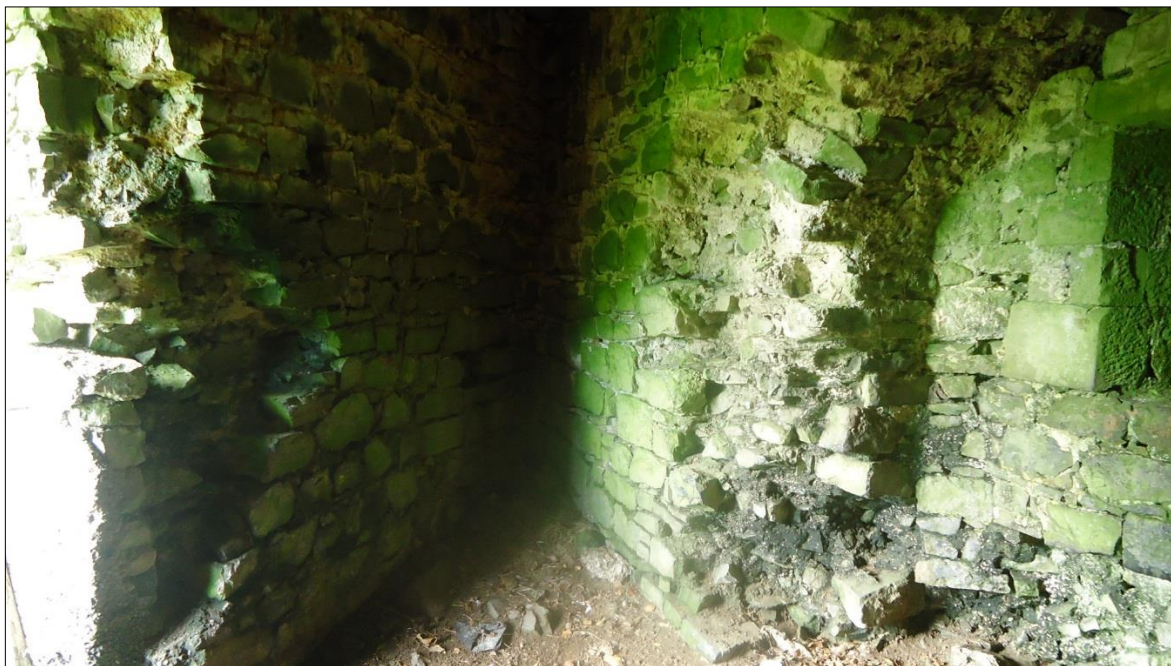
Plate 29: Ballintober Castle, north chamber in southwest corner tower, view looking at the oblique corner in the south angle where the chamber is formed from the external west wall meeting the corner tower

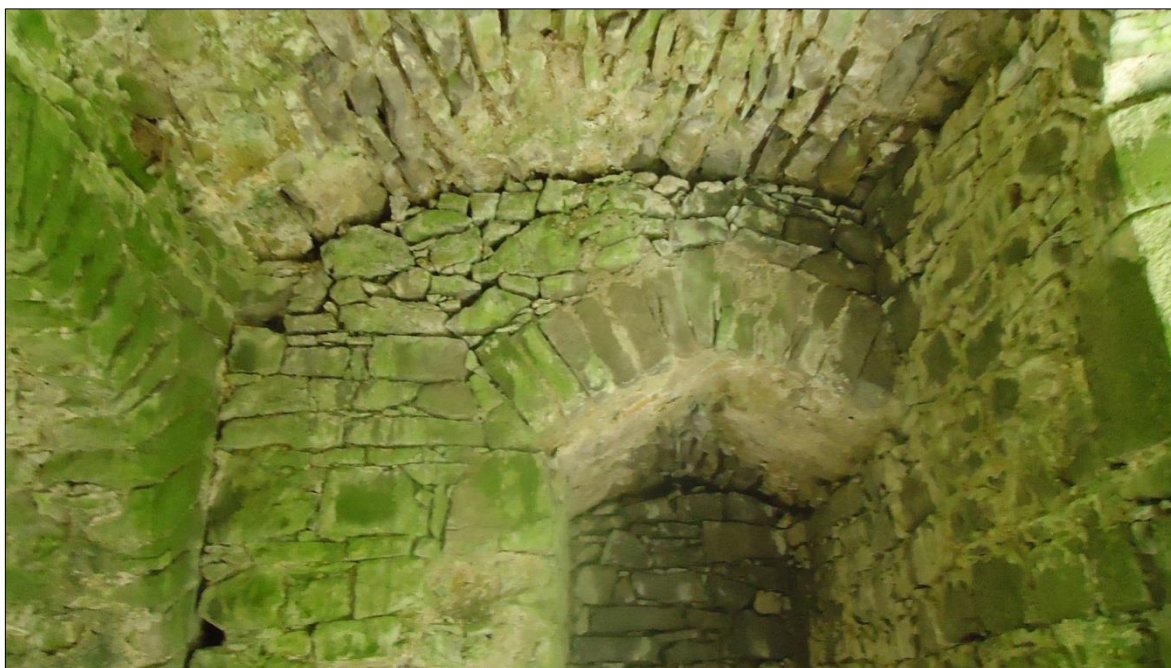
Plate 30: Ballintober Castle, north chamber in southwest corner tower, view looking north to the inserted garderobe wall on the left with its simple arch to form a recess to the right. The end/north wall of the recess is a blind for a second/primary garderobe chute behind it

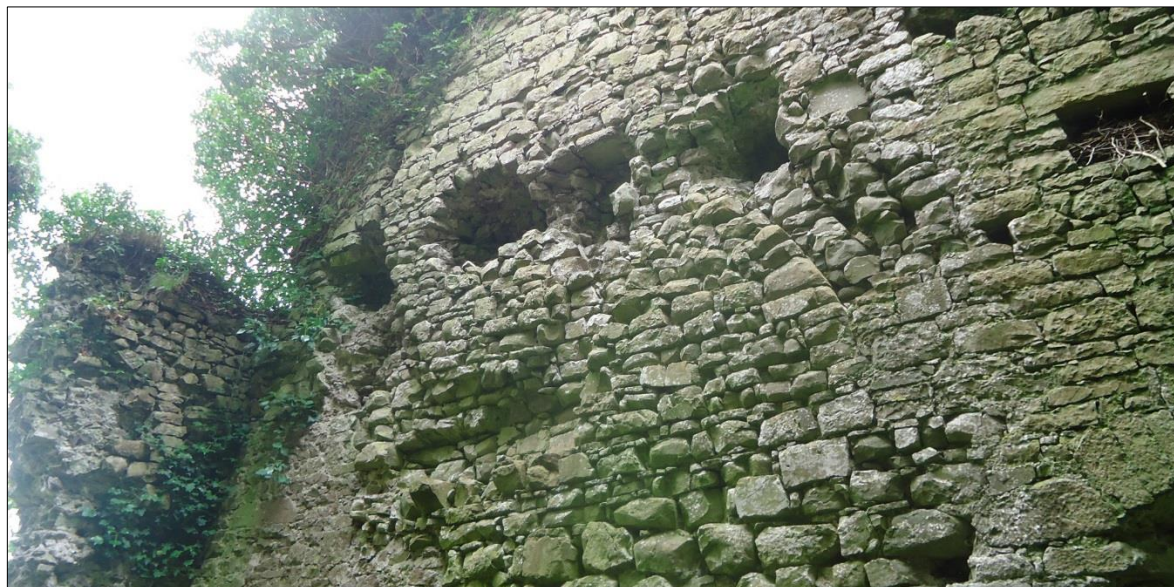
Plate 31: Ballintober Castle, southwest corner tower, view looking at the north side of the east wall, showing the arched recesses of the ground-floor ceiling, and a series of four recesses for joists above to support the a timber floor on the first floor. The absence of these elements on the right (south) side of the picture may indicate that this reflects rebuilding of the tower's interior at some point

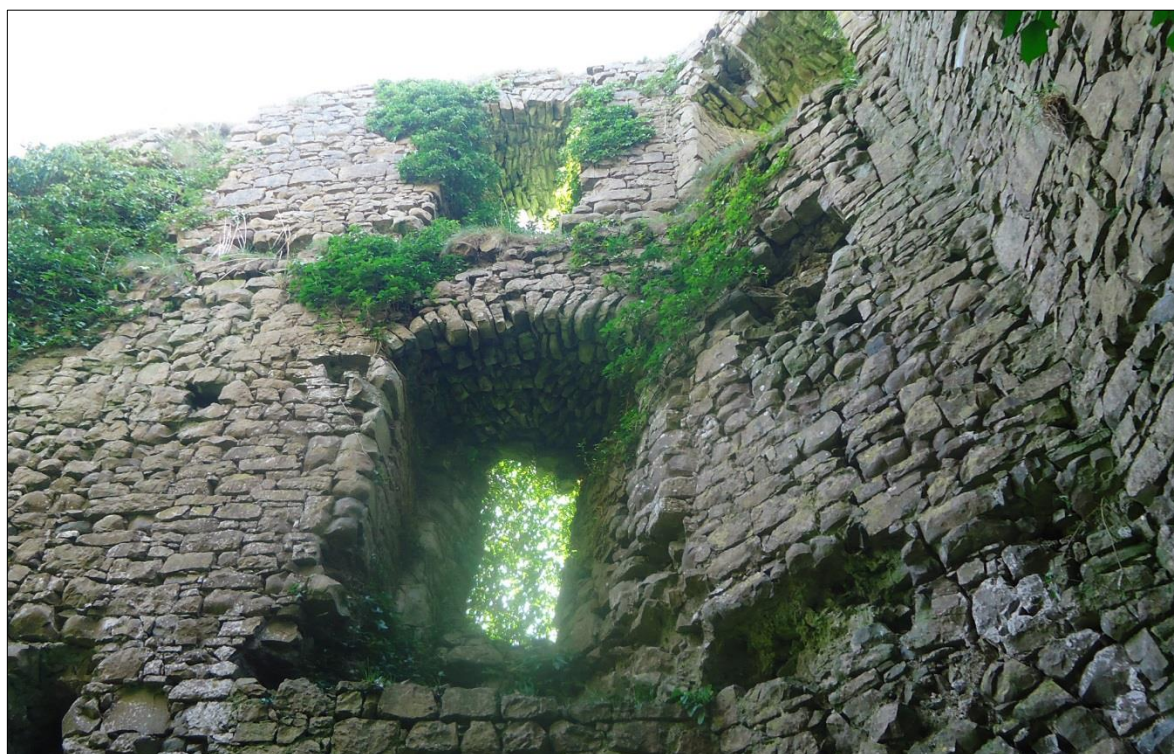
Plate 32: Ballintober Castle, southwest corner tower, view looking up at the first- and second-floor windows on the east wall

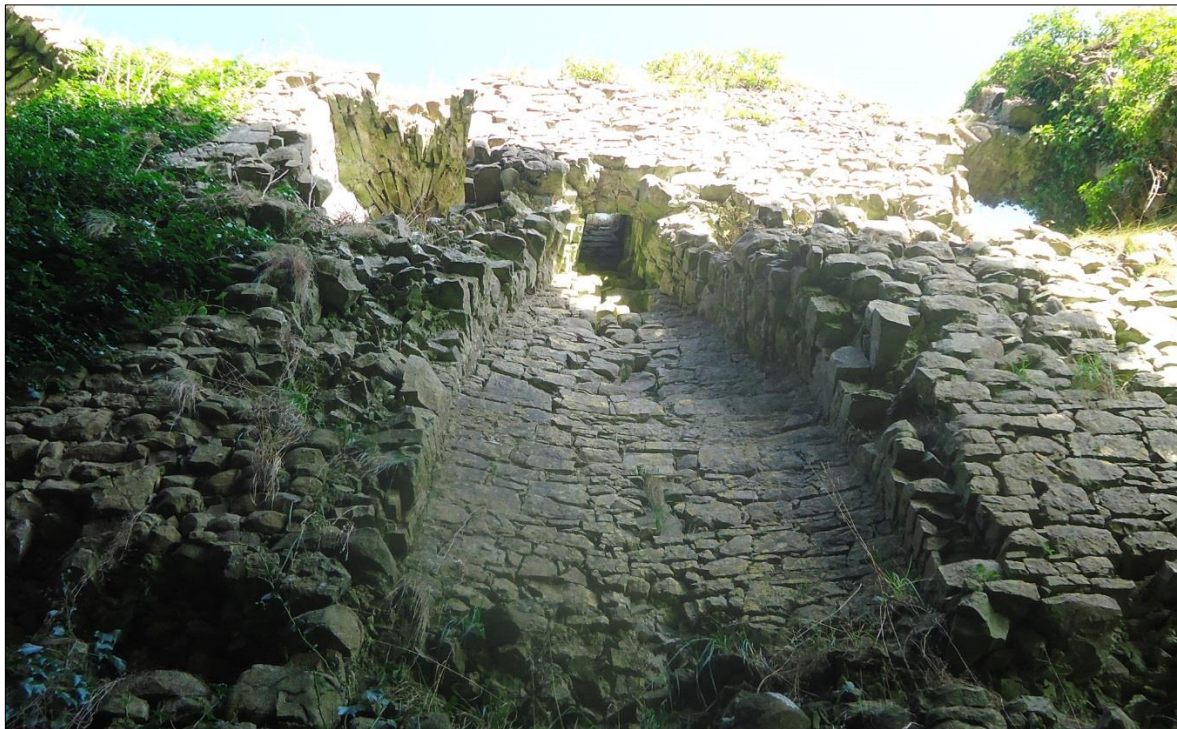
Plate 33: Ballintober Castle, southwest corner tower, view looking up to the fireplace on the first floor west wall. On the second floor above, the opening to the left (south) is a window and that on then right (north) is the entrance to the north chamber

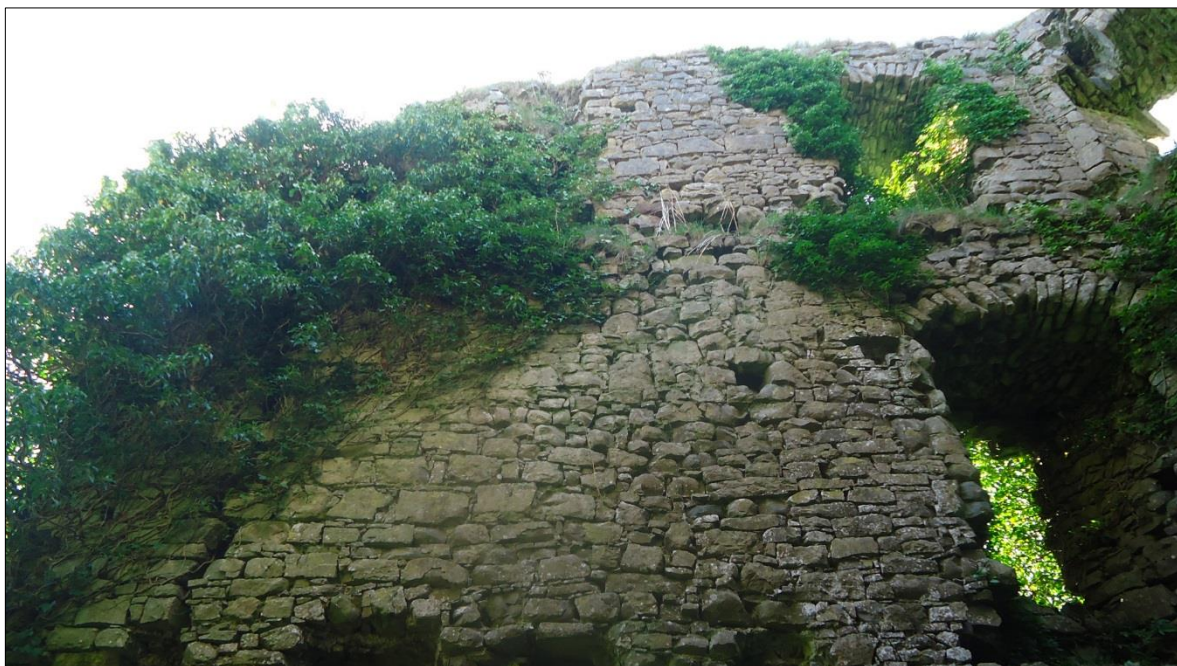
Plate 34: Ballintober Castle, southwest corner tower, view looking up to the first and second floors on the east wall, showing the angle for a window return just peeking out from the ivy growth on the left (north) side at second-floor level

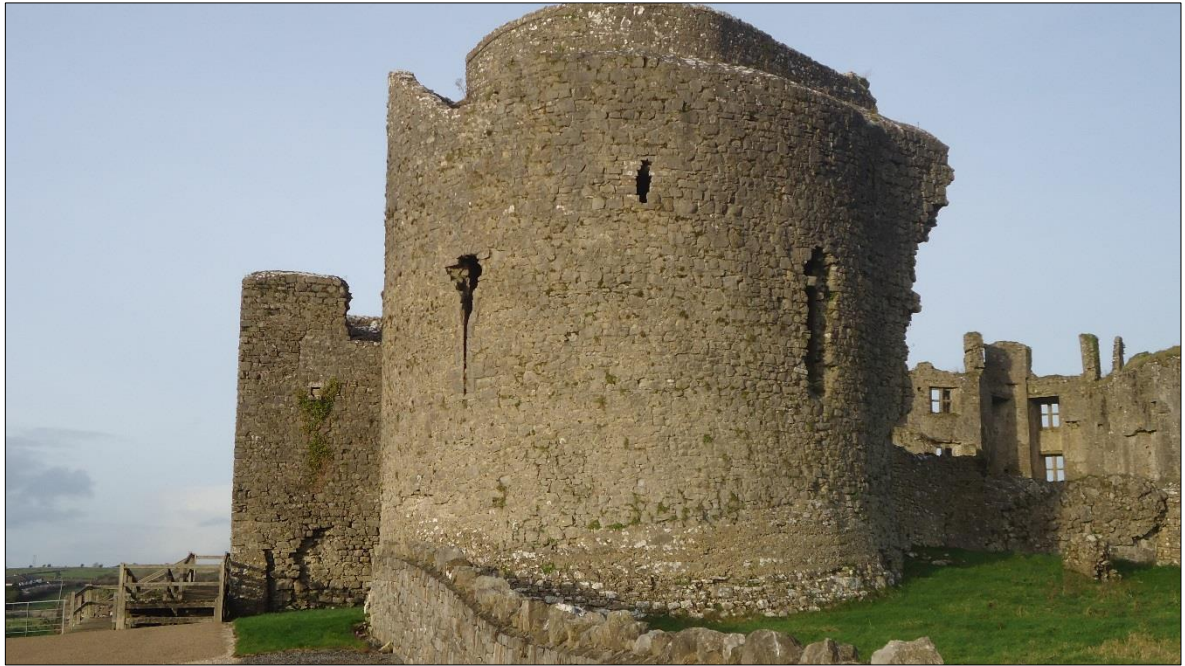
Plate 35: Defensive slit openings, Roscommon Castle. View shows the southwest corner tower with its tall narrow arrow slits, which (in common with those at Ballymote Castle, Plate 36) are noticeably taller and more defensible than those at Ballintober Castle

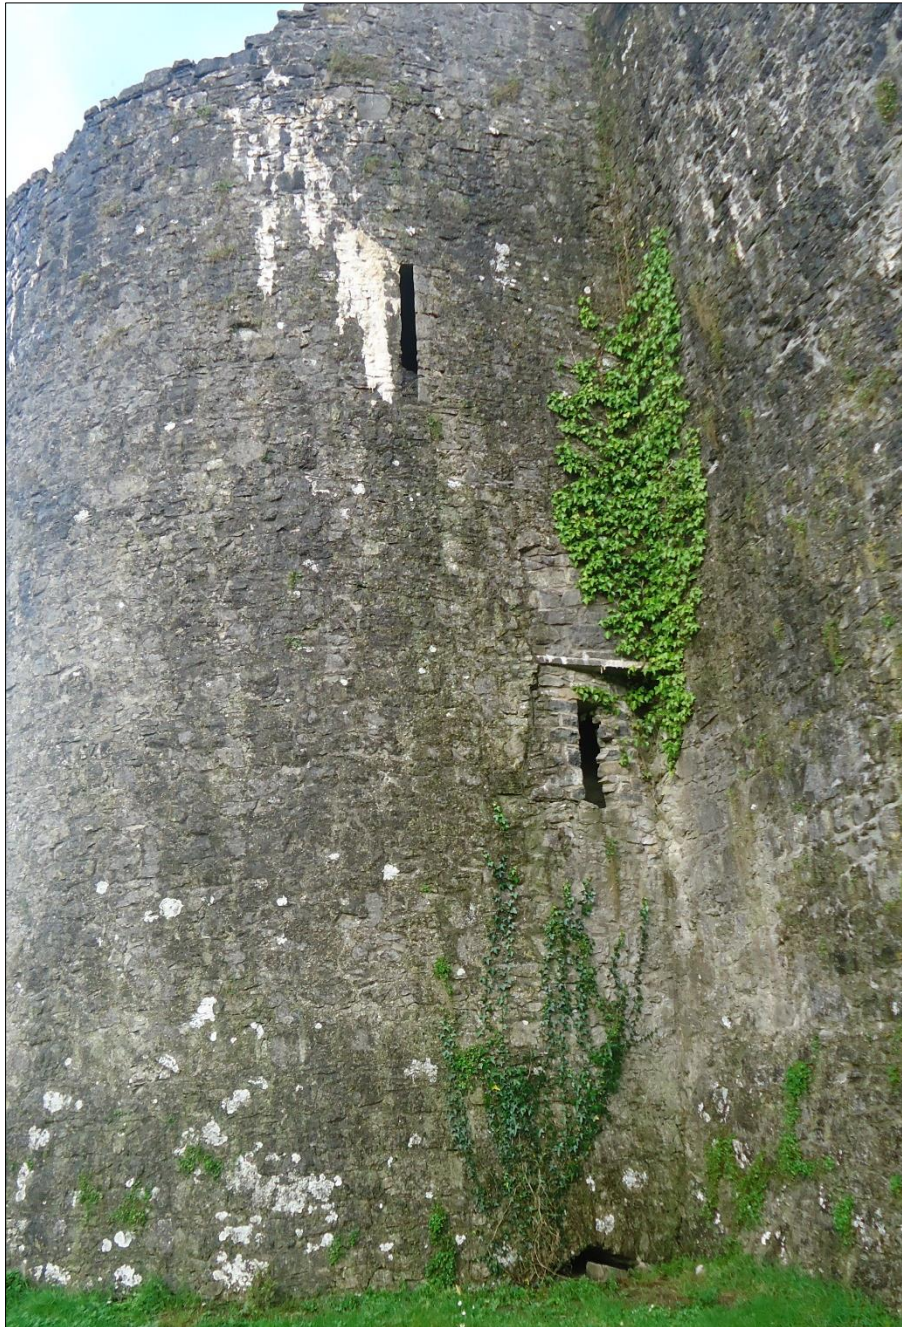
Plate 36: Defensive slit openings, Ballymote Castle. View looking Northeast at western mural tower, showing the tall arrow slits, to contrast with the much shorter versions at Ballintober.

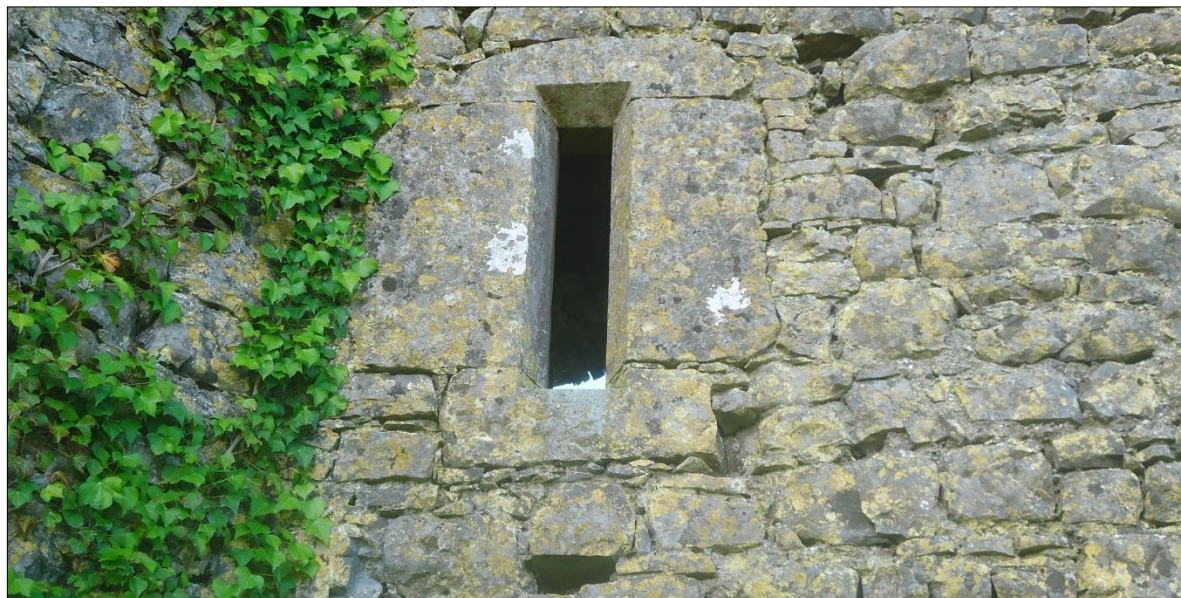
Plate 37: Ballintober Castle, northwest corner tower, view from outside looking at northeast-facing window on ground floor. These short vertical slits contrast with the defined arrow loops seen at Roscommon an Ballymote Castles in such locations (Plates 35-36)

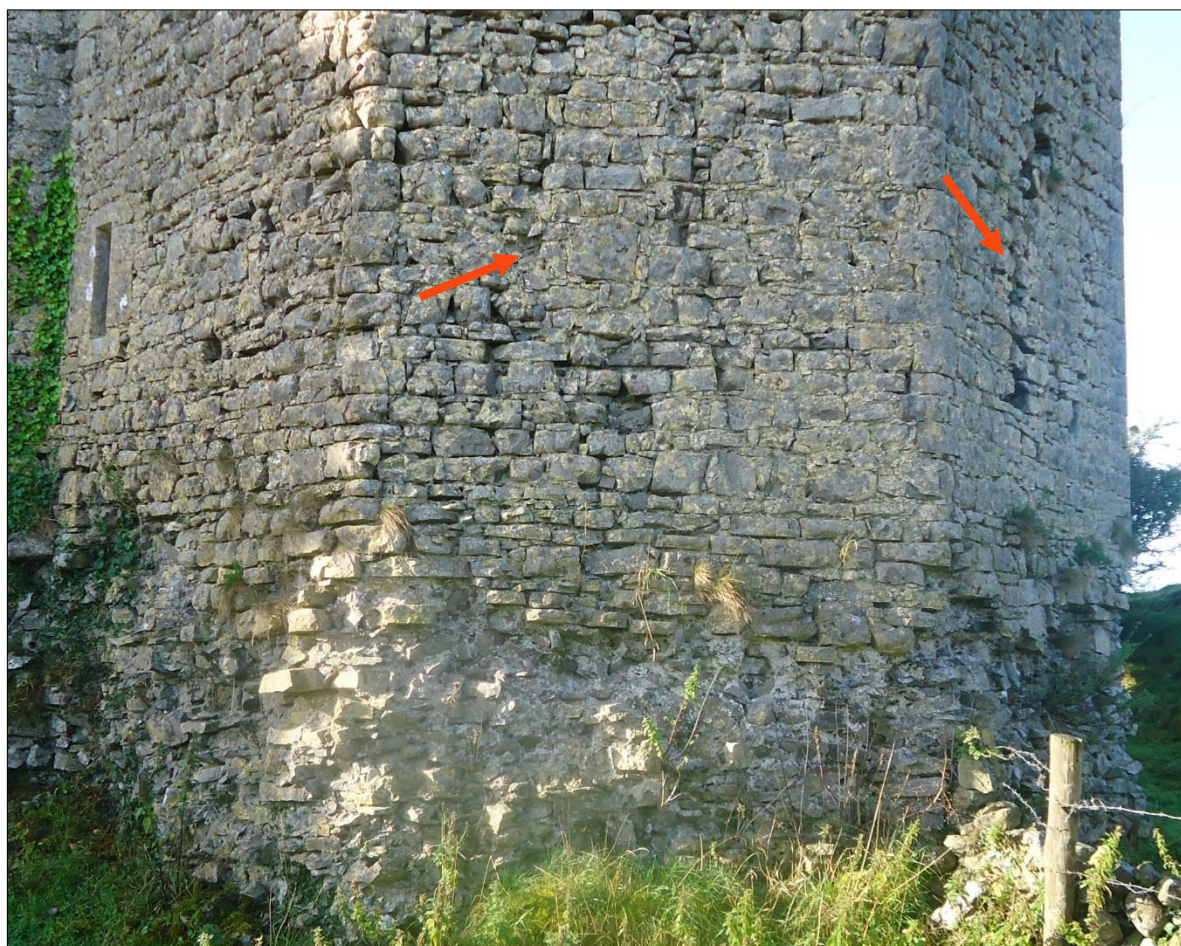
Plate 38: Ballintober Castle, northwest corner tower, view looking onto the north exterior at ground-floor level, showing two blocked-up openings of former slit windows in the north and northwest angles. The surviving opening in the northeast angle (Plate 37) is also shown

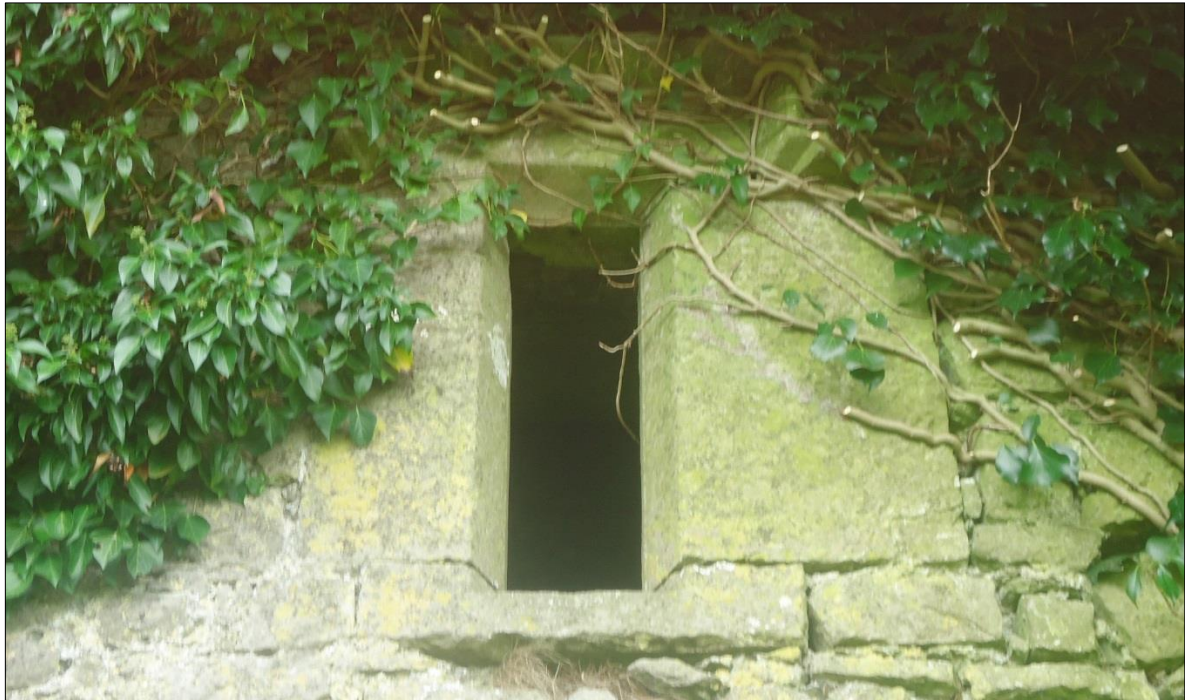
Plate 39: Ballintober Castle, northwest corner tower, view looking above entrance at mezzanine level to a short vertical opening with a flat hood moulding

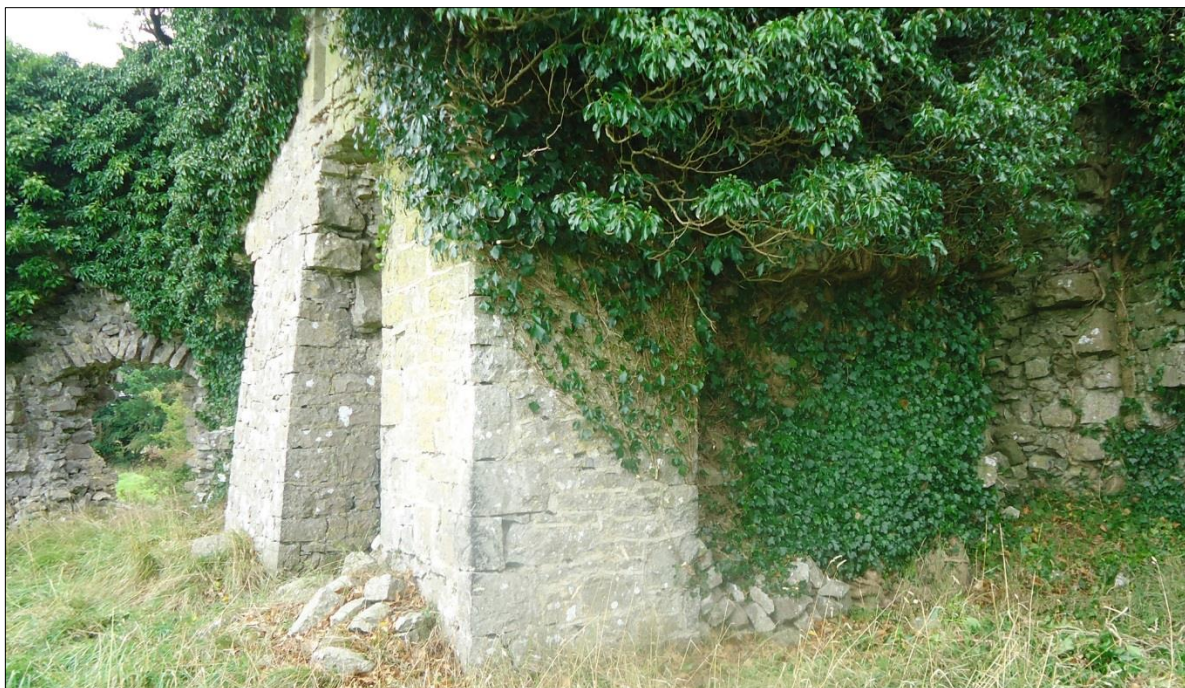
Plate 40: Ballintober Castle, northwest corner tower, view showing the buttressing added to the south wall to support the tower, presumably during the 19th century

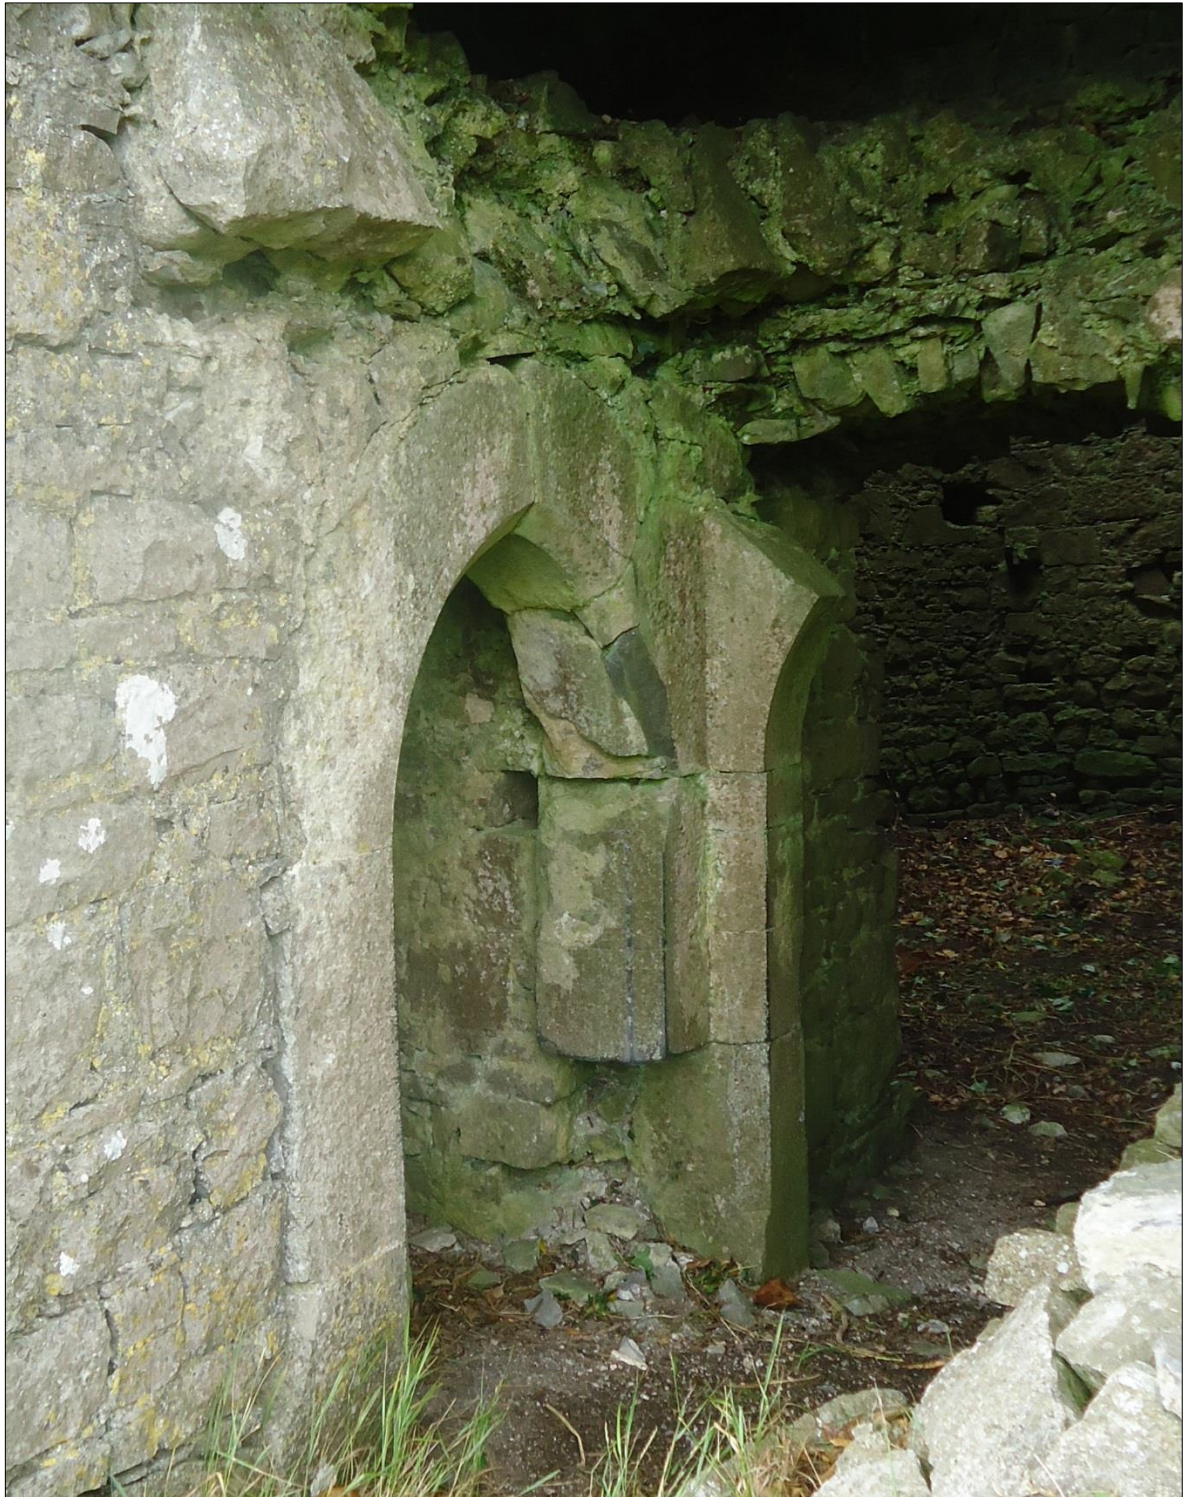
Plate 41: Ballintober Castle, northwest corner tower, view looking through entrance to two doorways, the left (West) leading to the stairs and the right (North) leading into the main chamber. The picture also shows the vaulting in the roof above, which has collapsed

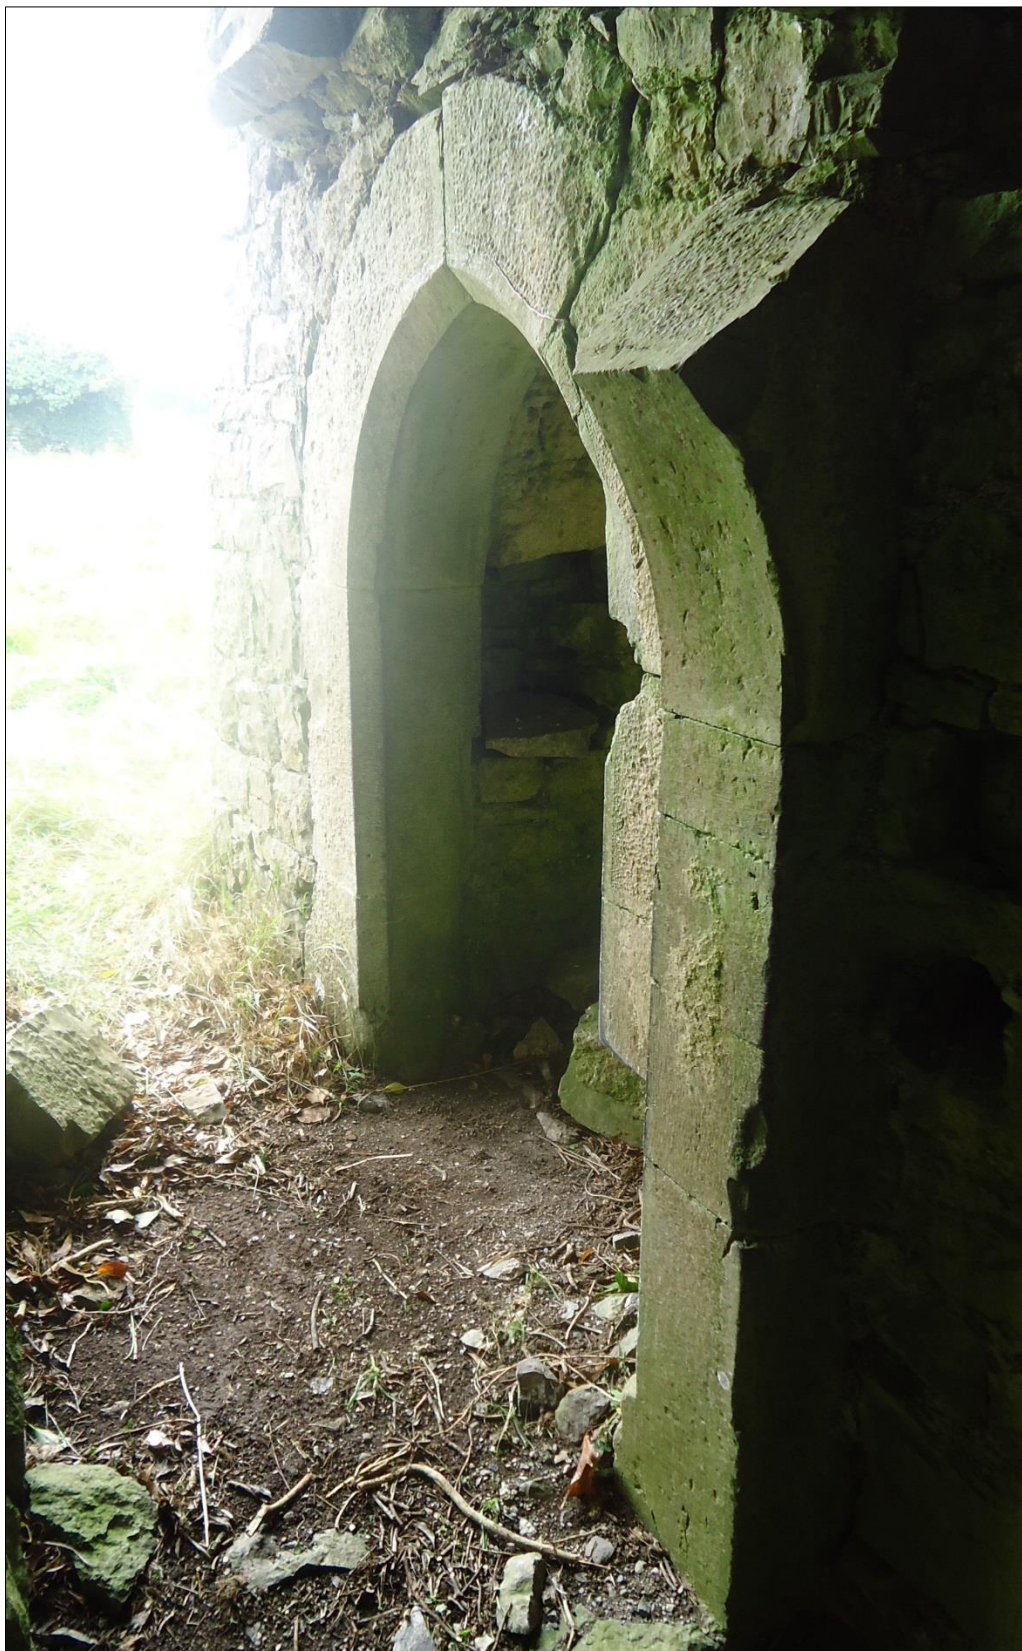
Plate 42: Ballintober Castle, northwest corner tower, view of doorway into stair passage, showing the nature of the doorway's construction, which is typical of the doors in this tower

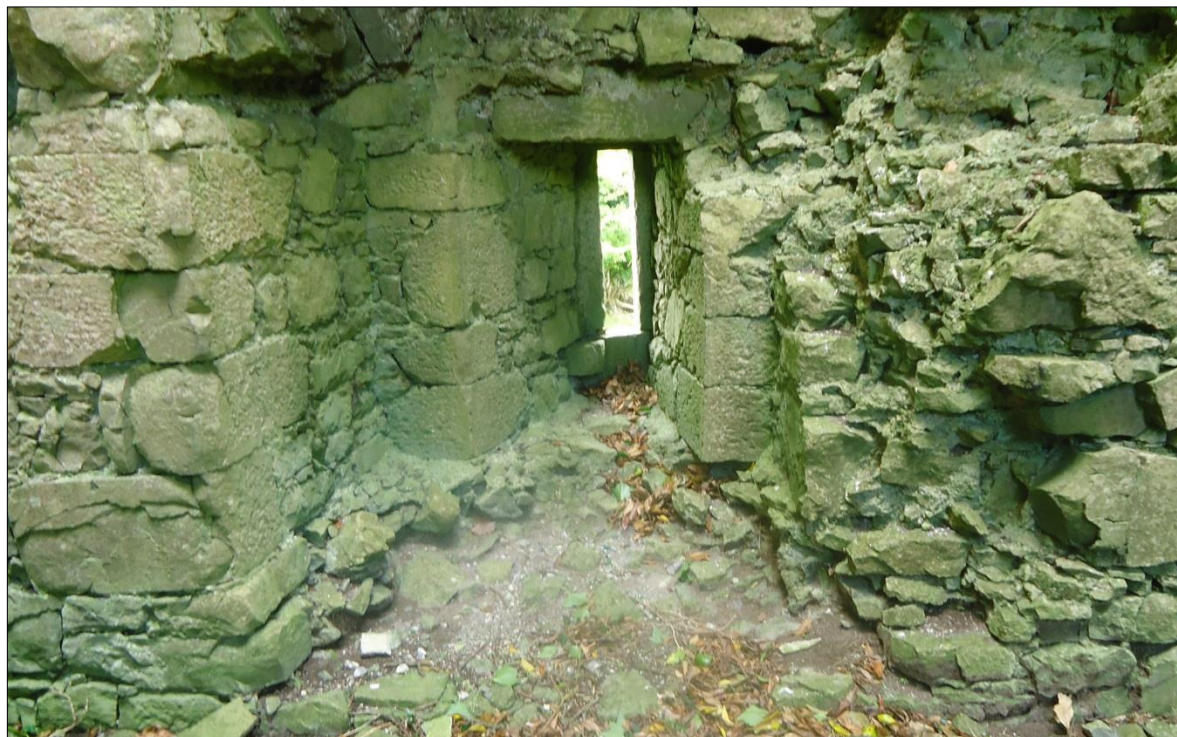
Plate 43: Ballintober Castle, northwest corner tower, view of the ground-floor window in the east wall

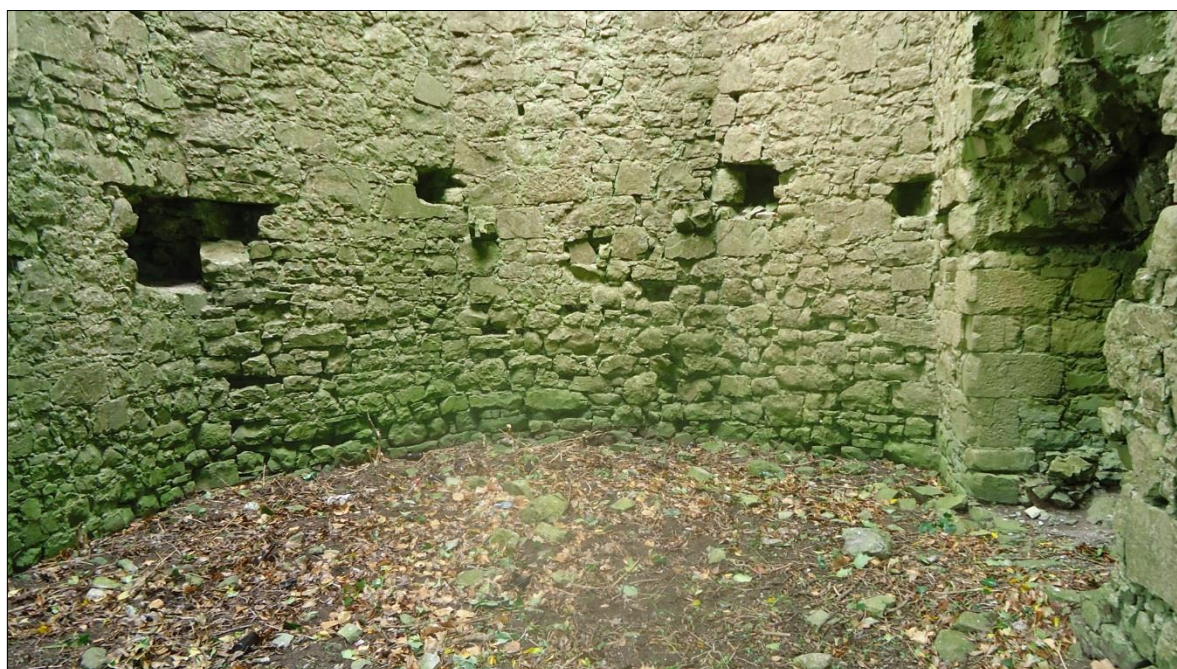
Plate 44: Ballintober Castle, northwest corner tower, view of the north end of the ground floor level, showing no indication of the blocked-up window openings discernible externally. The two squared recesses either side of the end-angle are to support joists for the floor level above

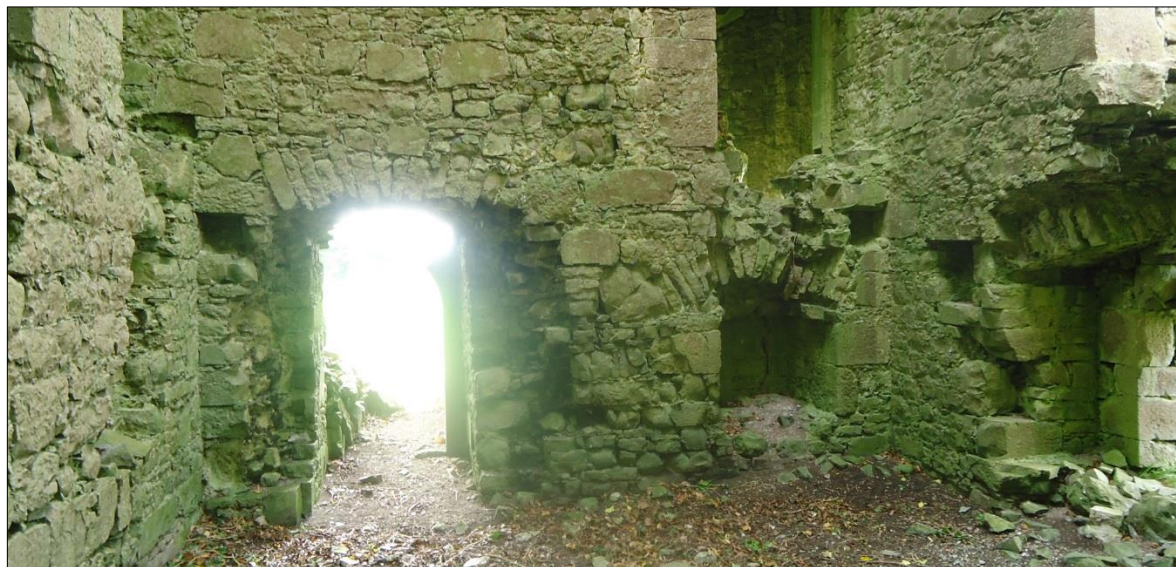
Plate 45: Ballintober Castle, northwest corner tower, view showing the ground floor looking south towards the entrance. The joist-recesses for the first-floor above are evident on the south wall of the main chamber

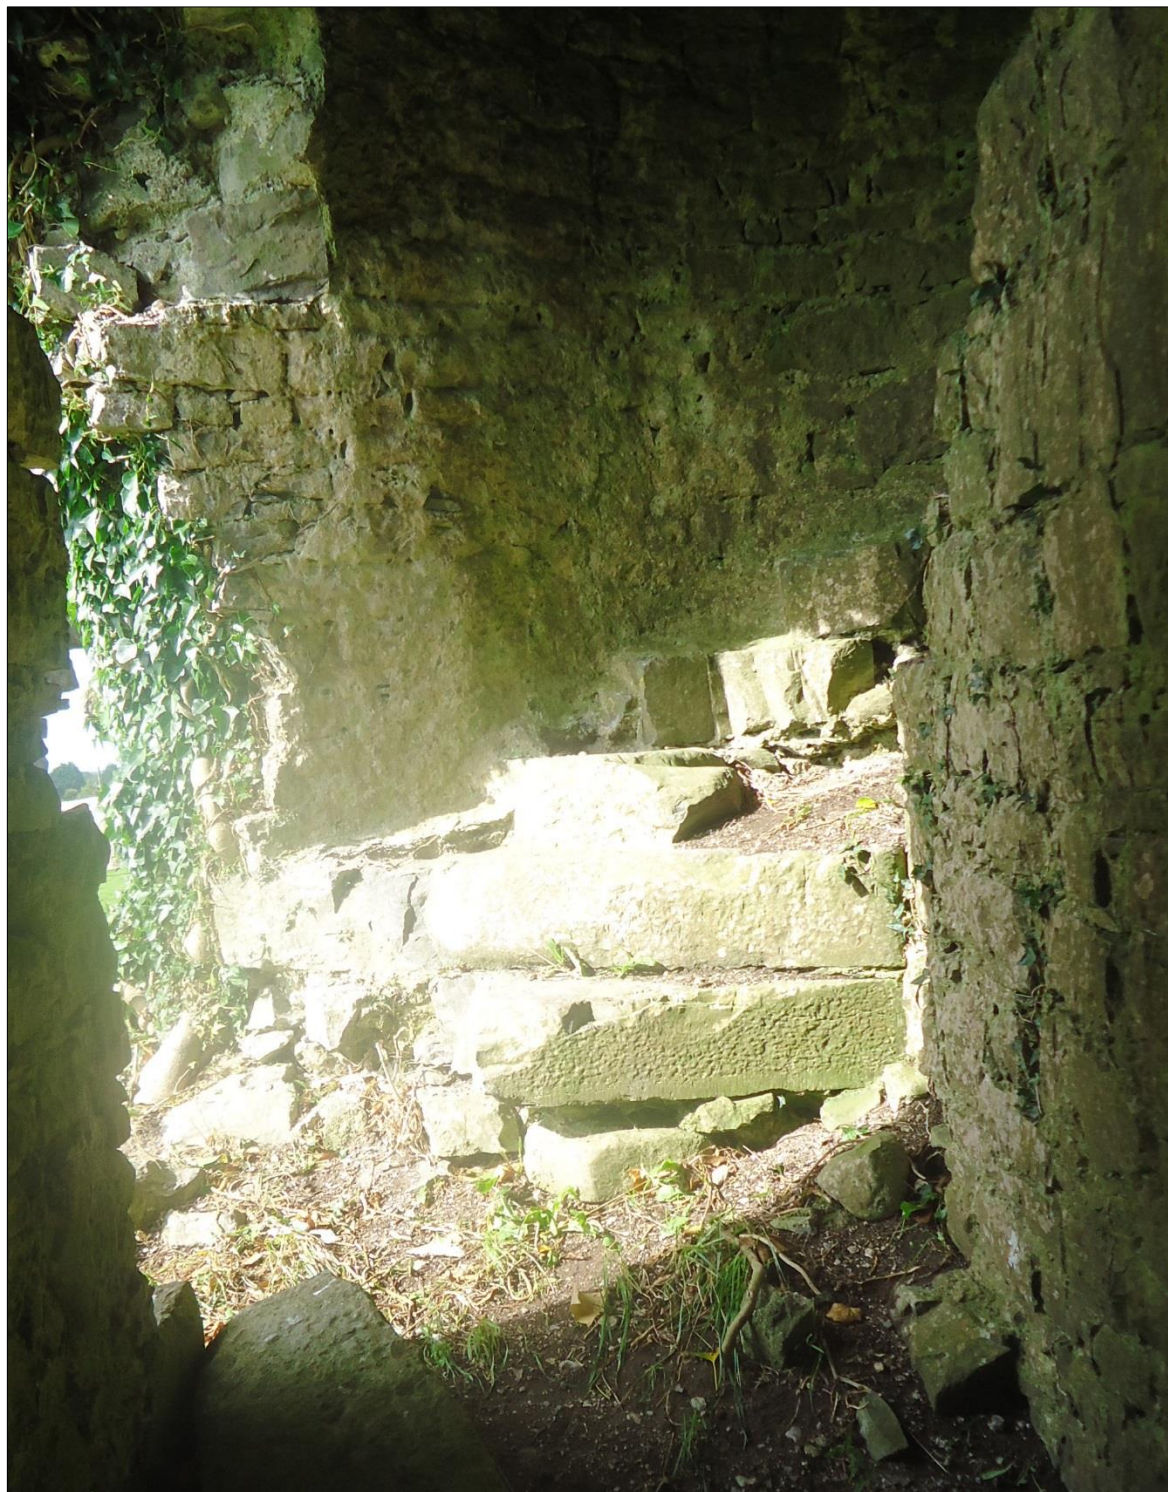
Plate 46: Ballintober Castle, northwest corner tower, view looking west to the base of the stairs

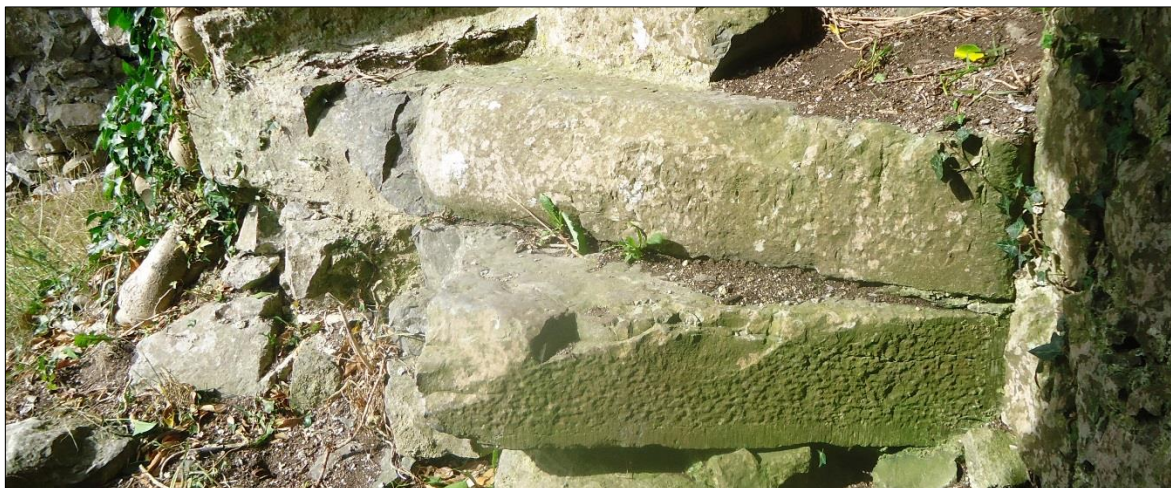
Plate 47: Ballintober Castle, northwest corner tower, detailed view of base of steps showing punch-dressing on lower step

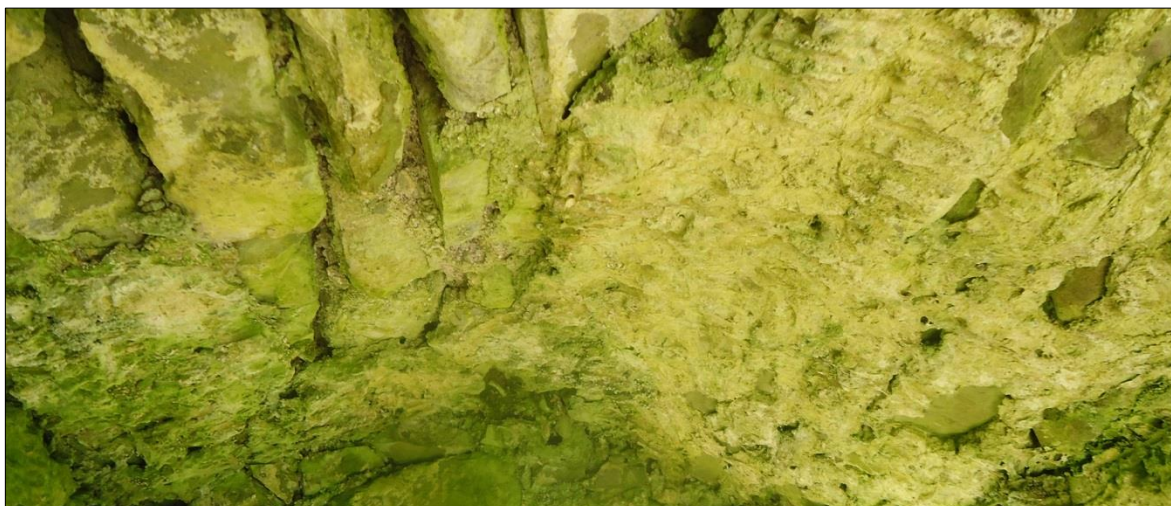
Plate 48: Ballintober Castle, northwest corner tower, detail of ceiling above entrance to first floor, showing remnants of wicker centring

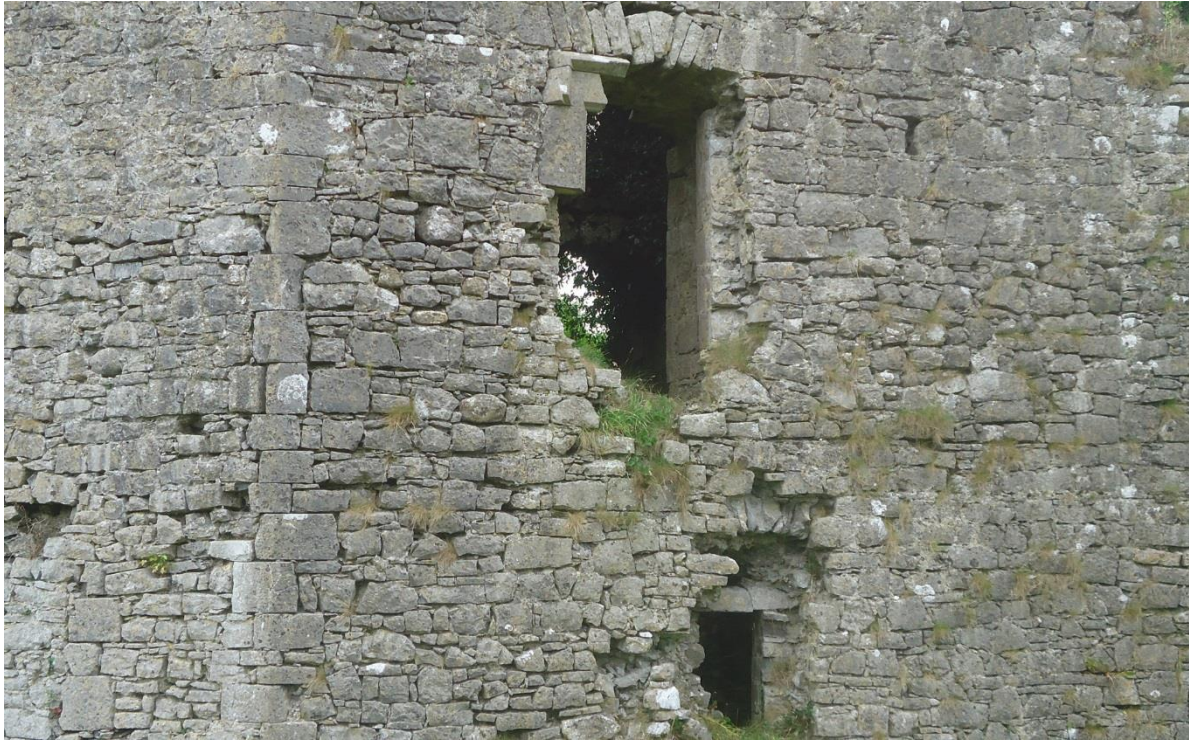
Plate 49: Ballintober Castle, northwest corner tower, external view showing the remains of the west-facing windows on the ground- and first-floor levels. Note too the quoin stones on the angle of the tower to the left (North) and the line of four quoin stones further left that mark the blocked-up ground-floor window in this angle
