Archaeological Survey
Ballintober Castle
Ballintober, Co. Roscommon
Ireland

RO027-048002-

Niall Brady

Castle Studies Trust
2014 Grant award

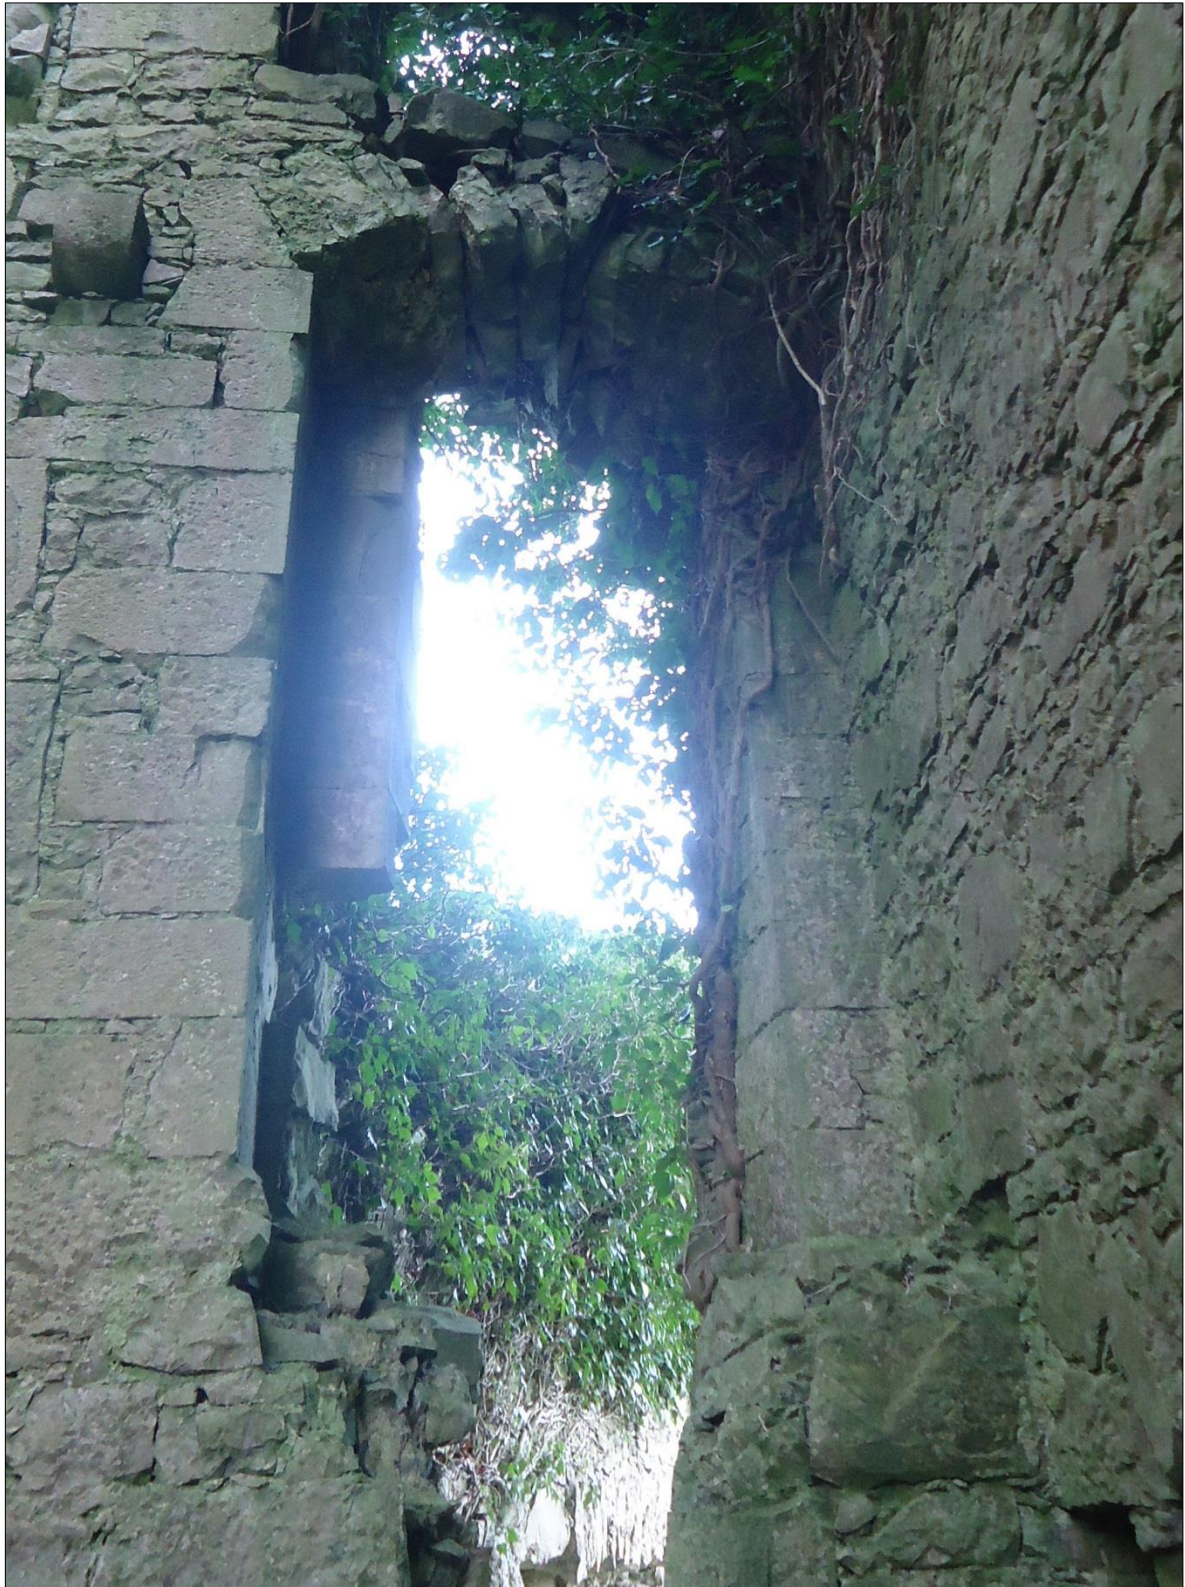
Plate 50: Ballintober Castle, northwest corner tower, view of the east-facing window opening in the first floor, suggesting the former presence of a tall narrow window overlooking the castle's interior

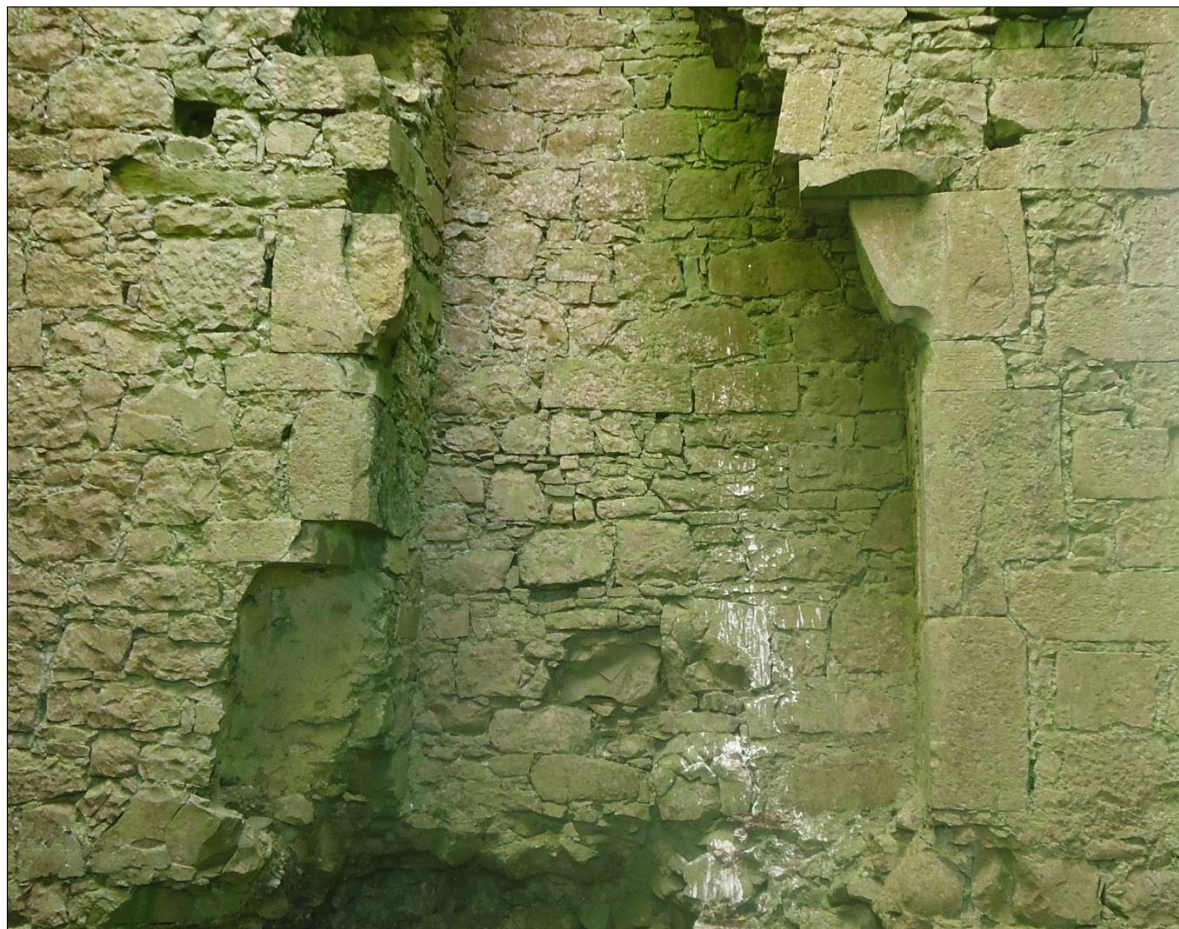
Plate 51: Ballintober Castle, northwest corner tower, view of the first-floor fireplace

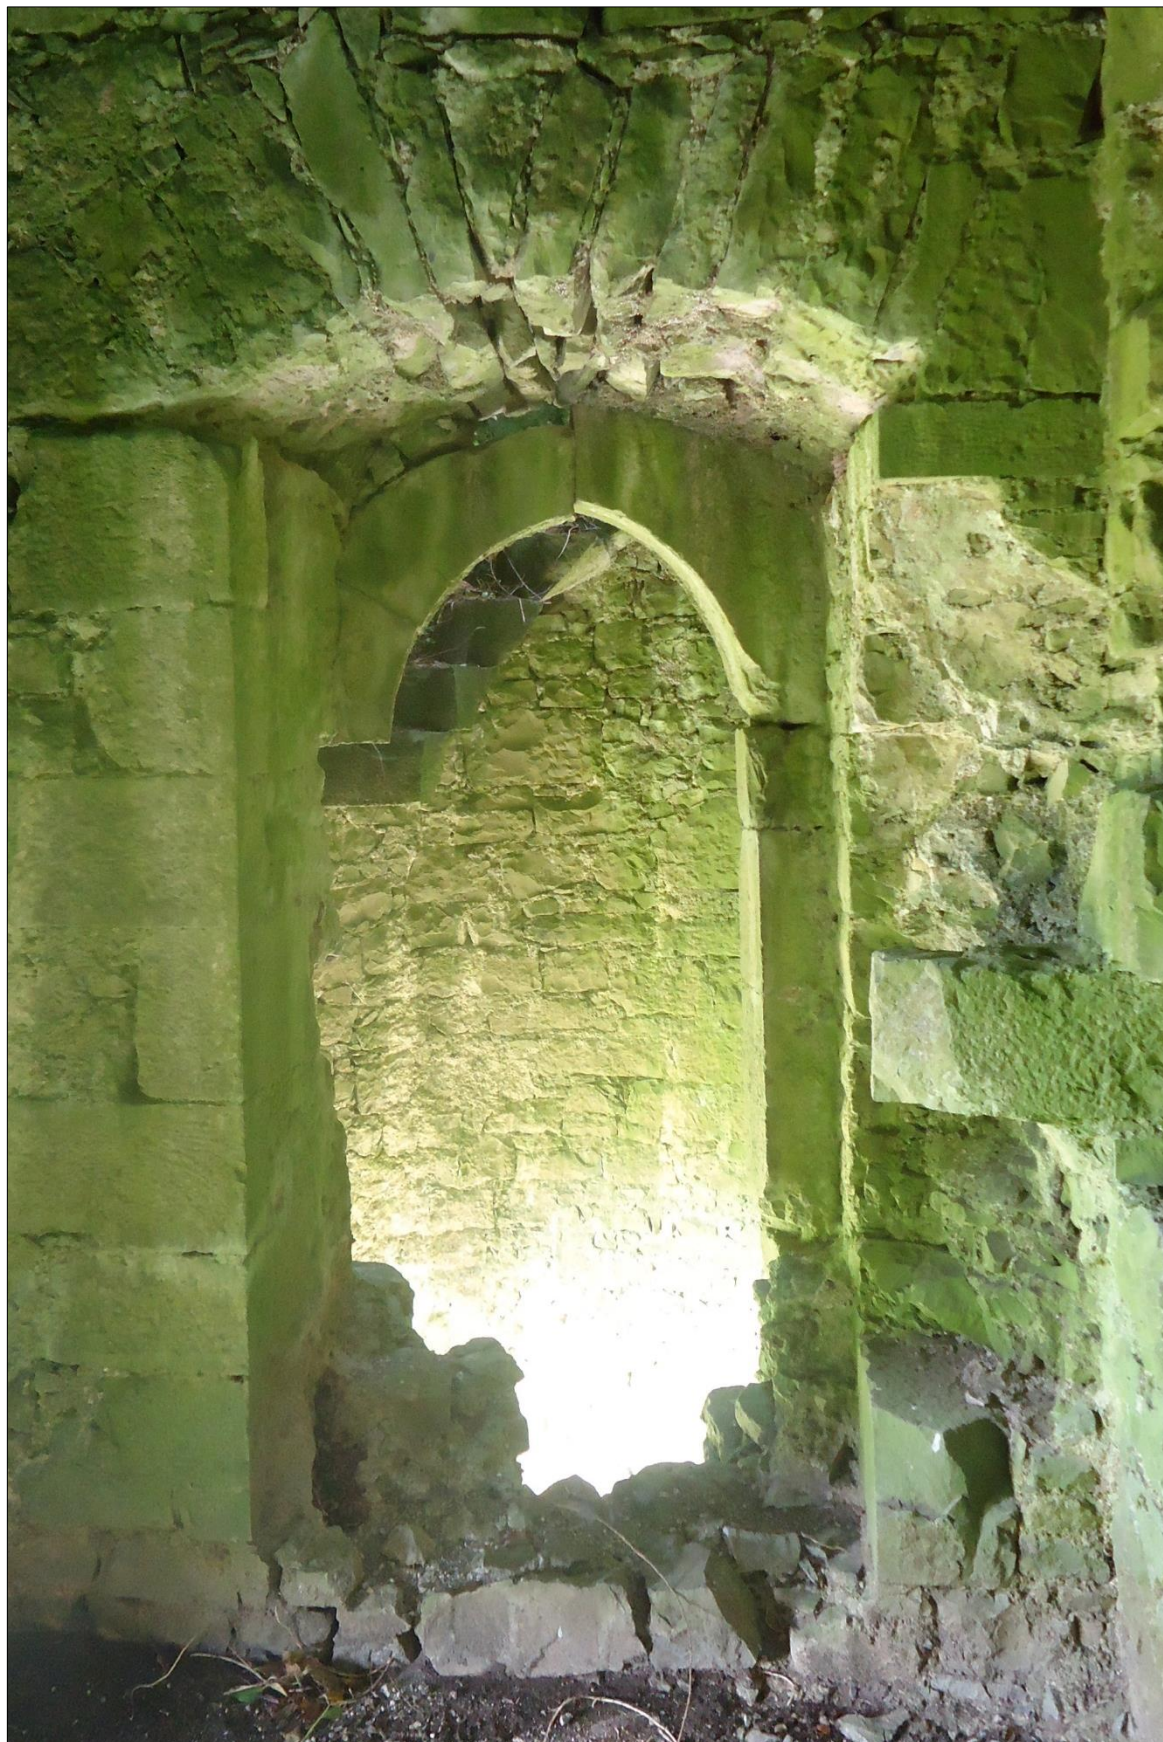
Plate 52: Ballintober Castle, northwest corner tower, view looking out (West) of the doorway into the mezzanine first-floor level

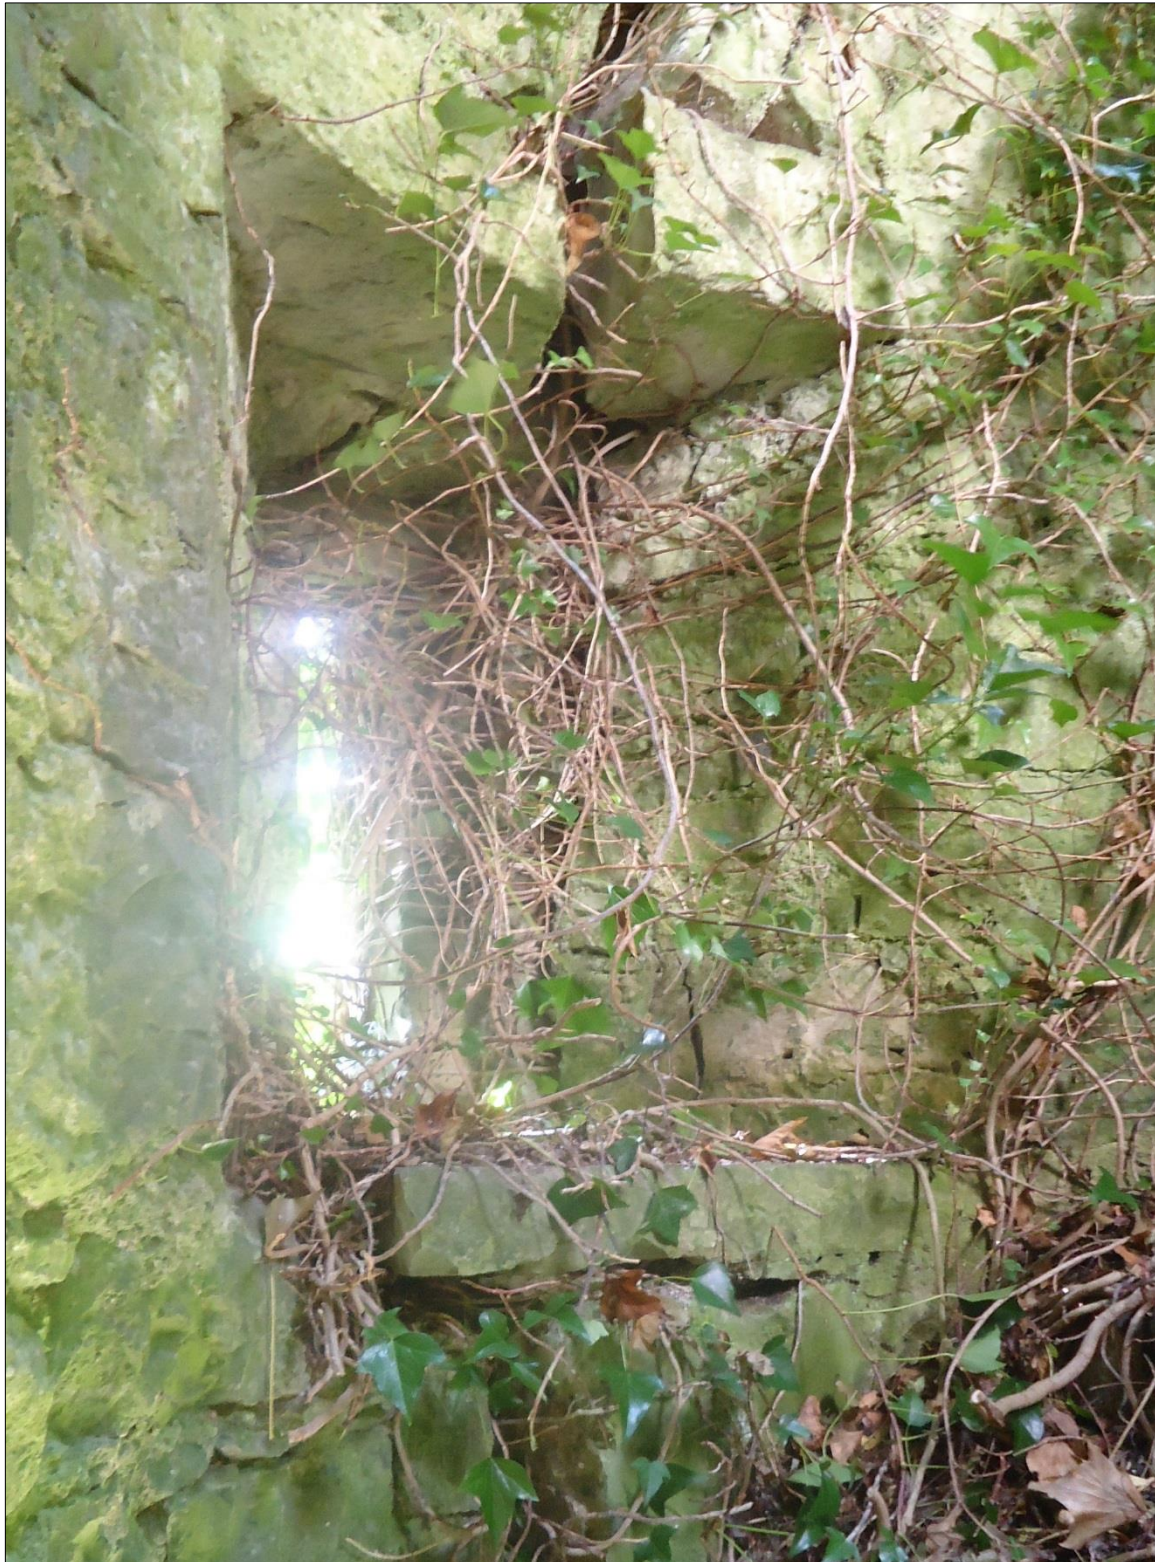
Plate 53: Ballintober Castle, northwest corner tower, view of stairwell light in south wall between the first and second floors

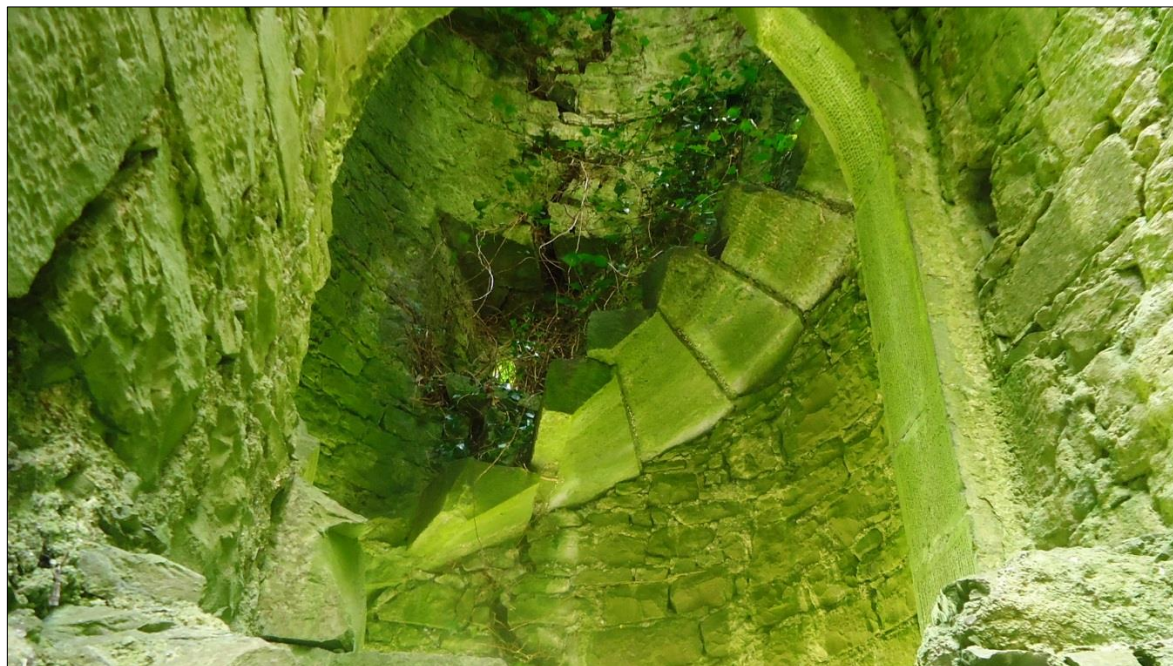
Plate 54: Ballintober Castle, northwest corner tower, view of the spiral stairs ascending above the first floor

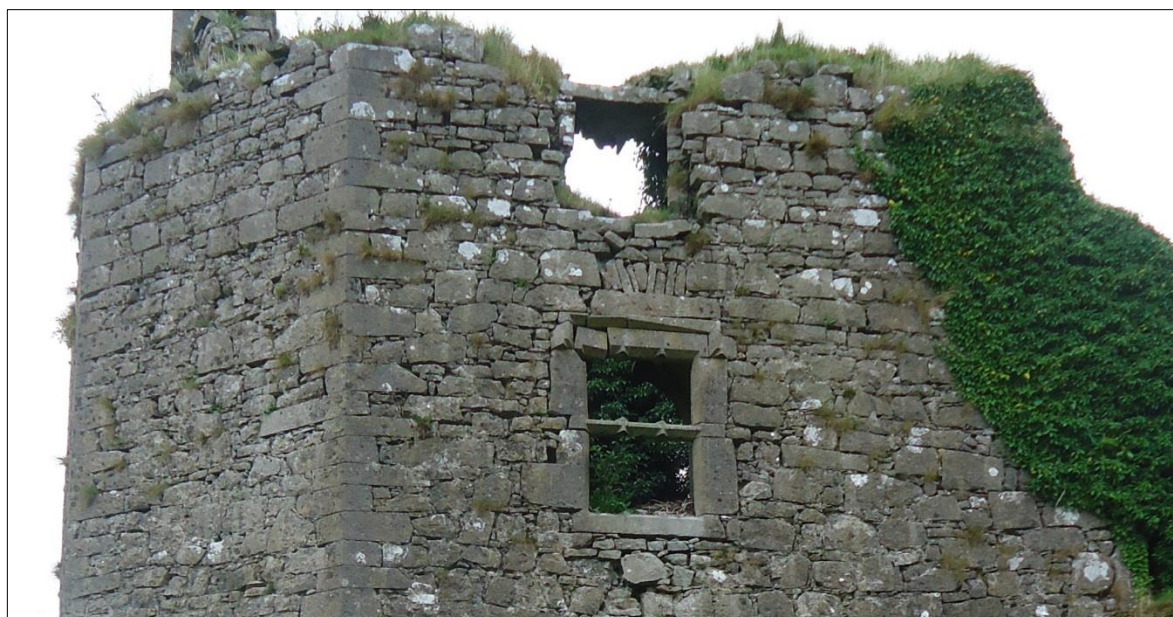
Plate 55: Ballintober Castle, northwest corner tower, looking at the west-facing second- and third-floor windows from outside

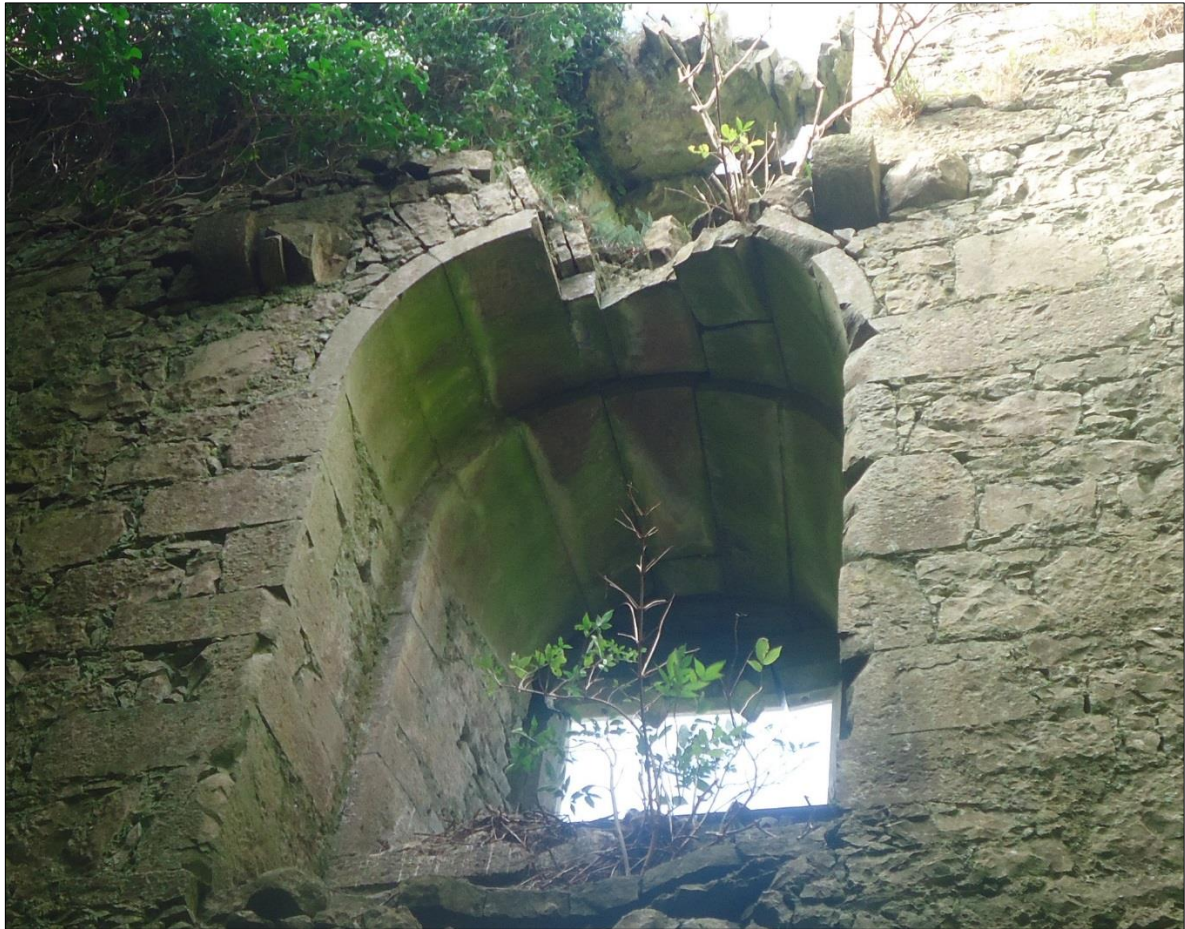
Plate 56: Ballintober Castle, northwest corner tower, view looking at the west-facing second- and third-floor windows from inside

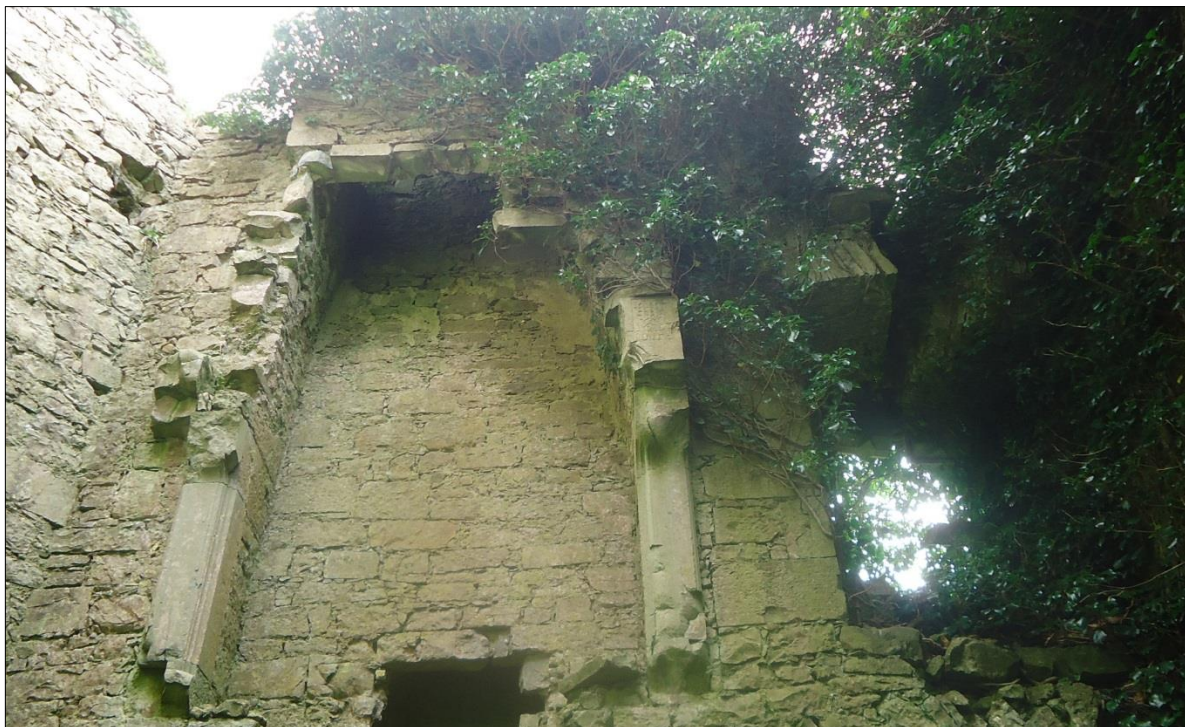
Plate 57: Ballintober Castle, northwest corner tower, view of the second floor showing the fireplace and window on the east wall

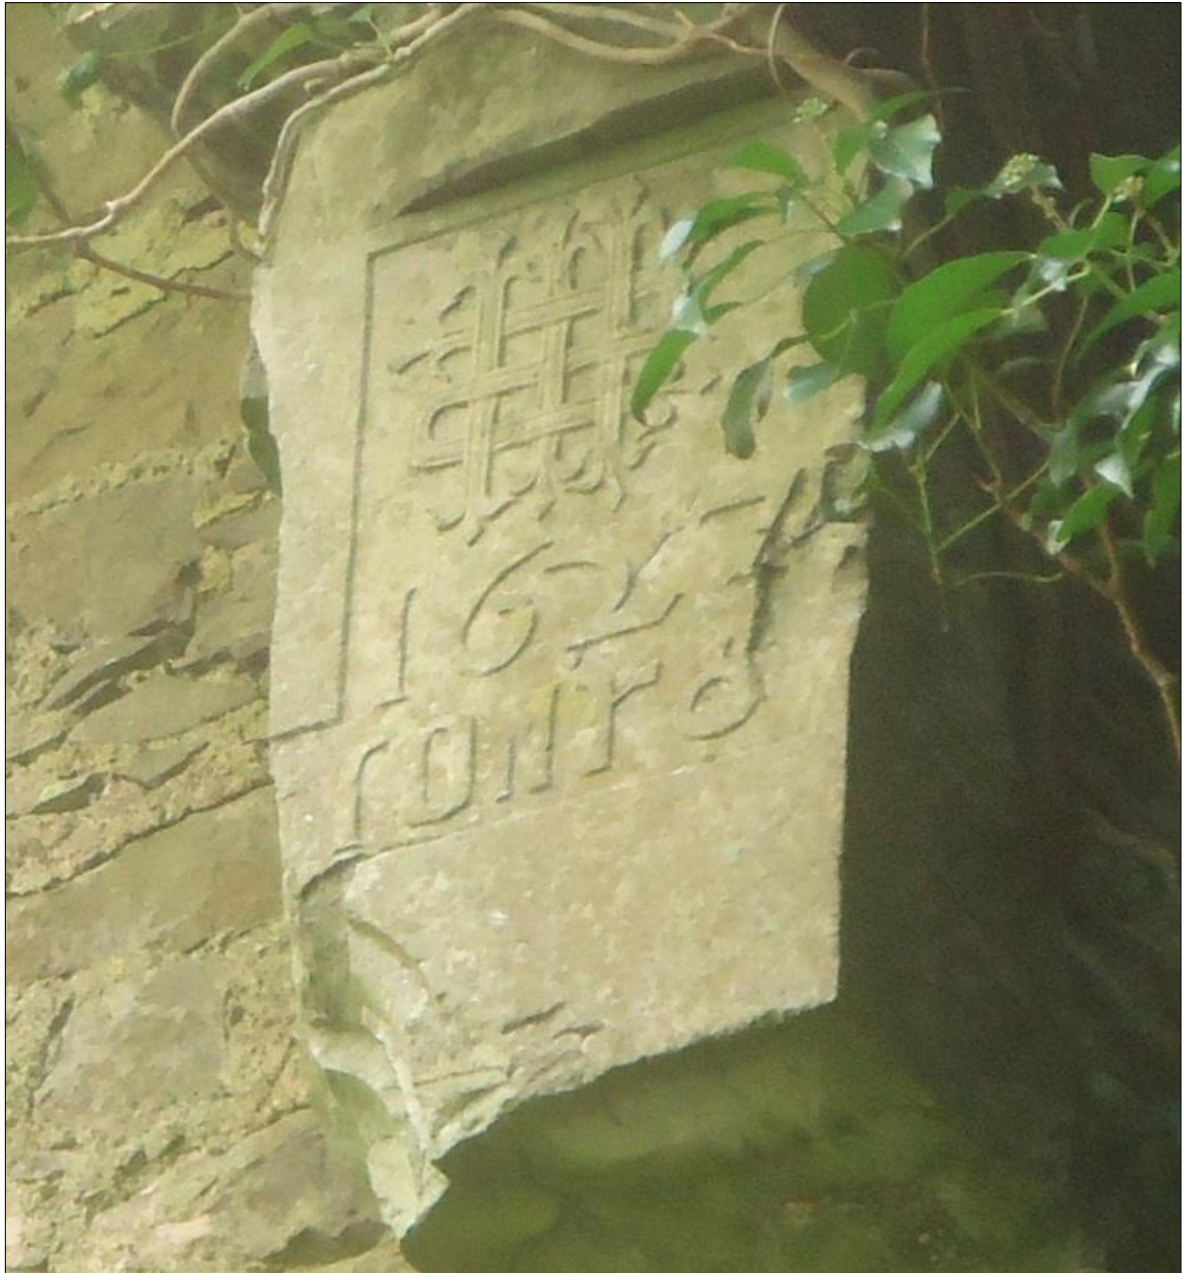
Plate 58: Ballintober Castle, northwest corner tower, detail of the plaque adorning the right (South) side of the second-floor fireplace, celebrating O'Connor residency in 1627

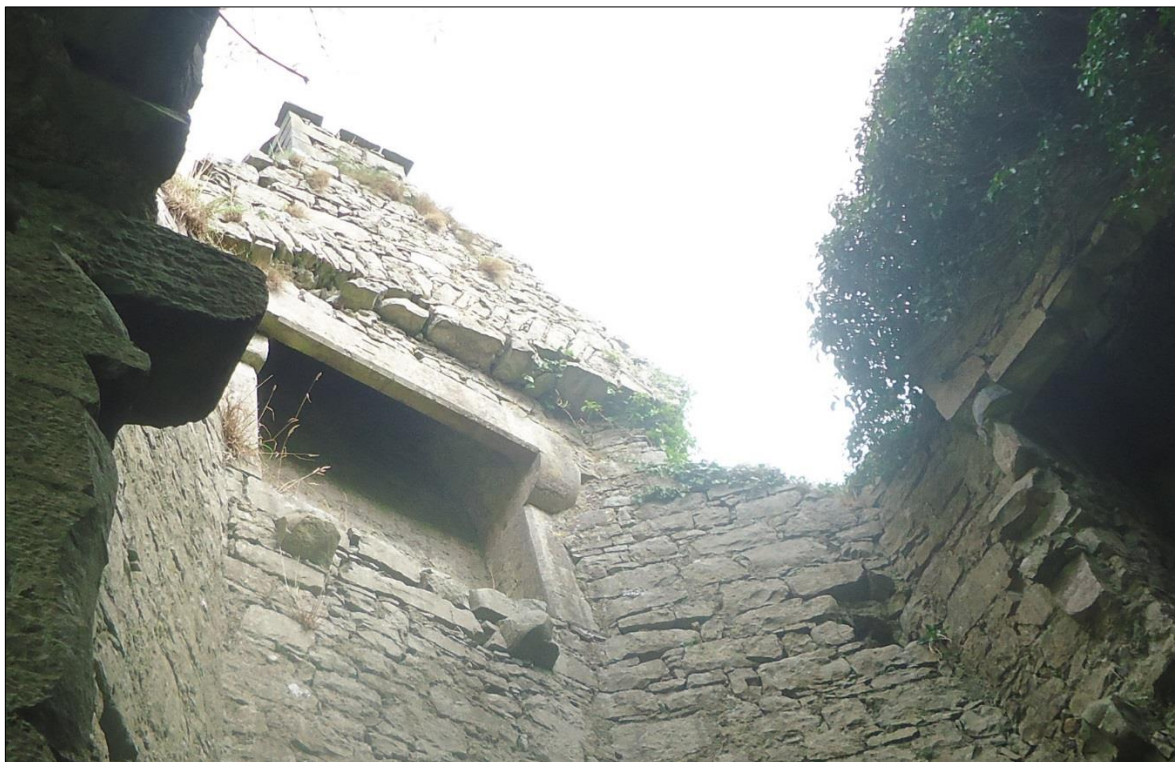
Plate 59: Ballintober Castle, northwest corner tower, view looking up to the third-floor fireplace in the north wall. The awkward alignment of the fireplace with the gable above indicates different building programmes. It is likely that the fireplace is the later addition

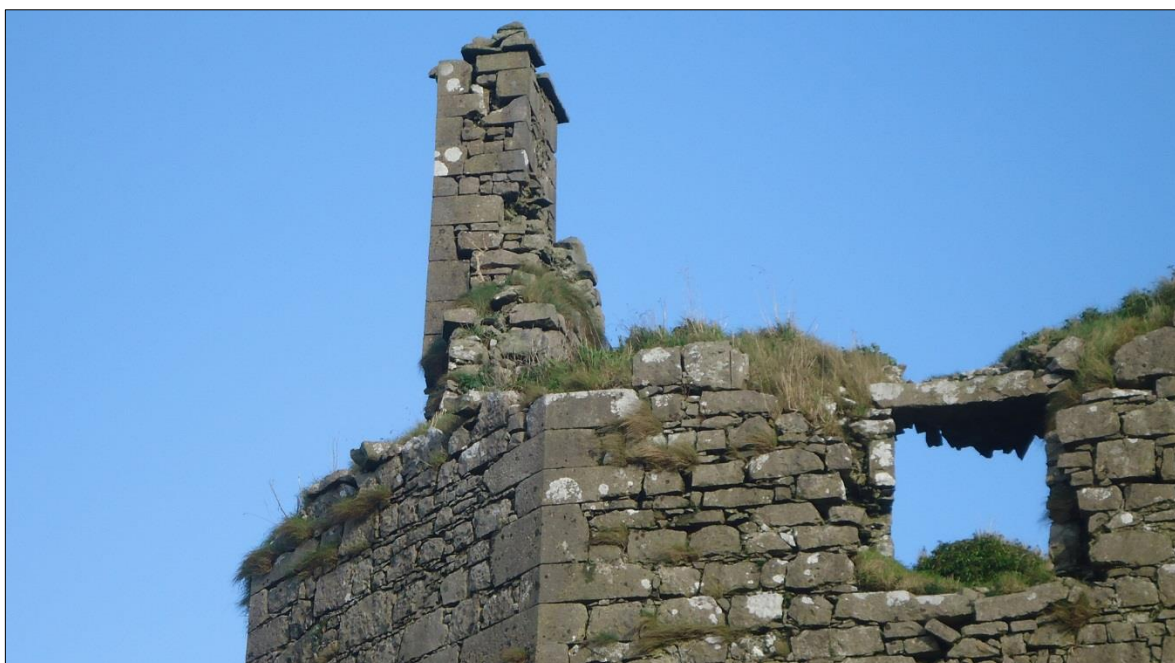
Plate 60: Ballintober Castle, northwest corner tower, exterior view of the roofline and chimney. Two dripstones are visible at the left (Northwest) angle at eaves level

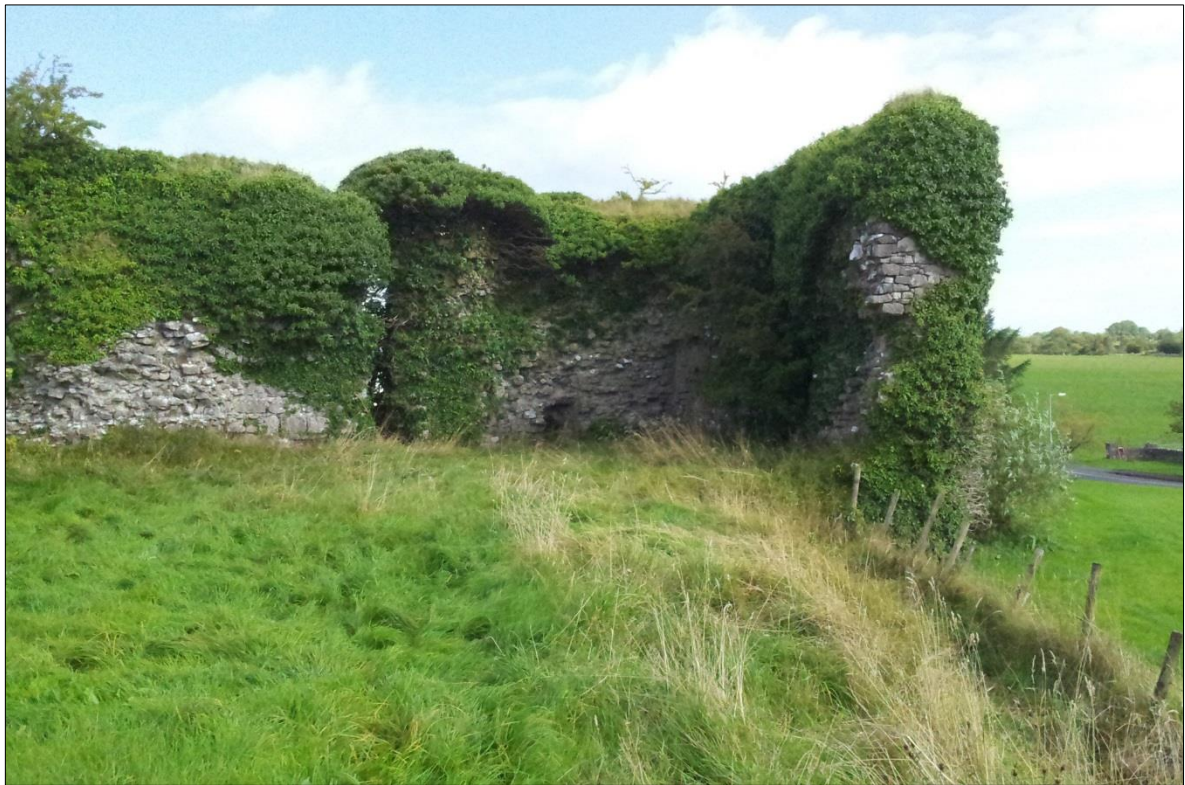
Plate 61: Ballintober Castle, northeast corner tower, view looking north at the standing remains

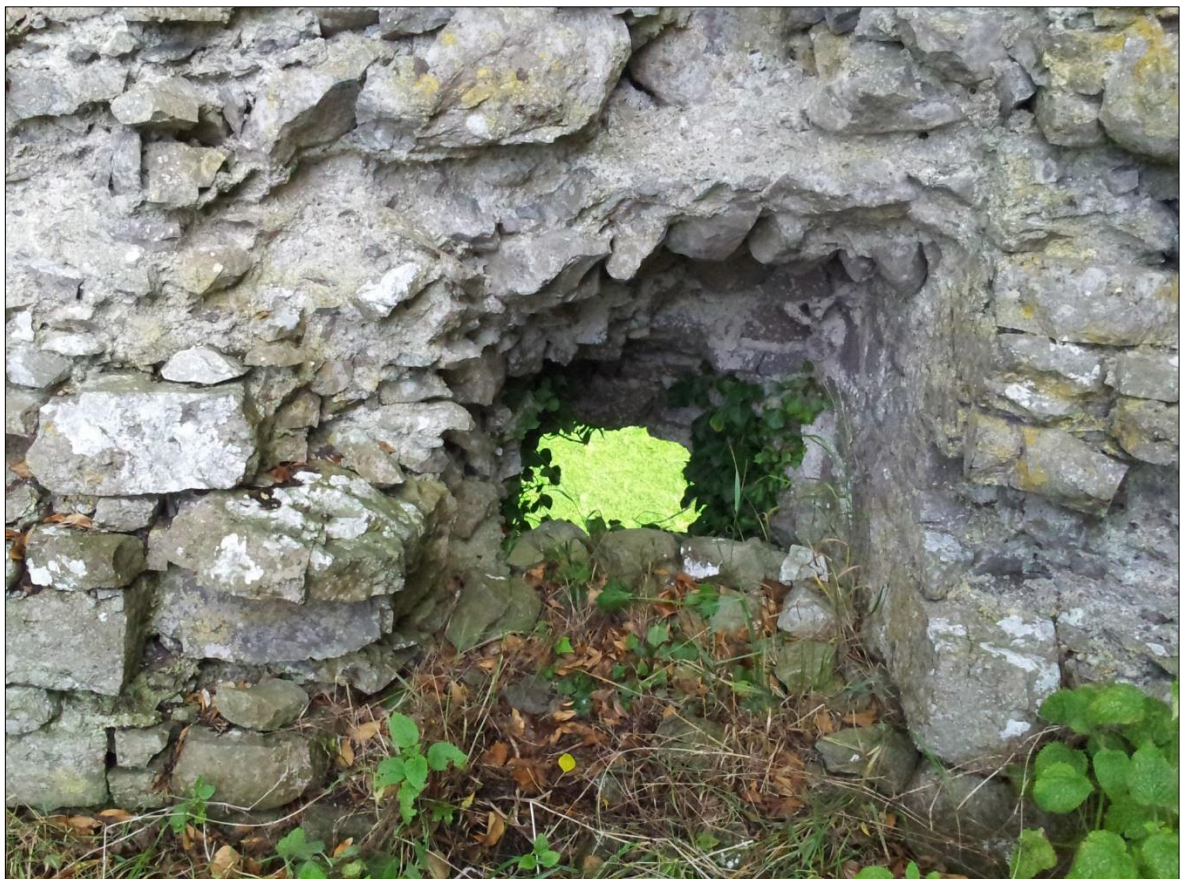
Plate 62: Ballintober Castle, northeast corner tower, view looking at the gun loop at ground level in the north wall

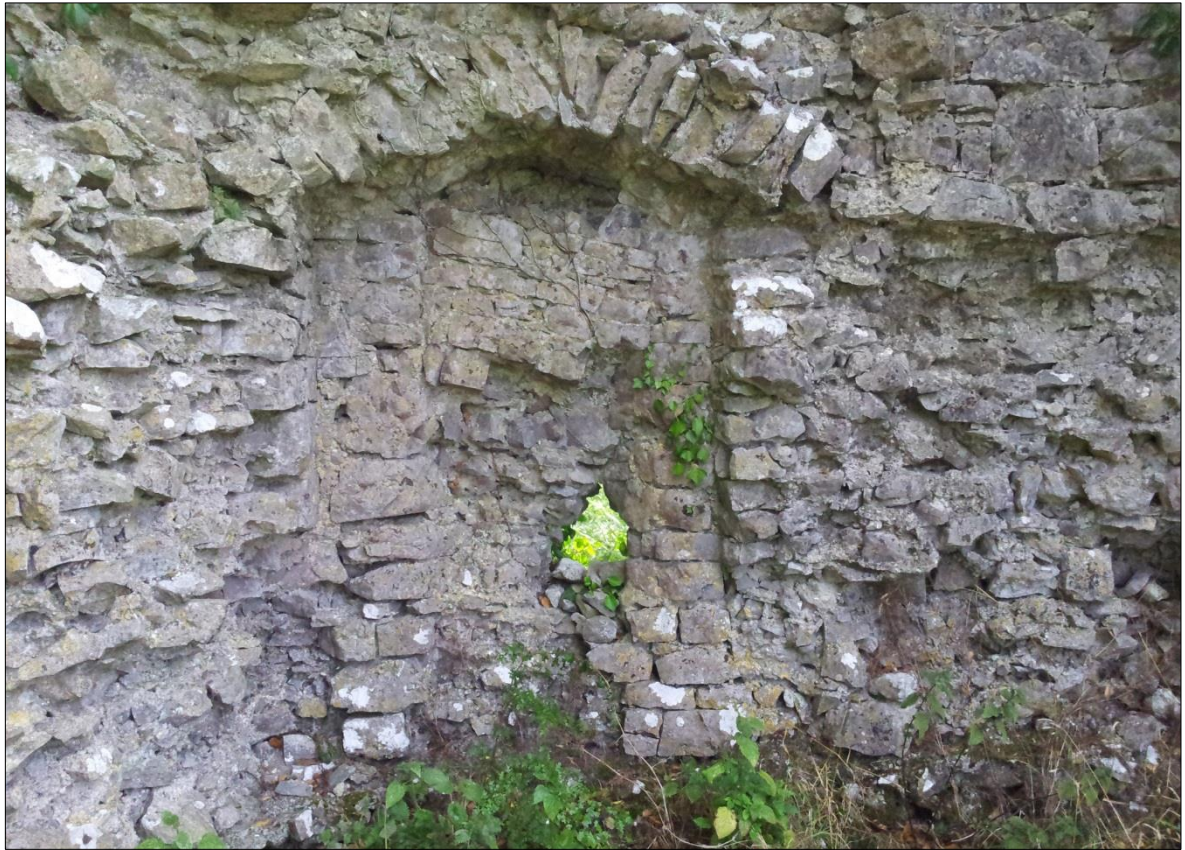
Plate 63: Ballintober Castle, northeast corner tower, view of reworked recessed opening in northeast angle of the ground floor

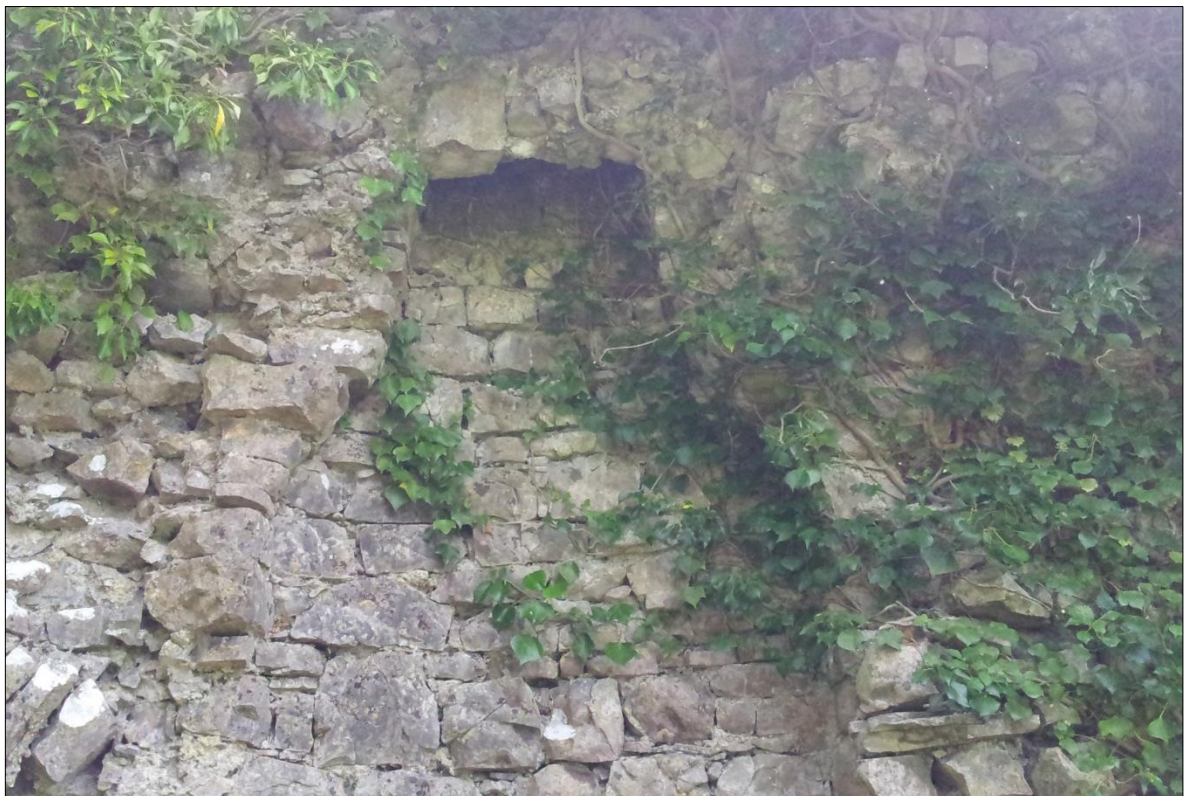
Plate 64: Ballintober Castle, northeast corner tower, view of the fireplace on the east wall of the first floor

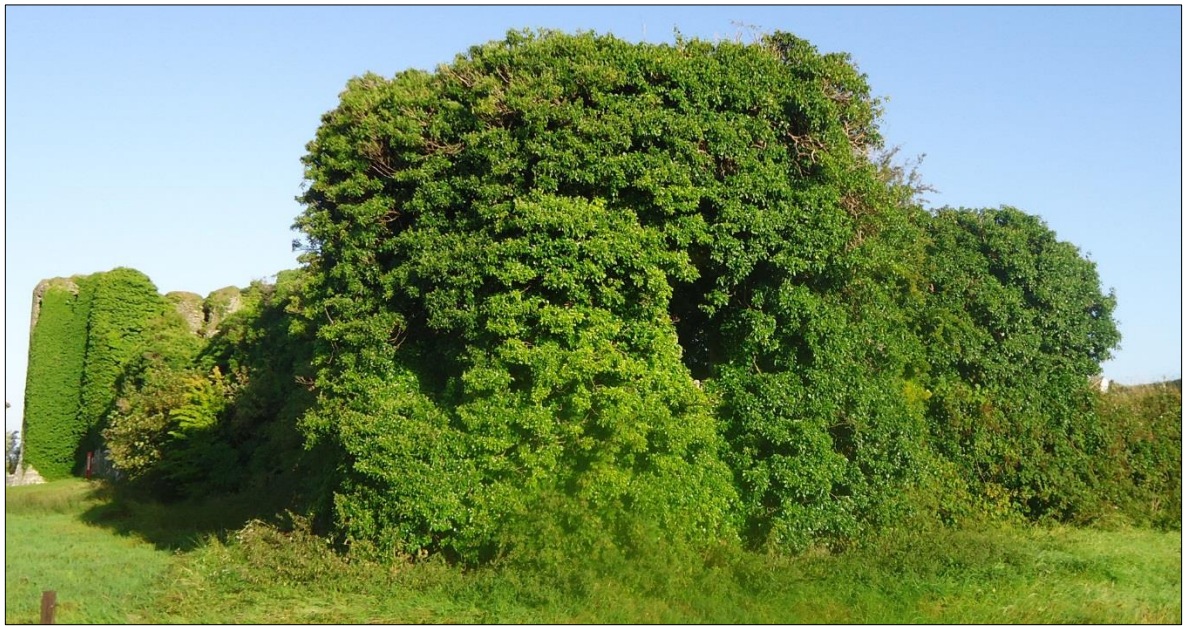
Plate 65: Ballintober Castle, southeast corner tower, exterior view from the southeast

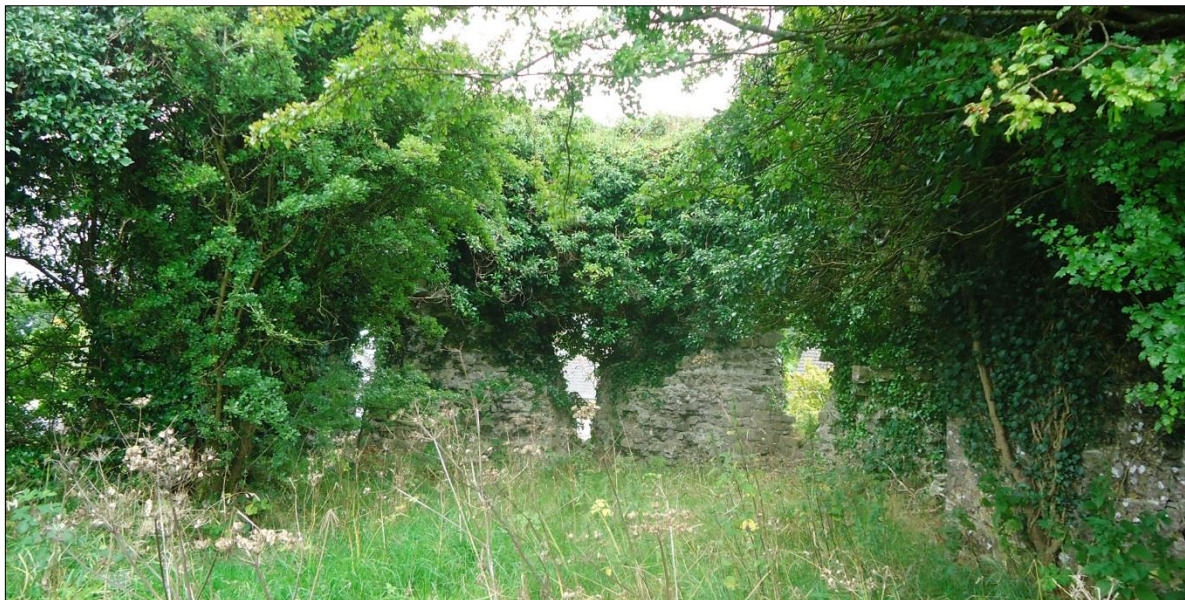
Plate 66: Ballintober Castle, southeast corner tower, interior view from the north

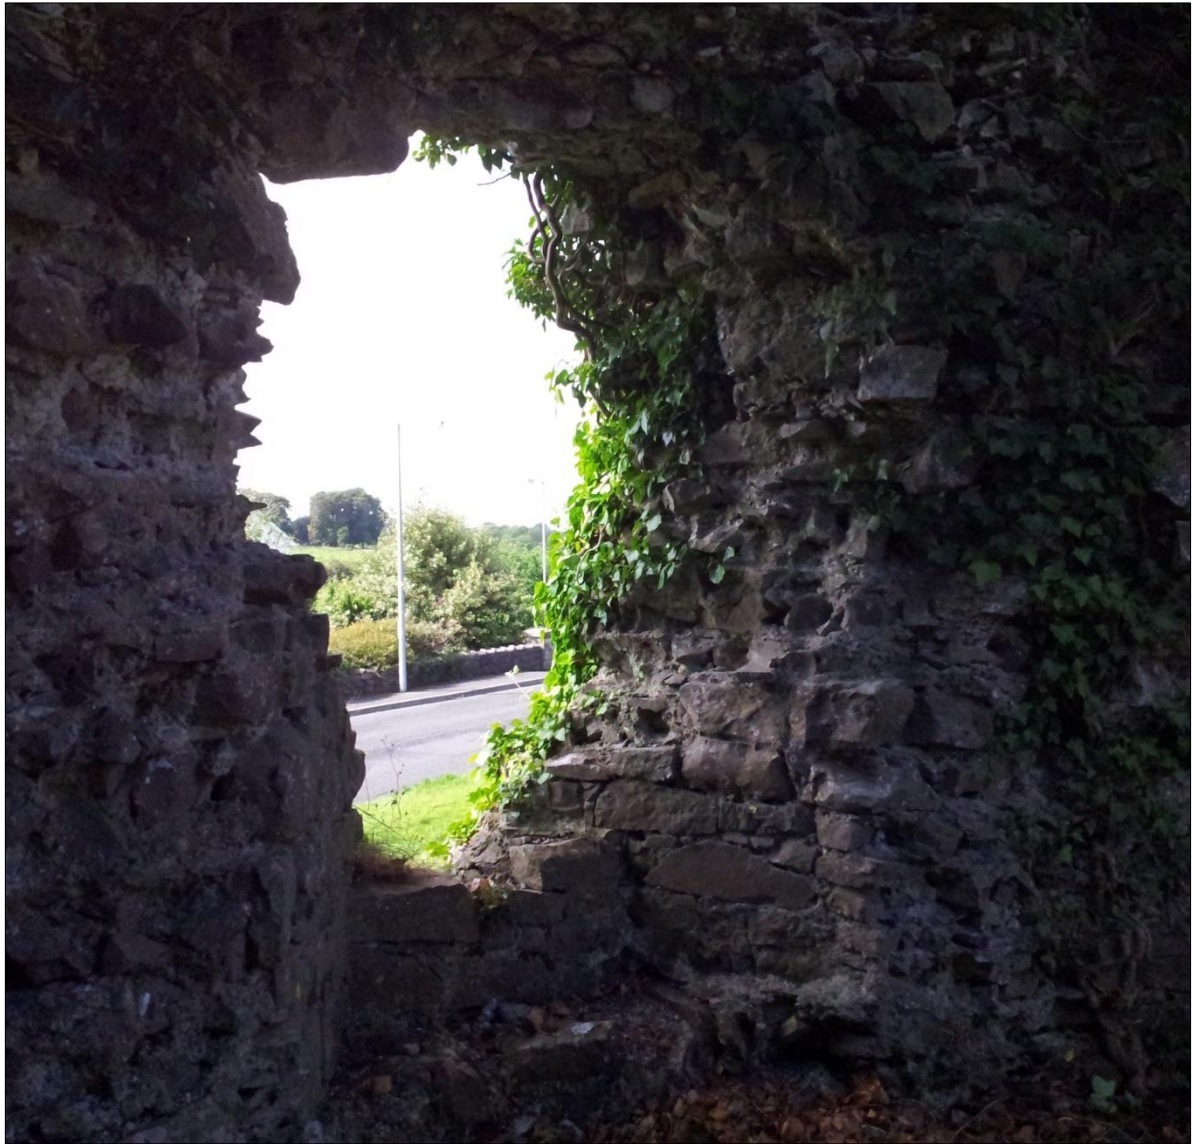
Plate 67: Ballintober Castle, southeast corner tower, view of the ruined recessed opening in the central (South-facing) angle

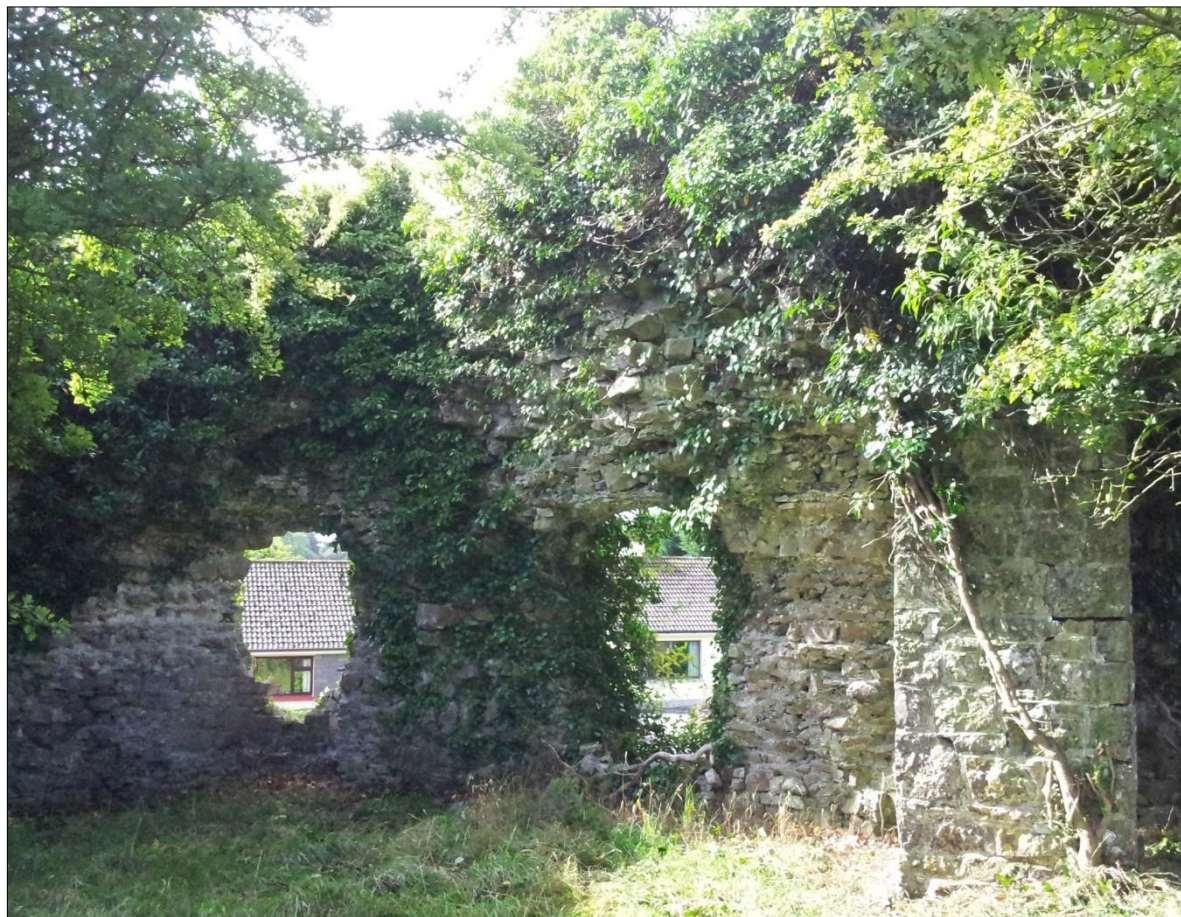
Plate 68: Ballintober Castle, southeast corner tower, view looking south, showing stone massing above the ground-floor openings, indicative of a vault structure. The vertical column on the right (West) side is a supporting buttress introduced presumably in the 19th century

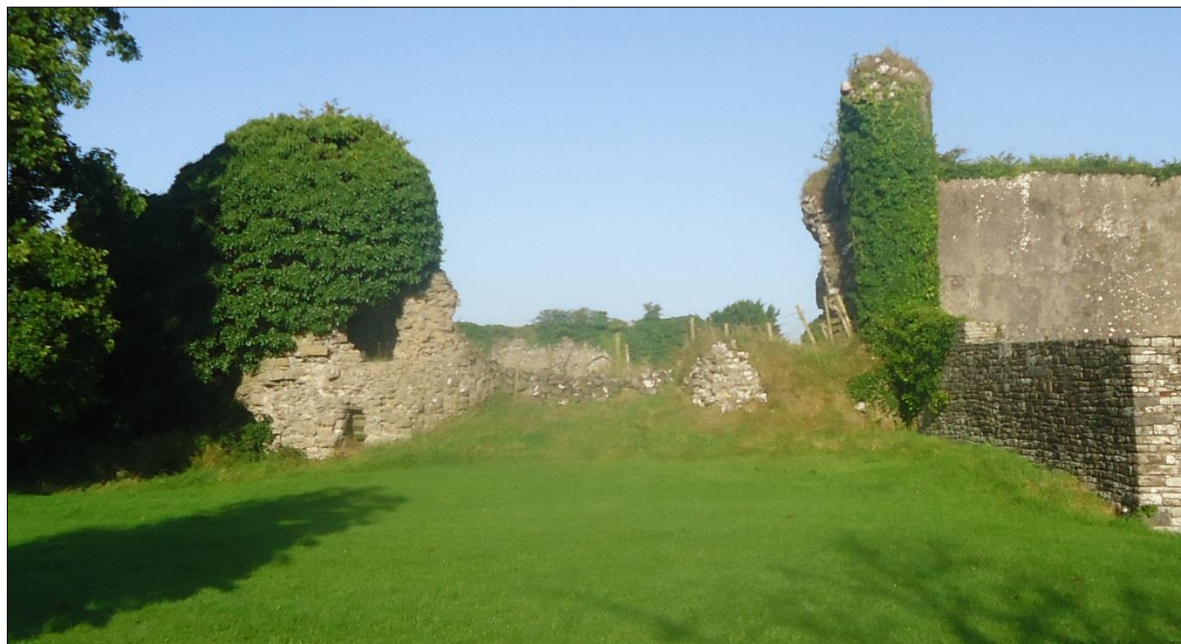
Plate 69: Ballintober Castle, eastern entrance, showing its two towers. The ground level is notably raised between the towers on approach to the entrance. The handball alley is to the right (North)
