Archaeological Survey
Ballintober Castle
Ballintober, Co. Roscommon
Ireland

RO027-048002-

Niall Brady

Castle Studies Trust
2014 Grant award

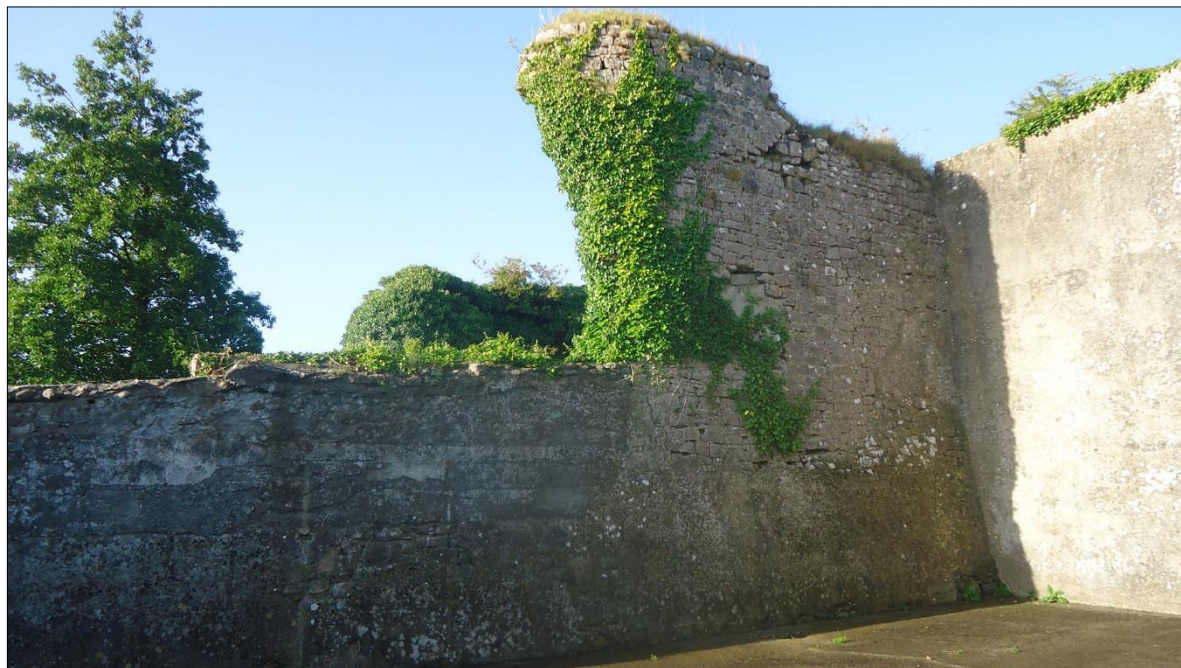
Plate 70: Ballintober Castle, eastern entrance, view from within handball alley showing the standing remains of the north tower. Note the steeply-pitched base batter that survives on the tower wall; it is one of few original elements of the castle's base batter that remains *in situ*

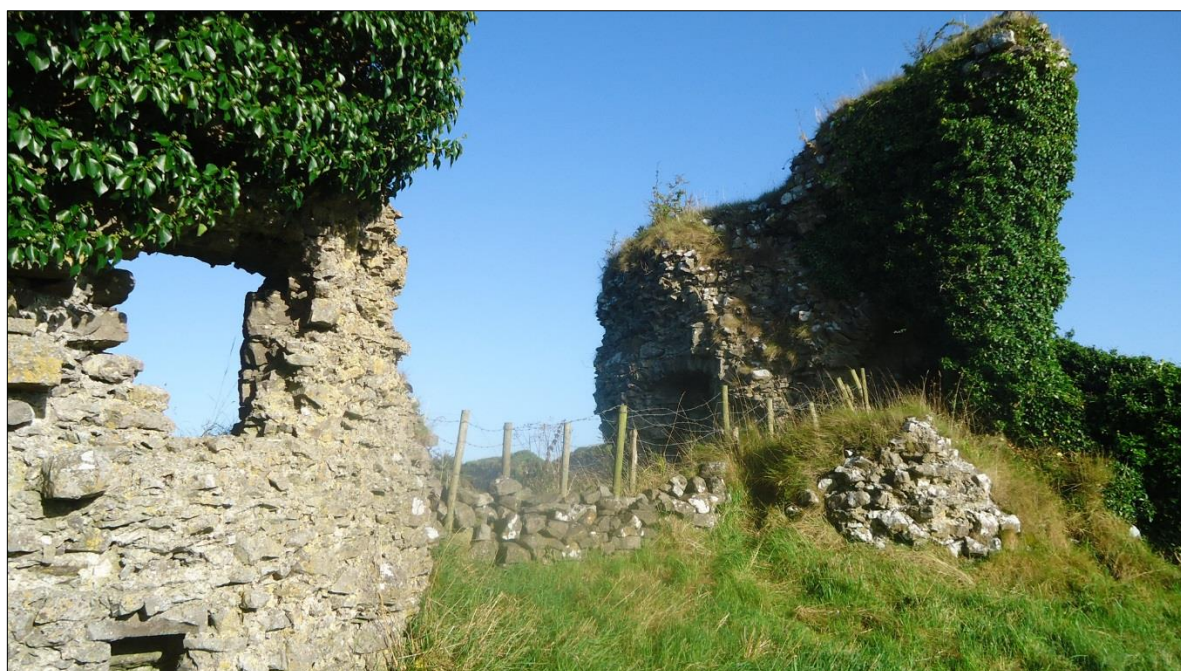
Plate 71: Ballintober Castle, eastern entrance, view looking north across entrance from the south tower to the north tower. The masonry mass in the foreground is the ruined base of the north tower

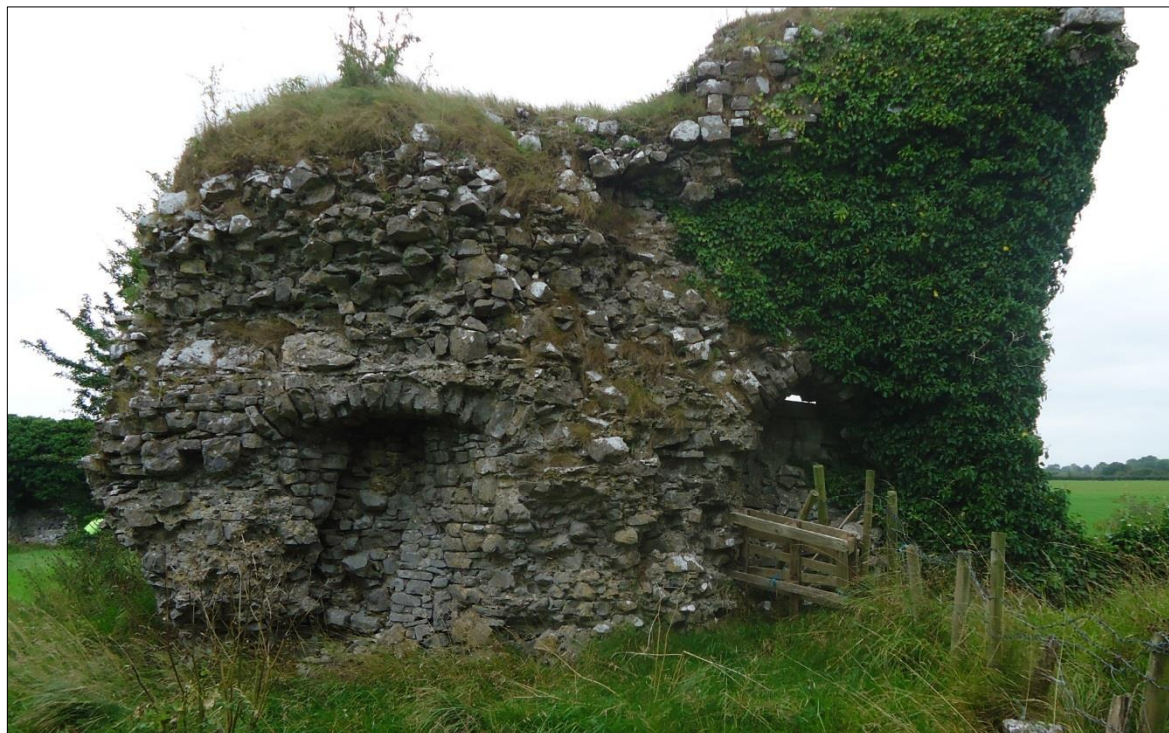
Plate 72: Ballintober Castle, eastern entrance, view of the north tower's interior, with the rear chamber to the left (West) and stone massing above indicative of vaulting, and front chamber to the right (East)

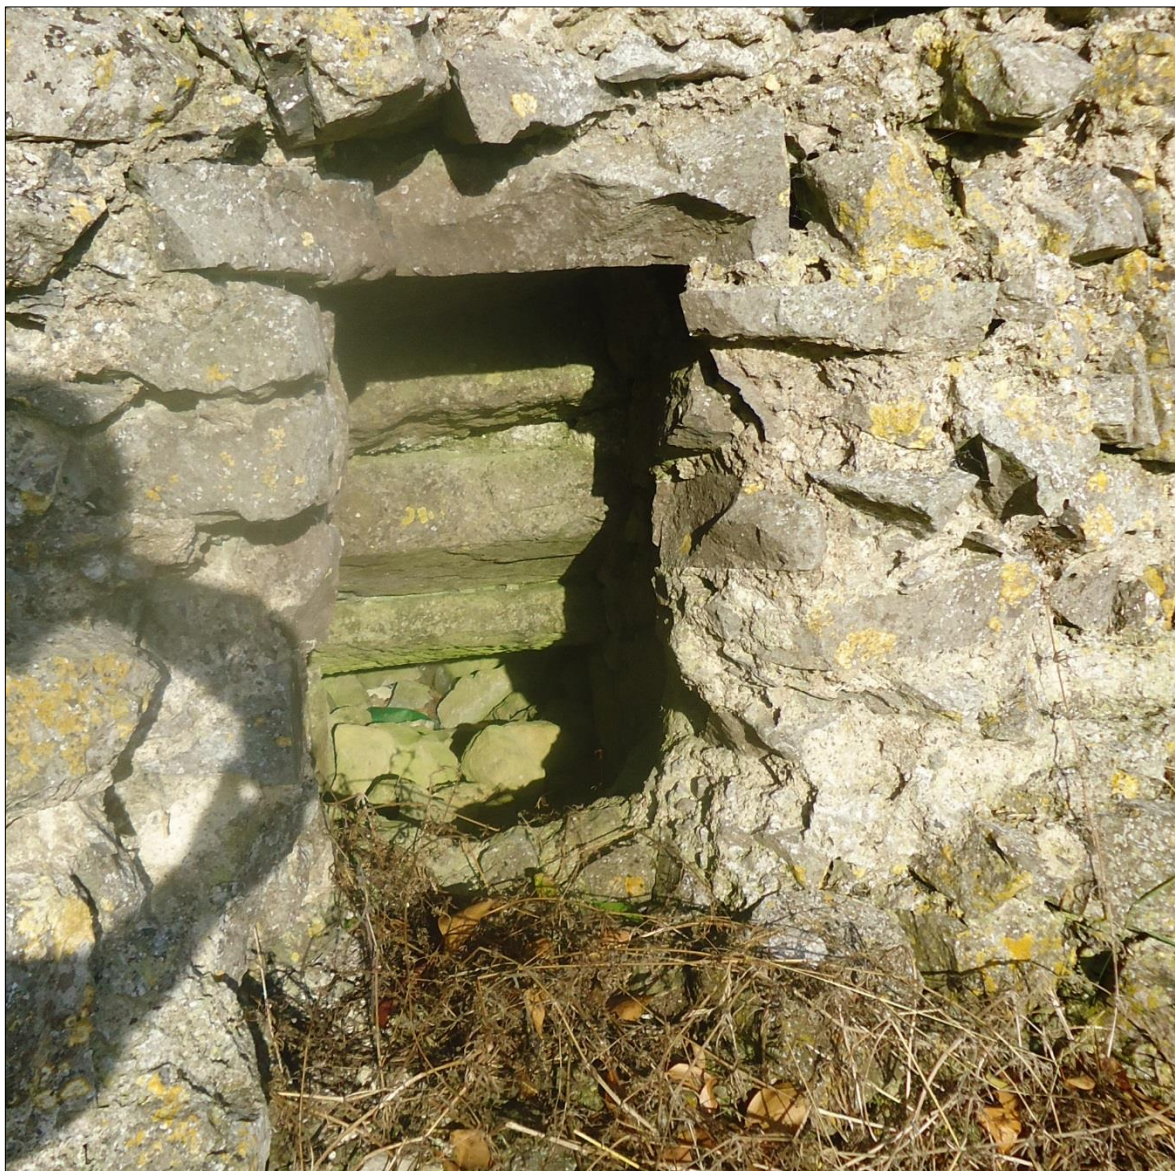
Plate 73: Ballintober Castle, eastern entrance, exterior view showing the basement-level window/
gun loop facing east

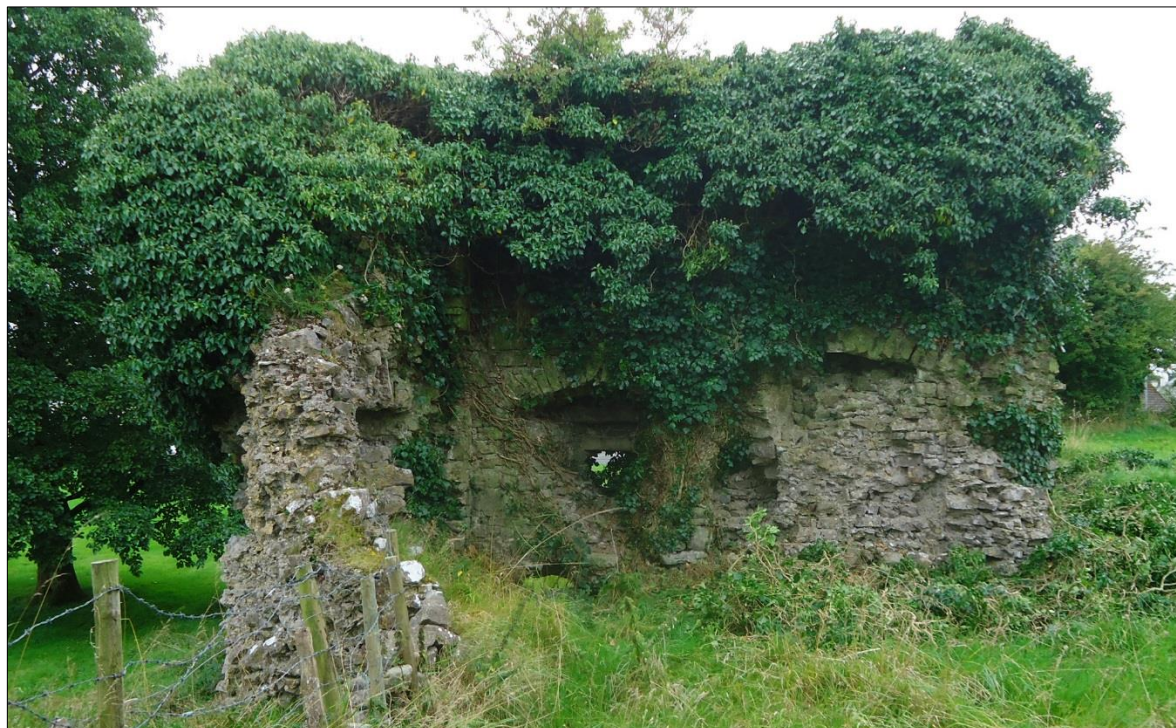
Plate 74: Ballintober Castle, eastern entrance, view of the south tower's interior, with the rear chamber to the right (West) and the front chamber to the left (East)

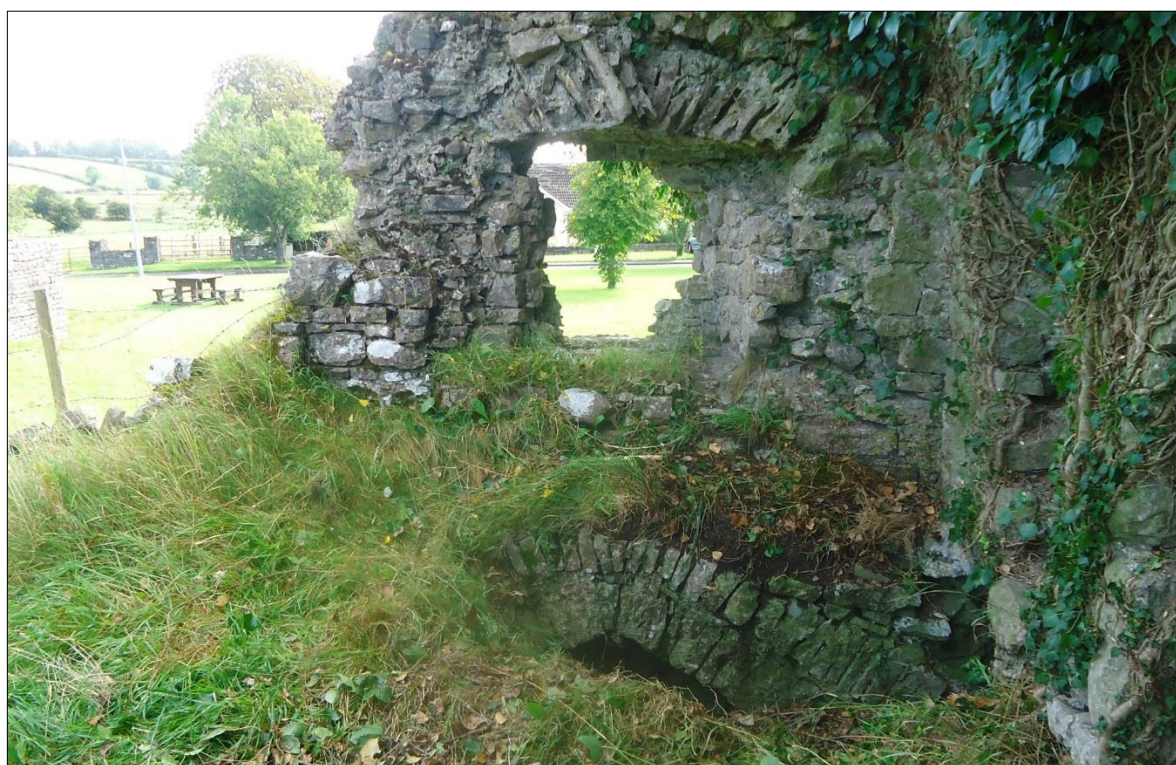
Plate 75: Ballintober Castle, eastern entrance, interior view looking East at ground-floor level, showing the basement arch extending below

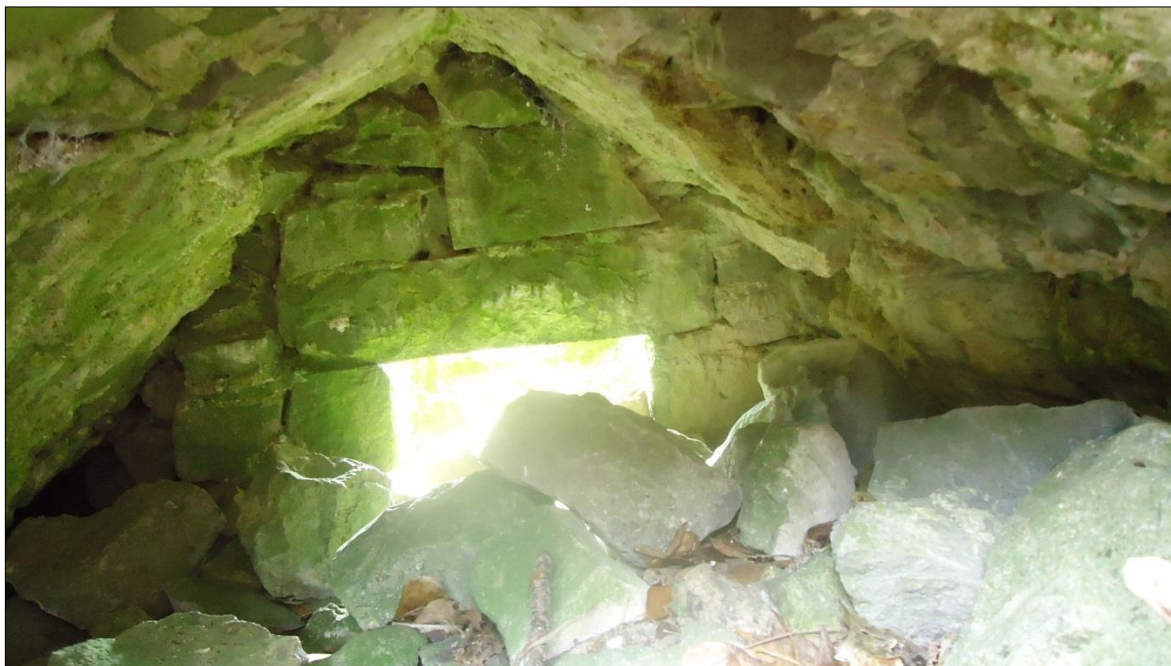
Plate 76: Ballintober Castle, eastern entrance, interior view of the basement level in the south tower looking East, showing the steeply-pitched roof, the window/gun-loop opening in the east wall, and the collapse that fills the chamber

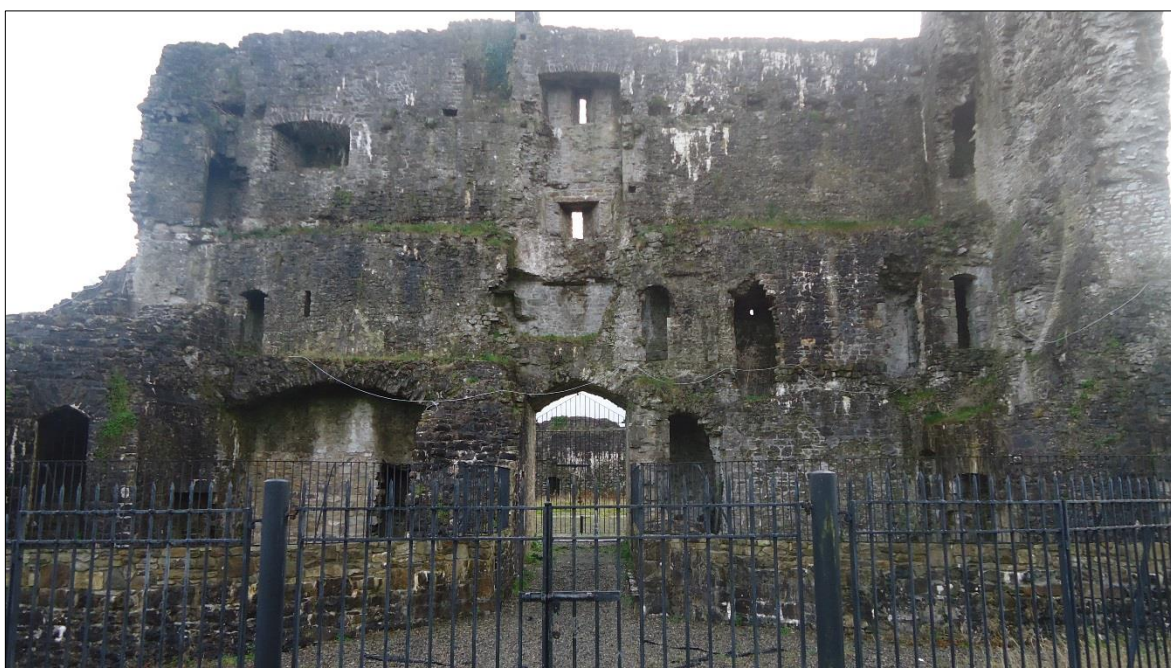
Plate 77: Entrance detail, Ballymote Castle. View is from the outside and shows the entrance at the centre, flanked by four-storeyed towers on each side, with the space between inhabited as part of the overall residential block. On a smaller scale, it is possible to imagine a similar arrangement existed at Ballintober Castle

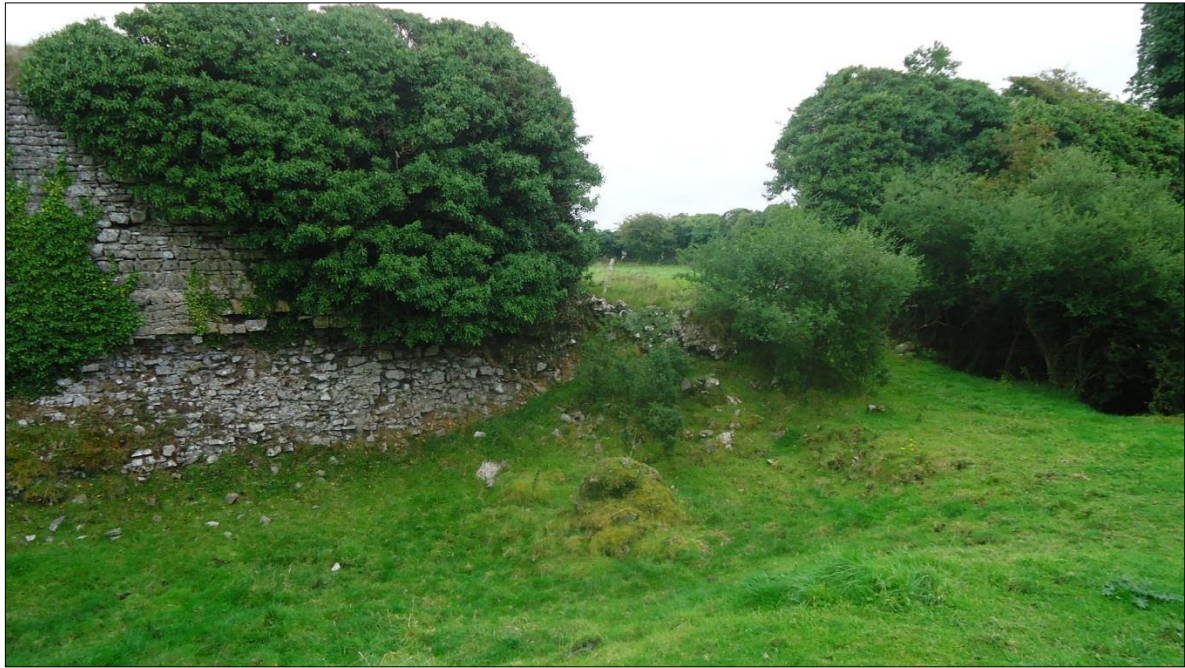
Plate 78: Ballintober Castle, postern gate entrance area, exterior view looking across the fosse at the causeway. There is no standing structure of the gate feature today, only a gap in the perimeter wall that coincides with the causeway

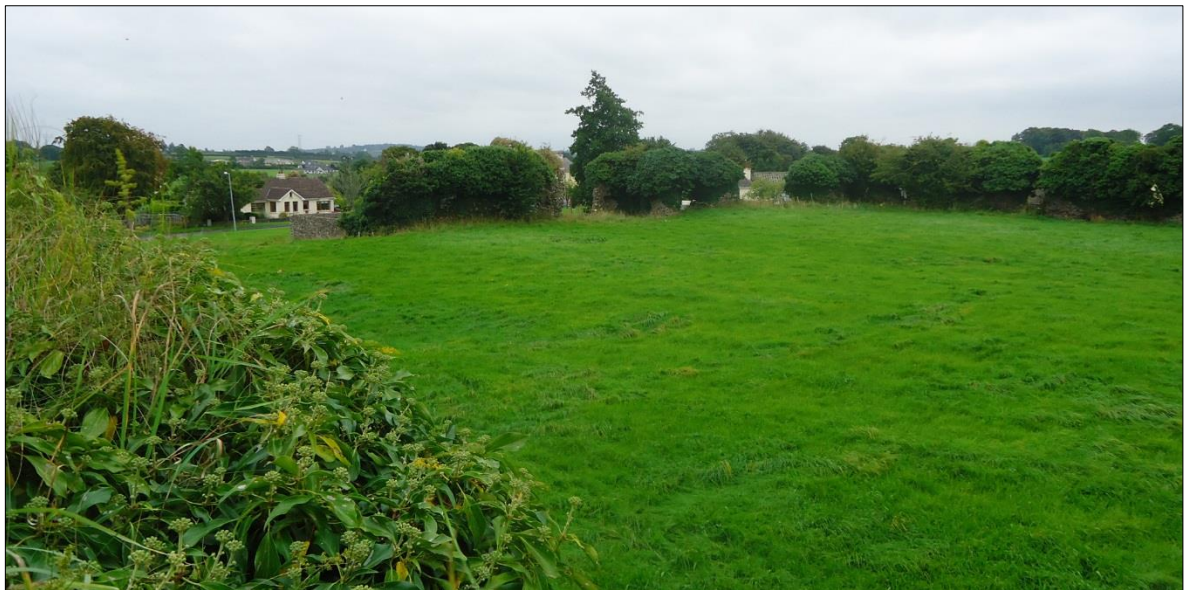
Plate 79: Ballintober Castle, view of interior from the north wall looking southeast

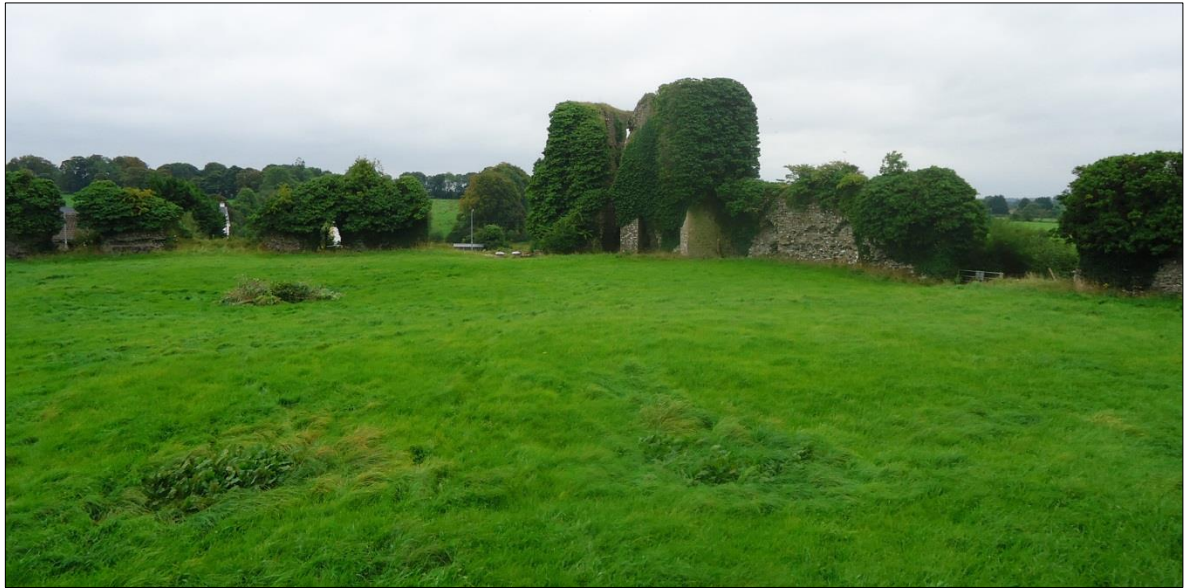
Plate 80: Ballintober Castle, view of interior from the north wall looking southwest

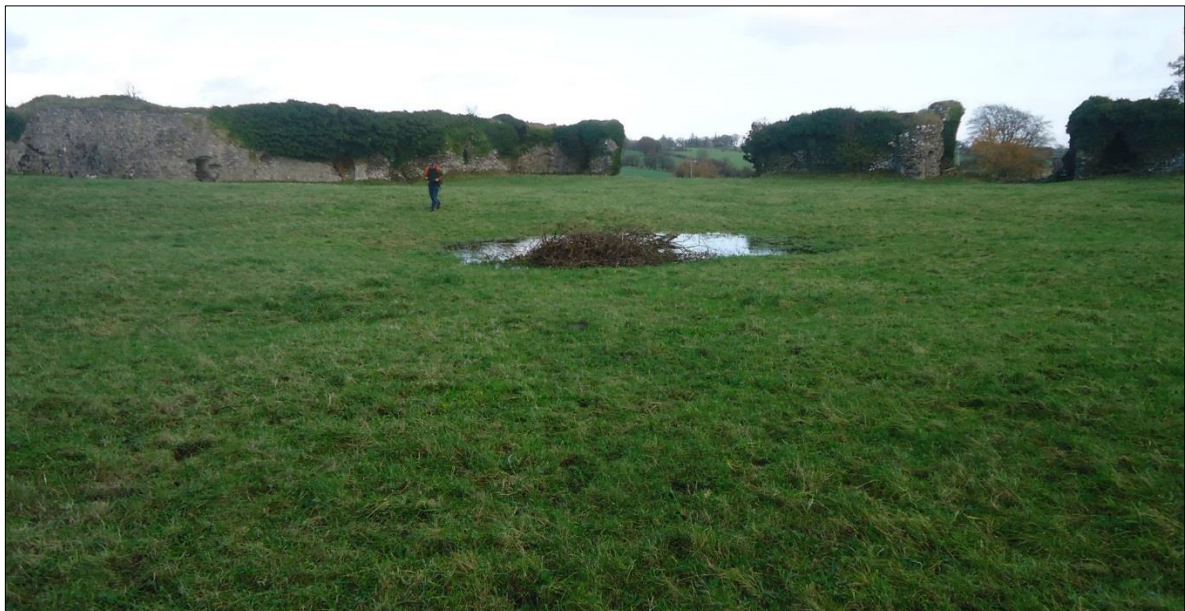
Plate 81: Ballintober Castle, view of interior from the southwest looking northeast
