# An excavation in the inner bailey of Shrewsbury Castle

Nigel Baker BA PhD FSA MCIfA

*A report to the Castle Studies Trust*

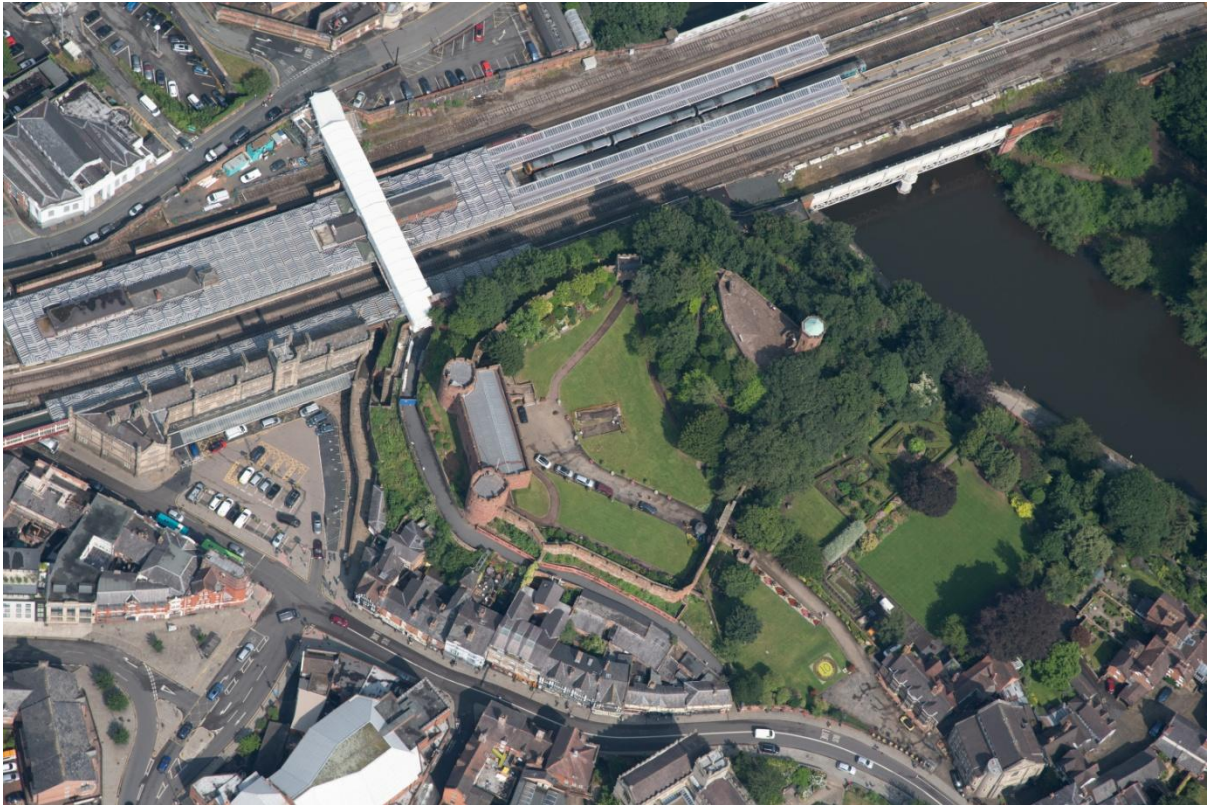
I. Shrewsbury Castle: the inner bailey excavation in progress, July 2019. North to top. (Shropshire Council)

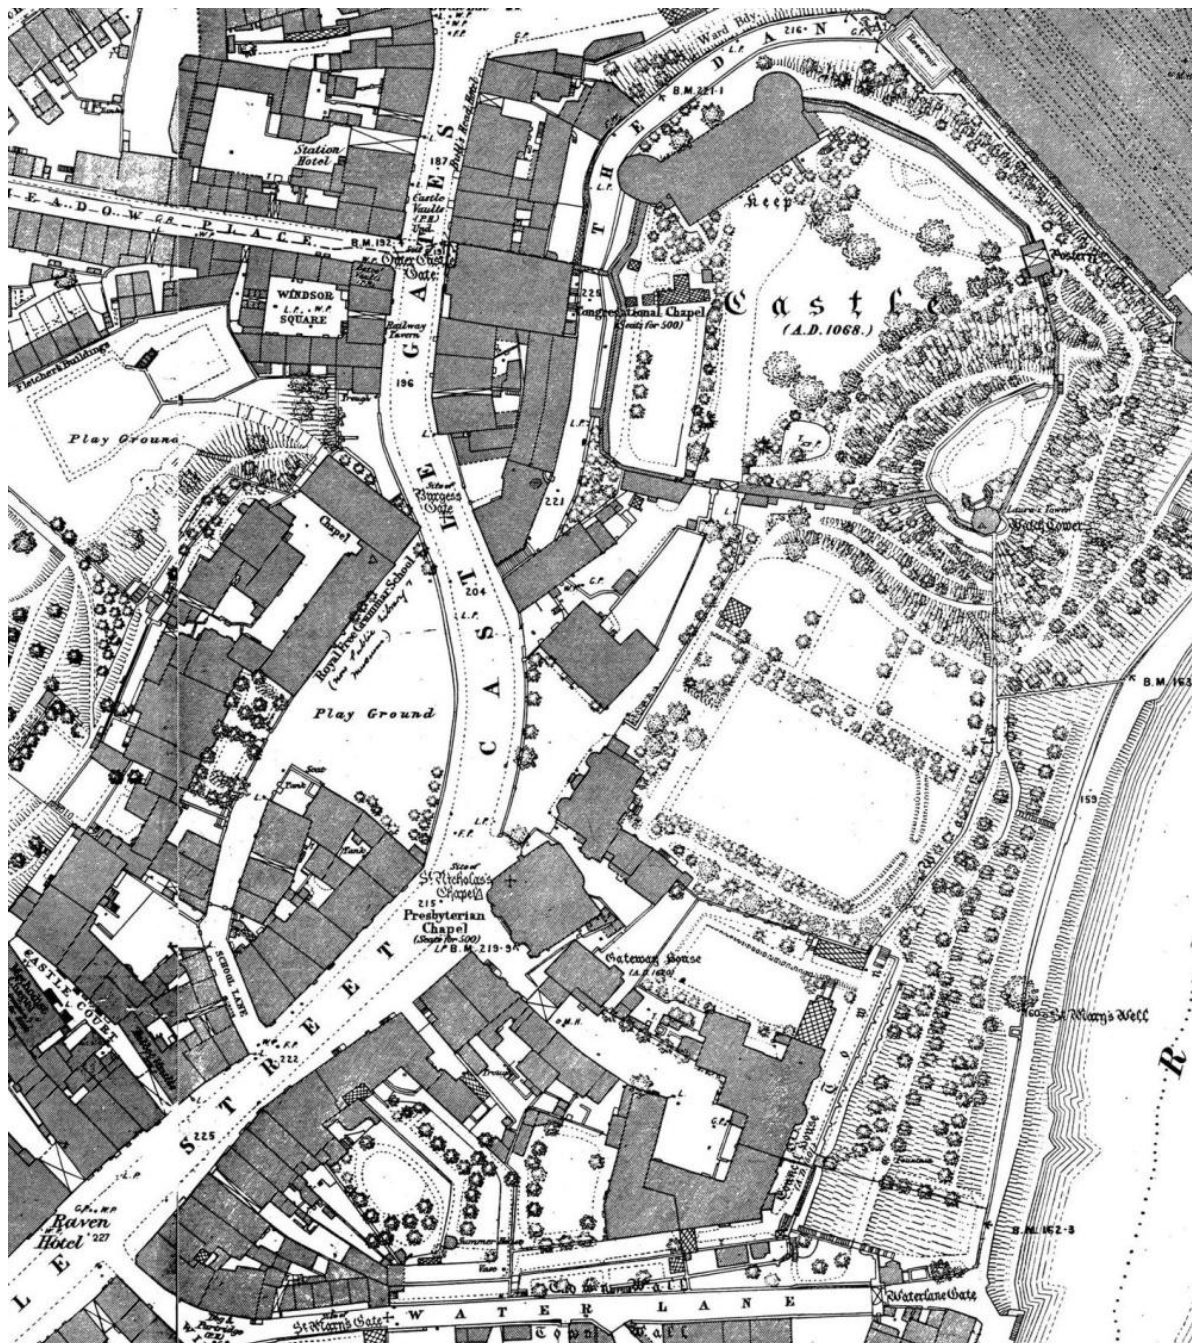
3. The complete castle: the former outer bailey is clearly evident on the 1<sup>st</sup> edition O. S. 1:500 plans of 1882; the narrowing of the main street marks the site of the gate

but we may be looking at a situation of raised levels in the back yards of the two properties that used to stand here, fronting Castle Gates (see fig. 3). It is likely that, before the 17<sup>th</sup> century, approaching the castle as now, from the south, one would have perceived the inner bailey at a higher level, perhaps with a causewayed approach along the existing driveway up to this higher level.

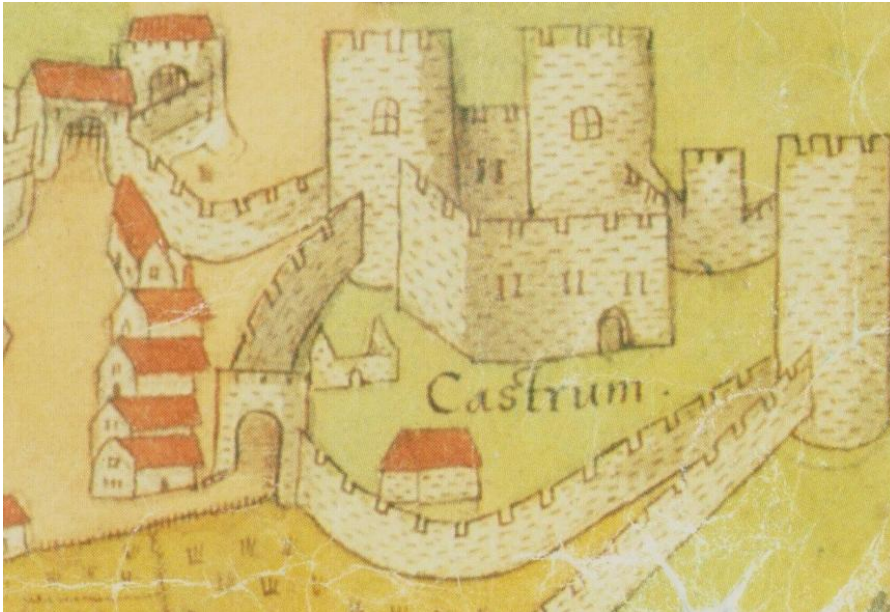
4. The inner bailey, c.1575: detail from the Burghley Map

The curtain walls and mural towers were then intact; the present hall was roofless, so too was an unidentified building, possibly the chapel of St Michael, to its left/south; a roofed building stood just inside the gate in the area of the castle well; a large mural tower (presumably the 'watch tower' whose base remains under Laura's Tower) stood on what must have been the motte, and a small crenellated tower can be seen between this and the hall – presumably on the site of the present postern gate.

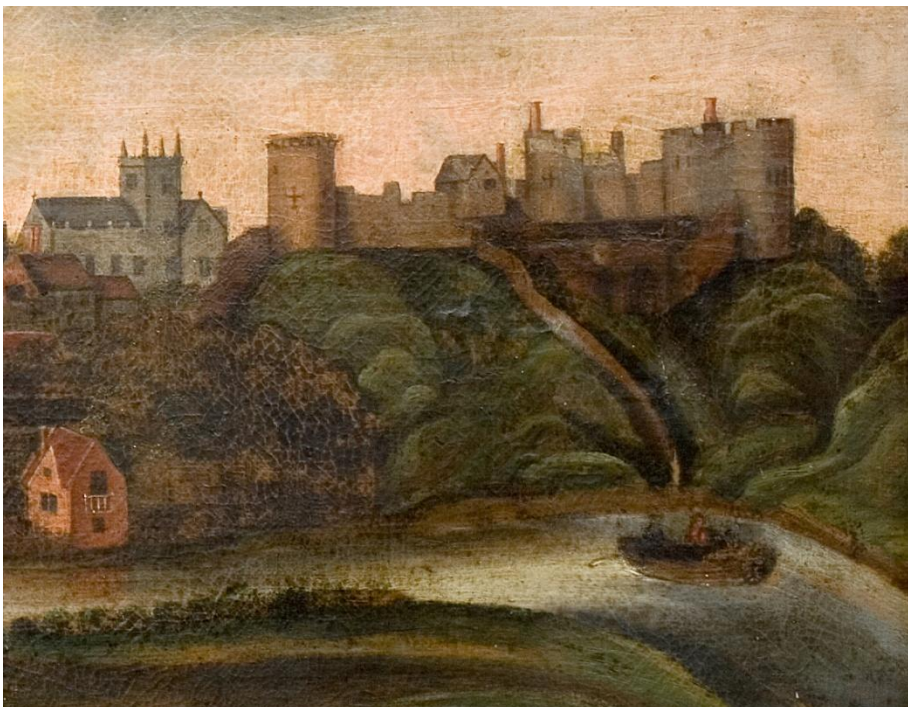
5. The castle in c.1640, just before modernisation by the Royalists in 1643-44. Detail from the panorama of Shrewsbury from the east (SM&AG)

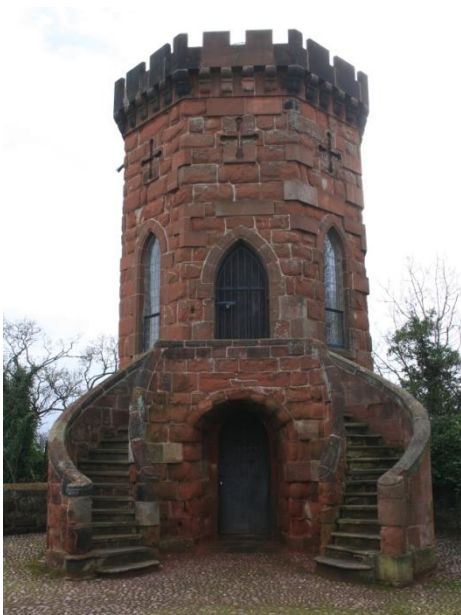
7. Thomas Telford's Laura's Tower of c.1790 on the motte top

The level top of the motte stand 13m above the surface of the inner bailey. In plan, the motte top is now roughly triangular, widest on the south-west side, but the clear historical evidence of damage by landslips resulting from erosion by the river suggests that it may originally have been oval and perhaps up to twice its present area. The motte top is retained on its eastern/riverside/damaged side by a substantial retaining wall of pale, probably Grinshill, coursed sandstone ashlar with contrasting bands of red sandstone, identifying it with some certainty as work by Edward I's builders, in imitation of Caernarfon, late in the 13<sup>th</sup> century, making good after the collapse. At the southern end of the motte this wall is bonded into the semi-circular base of a tower: this was known in the 18<sup>th</sup> century as the 'watch tower' and illustrations suggest it stood until Thomas Telford built the Gothick 'Laura's Tower' on top of it, as a summerhouse, in the 1790s.

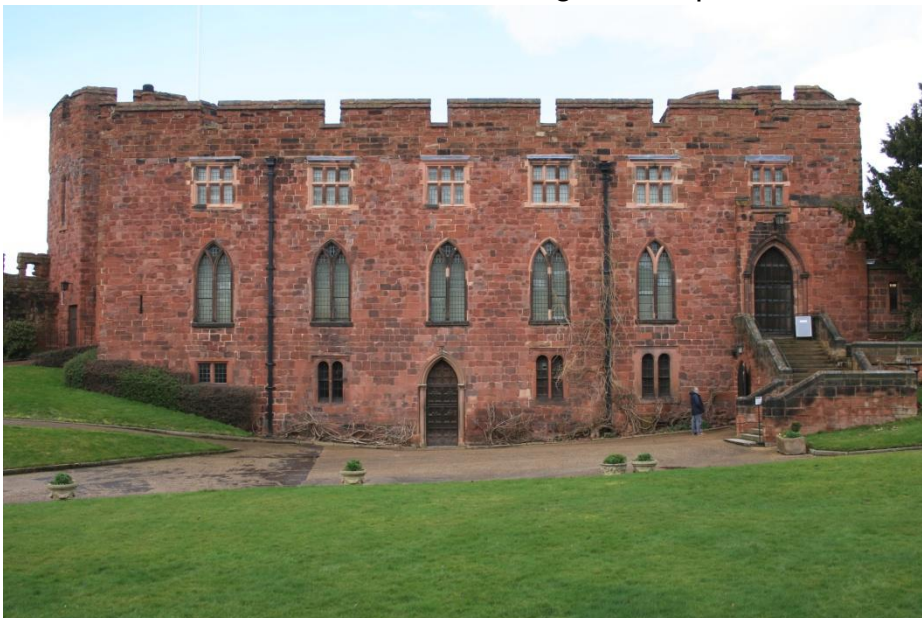
8. The castle hall: the inner bailey (south-east) elevation

The building was examined by buildings archaeologist Richard K Morriss in 2000. Externally, it is nearly all of the early 13<sup>th</sup> century, except for the tops of the walls, which are Thomas Telford's work of the 1790s, as are the 1<sup>st</sup> floor windows, which were inserted into original openings; the door at the east end was built during a restoration episode in 1925-6 by Sir Charles Nicholson when the site was acquired by the Borough but it was built where Telford had inserted a window into the original door position.

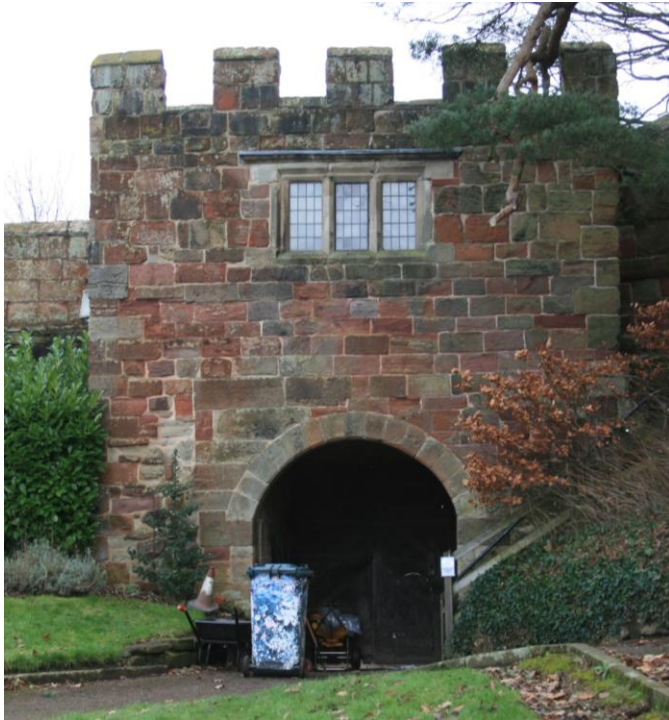
9. The Postern Gate; the inner bailey elevation

This is a very simple two-storey structure comprising a single chamber with crenellated parapets above a barrel vaulted passage running between the inner and outer door arches. The historical evidence shows that the 'arch stones' of the present building were laid in 1643 (Worton 2012, 106) and the general form of the building is of that date, but it is equally clear that this was a rebuilding of an earlier structure. The inner bailey (south) elevation shows a clear straight joint to the north/left of the archway and one historic illustration shows a projecting mass of masonry here (SA 6001/198/280) suggesting that the building was reduced in depth. The Shrewsbury panorama of c.1640 shows a postern gate in this location, the Burghley Map shows a small tower here (figs. 5 and 4). The outer archway has a slot for a portcullis above it, but no evidence of there ever having been one in the first-floor chamber (Morriss 2001, 46). Various kinds of sandstone are present, including large blocks of ashlar some of which, on the exterior, have Lewis holes in their faces. The door leaves are of 1643-44: the outer face (and the surrounding masonry) has musketry damage from the action in 1645.

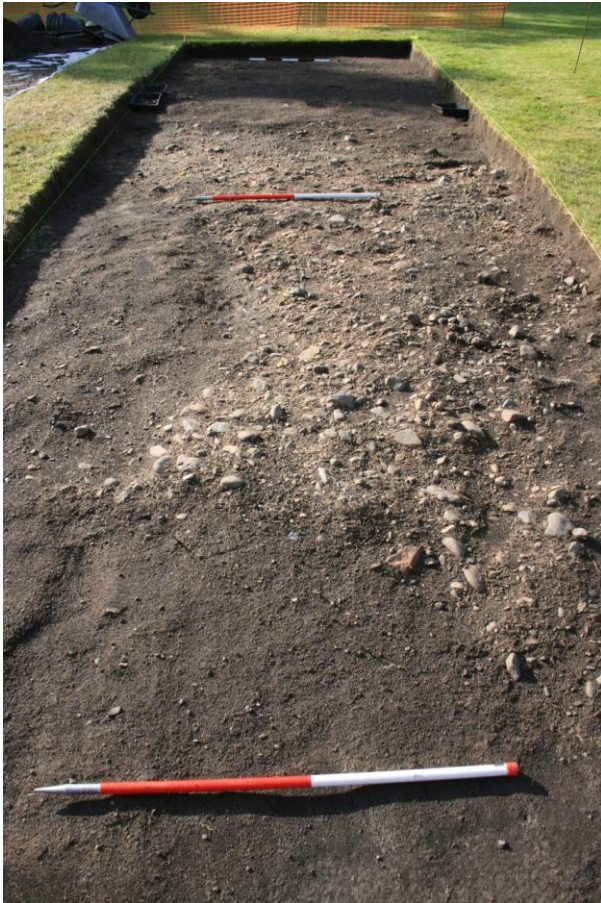
12 Gravel 003, as first defined and after heavy rain, cut by topsoil filled features, probably flowerbeds, 004/005 to left, 007/008, foreground, under the one-metre scale; looking east

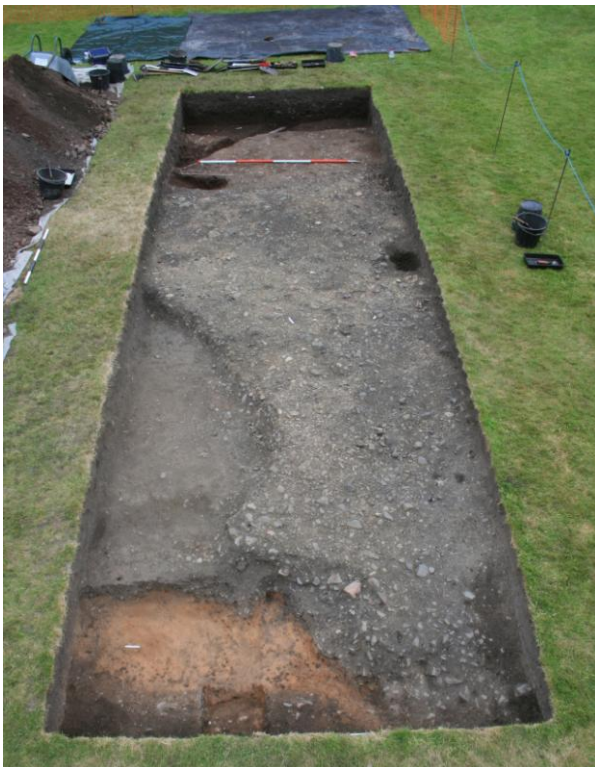
13 Gravel 003 cut by features 004/005 left and 007/008, bottom, after excavation, revealing the orange sand underlying gravel 003. Looking east

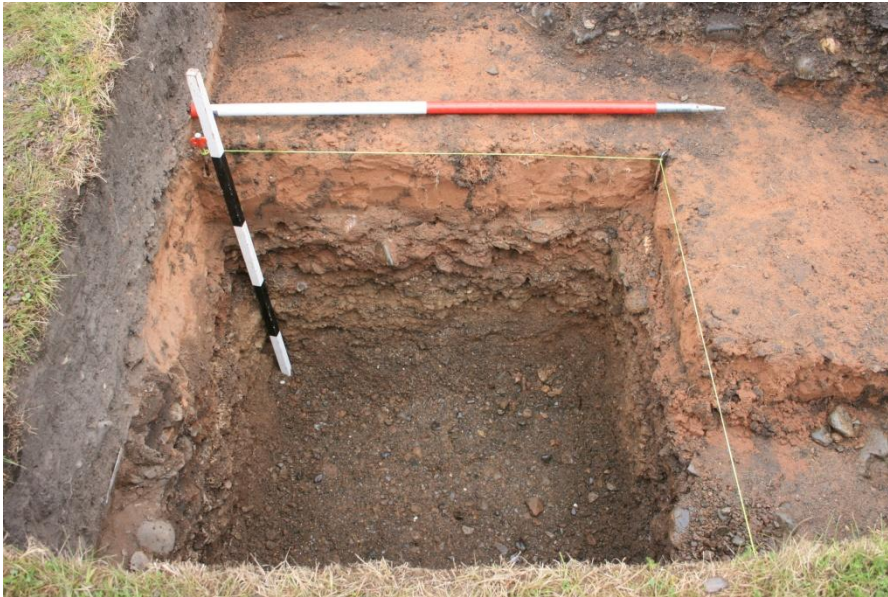
14 Sondage in the north-west corner of the trench, looking east, revealing the sequence of natural sand and gravels with a sharp granular pea-grit at the base of the excavation. The edge of the uppermost gravel 003 can be seen top right

Given the radical nature of this interpretation and its implications, 003 and the deposits it overlay were thoroughly tested. A one-metre wide strip was excavated along the southern side of the trench through 003 to a depth of c.20cms, showing that the exposed dirty gravel gave way to a cleaner, unstained, gravel of precisely the same composition (see fig.25). Secondly, a one-metre square sondage was excavated in the north-west corner of the trench to a depth of 1.2m below present ground level (fig.14). No artefacts were recovered during this exercise; all the deposits thus tested were sterile and were fully consistent with a natural glacial origin.

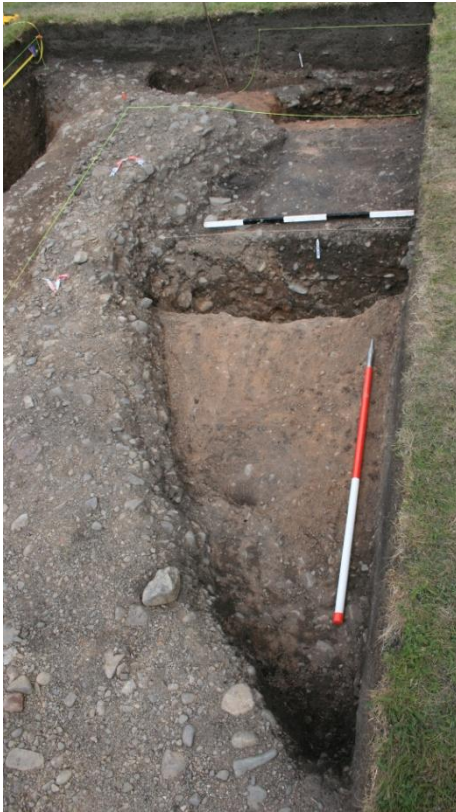
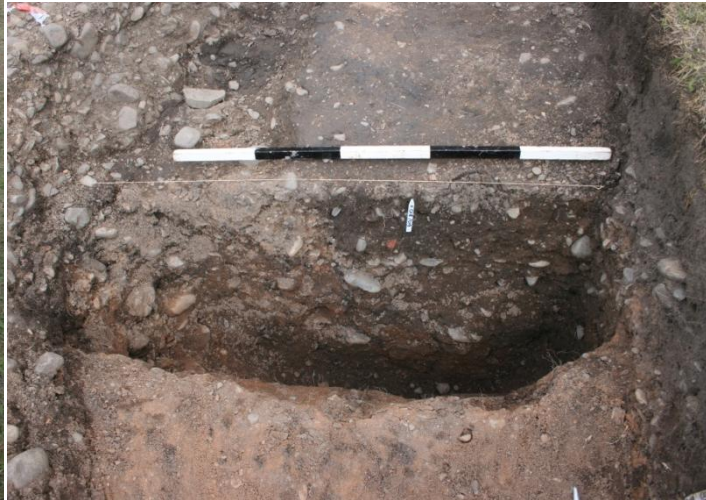
15, 16, Feature 004 (a probable flower bed) after excavation with pit 018 under it half-sectioned; both looking west

Removal of the fill 005 from cut 004 showed that it overlay an earlier cut feature 018 (fill 019) that appeared to be sub-circular, about a metre in width with sloping sides; this was half-sectioned but contained no dateable artefacts. Excavation in this area was not completed in the time available.

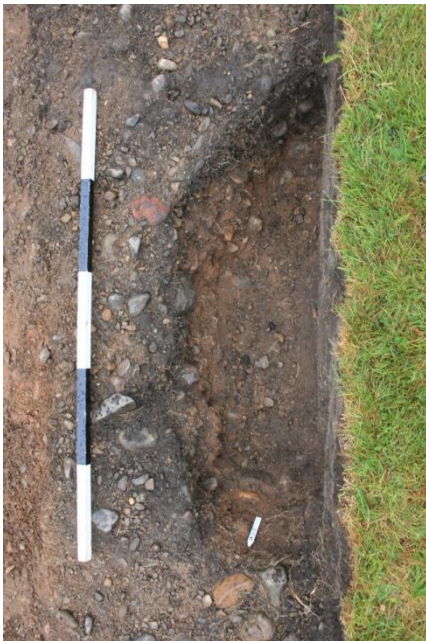
17 Pit 015 in the centre of the south section. East to top

On the southern edge of the trench two cut features were excavated. Mid-way along the section a small pit 015, filled with dark stony soil (016), was excavated and produced 19<sup>th</sup>-century pottery, glass and clay pipe fragments.

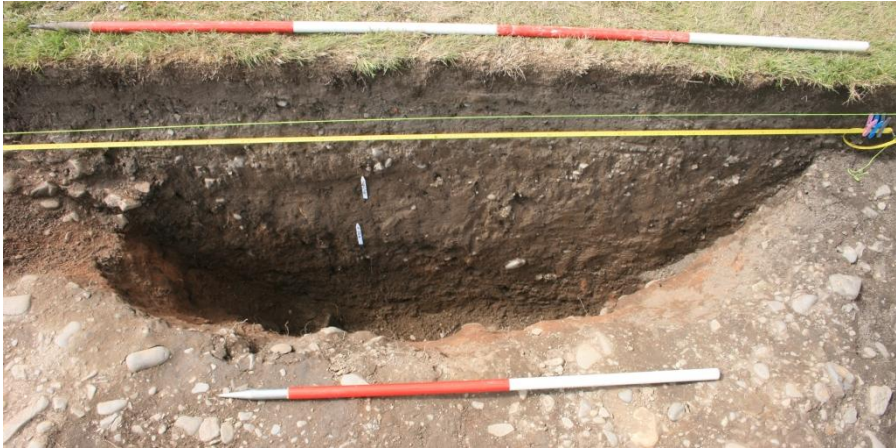
18 Pit 020, after excavation, looking south

of the trench, containing 19<sup>th</sup>-century material. Removal of this allowed the definition of feature 020 cutting through the gravel 003, which resolved into a sub-circular steep-sided cut feature, interpreted as a pit, filled with a largely stone-free soil (021) with a high clay content. This overlay a lower, darker, fill (022) of silty soil with small stones. These fills contained quantities of animal bone, a fragment of worked bone, and pottery identified as being of pre-Conquest date.

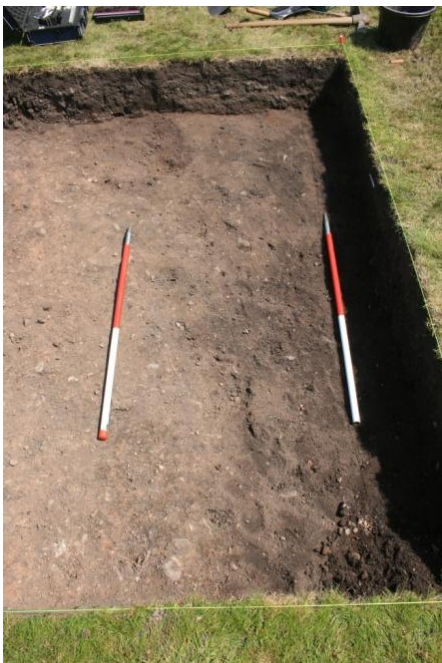
19 Pre-excavation shot (north to top) of linear feature 009 (fill 010)

The natural gravel 003 was not at first apparent over the easternmost three metres of the excavation trench. At the east end, removal of subsoil 002 disclosed a linear cut 009 along the east section. Its fill (010) of dark silty soil with abundant charcoal flecking contained pieces of coal and brick, ceramics of medieval to 18<sup>th</sup>-century date and quantities of animal bone. It was interpreted as a ditch or drain running in a north-south direction; it survived to a depth of just over 0.5m.

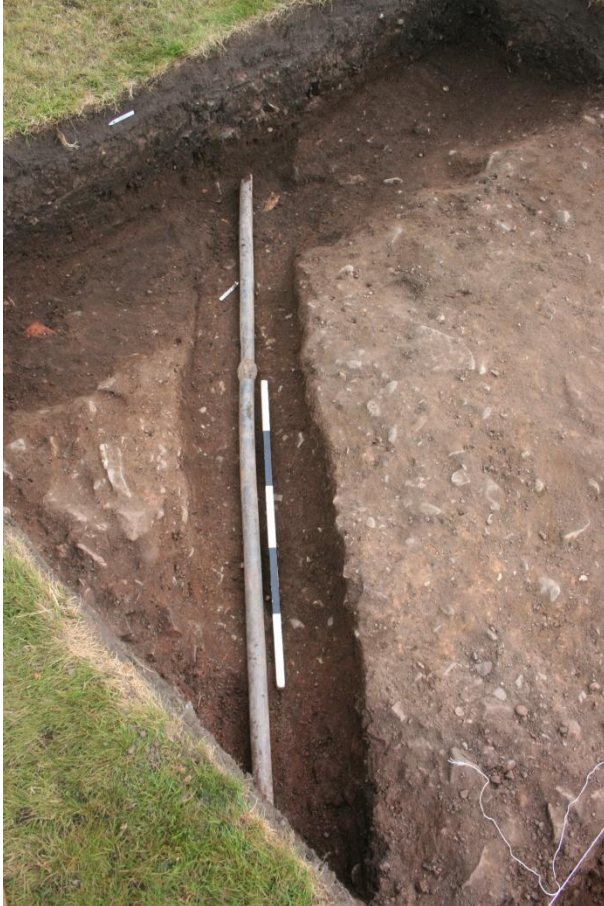
20. Water-pipe trench 011 cutting linear feature 009 (top, along the east end section). The red-coloured soil at the near end of the pipe trench was resolved into a cut feature, 013

Excavation of 009 showed that it was not cut directly into the natural gravel 003 but into a mixed red-brown soil (006) with abundant degraded red sandstone pieces. It also revealed a linear cut (011) crossing the trench in a north-west to south-east direction consistent with geophysical evidence for a service trench on this alignment, heading from the toilet facilities under the castle hall steps towards the castle well. Removal of its fill (012) containing various post-medieval ceramics duly revealed a lead water pipe, probably installed c.1925 as an overflow from the castle facilities into the well.

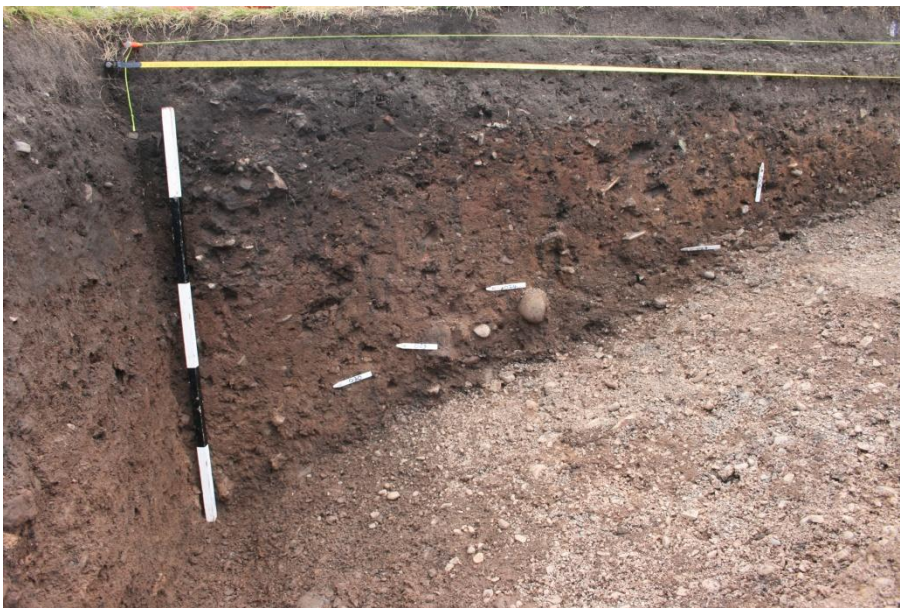
22 Detail of the cut for the motte ditch and its fills, looking south (scale = 1m). The dark fill (010) of the probable later ditch 009 extends down to c. 40cms from the top of the scale bar, the red-brown soils below representing the earlier ditch fills commencing with 006 (top). The contrast with gravel 003 forming the side of the ditch (right and bottom) is very clear

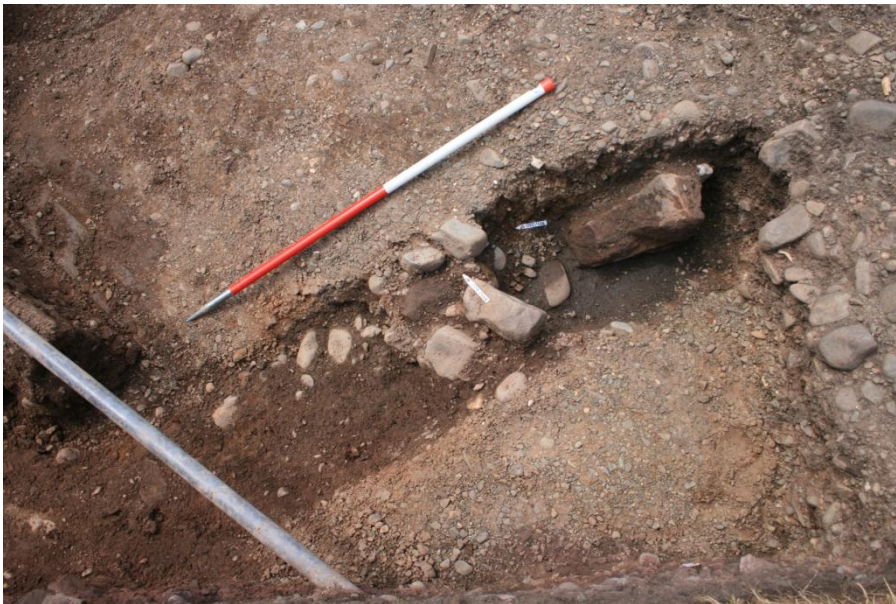
23 Probable post-hole 025 (centre right), after excavation, and slot or gully 027, lower left, after definition: looking south-west

On the north side of the trench, in the area bisected by the water-pipe trench, cut into the slope of gravel 003 was a small sub-circular cut feature (025) up to 0.4m deep containing large stones and interpreted as a probable post-hole. Extending north-east from this feature and similarly cut into the gravel slope was a linear cut feature (027) containing a fill of medium-brown clayey soil (028) with gravel, and sherds of medieval cooking pot. This was interpreted as a probable beam-slot or gully, though little of it was visible as a consequence of disturbance by the later pipe-trench 011 and pit 013; the relationship between the probable post-hole and slot could not be determined with certainty but the filling of the post-hole appeared to be later than the filling of the slot or gully. The probable post-hole 025 was sealed only by the subsoil 002 but the slot or gully 027 appeared to be sealed by the sequence of fills within the ditch below 006. The slot/gully could, however, have been cut from a higher level and only detected by means of the contrast with the gravel 003.

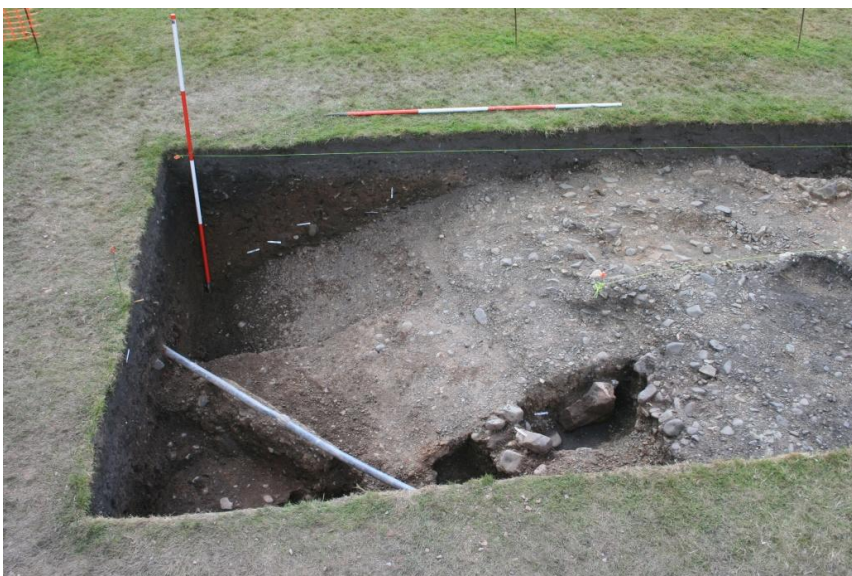
24 General view of the eastern end of the trench on completion and the large 45-degree cut interpreted as the motte ditch. Looking south

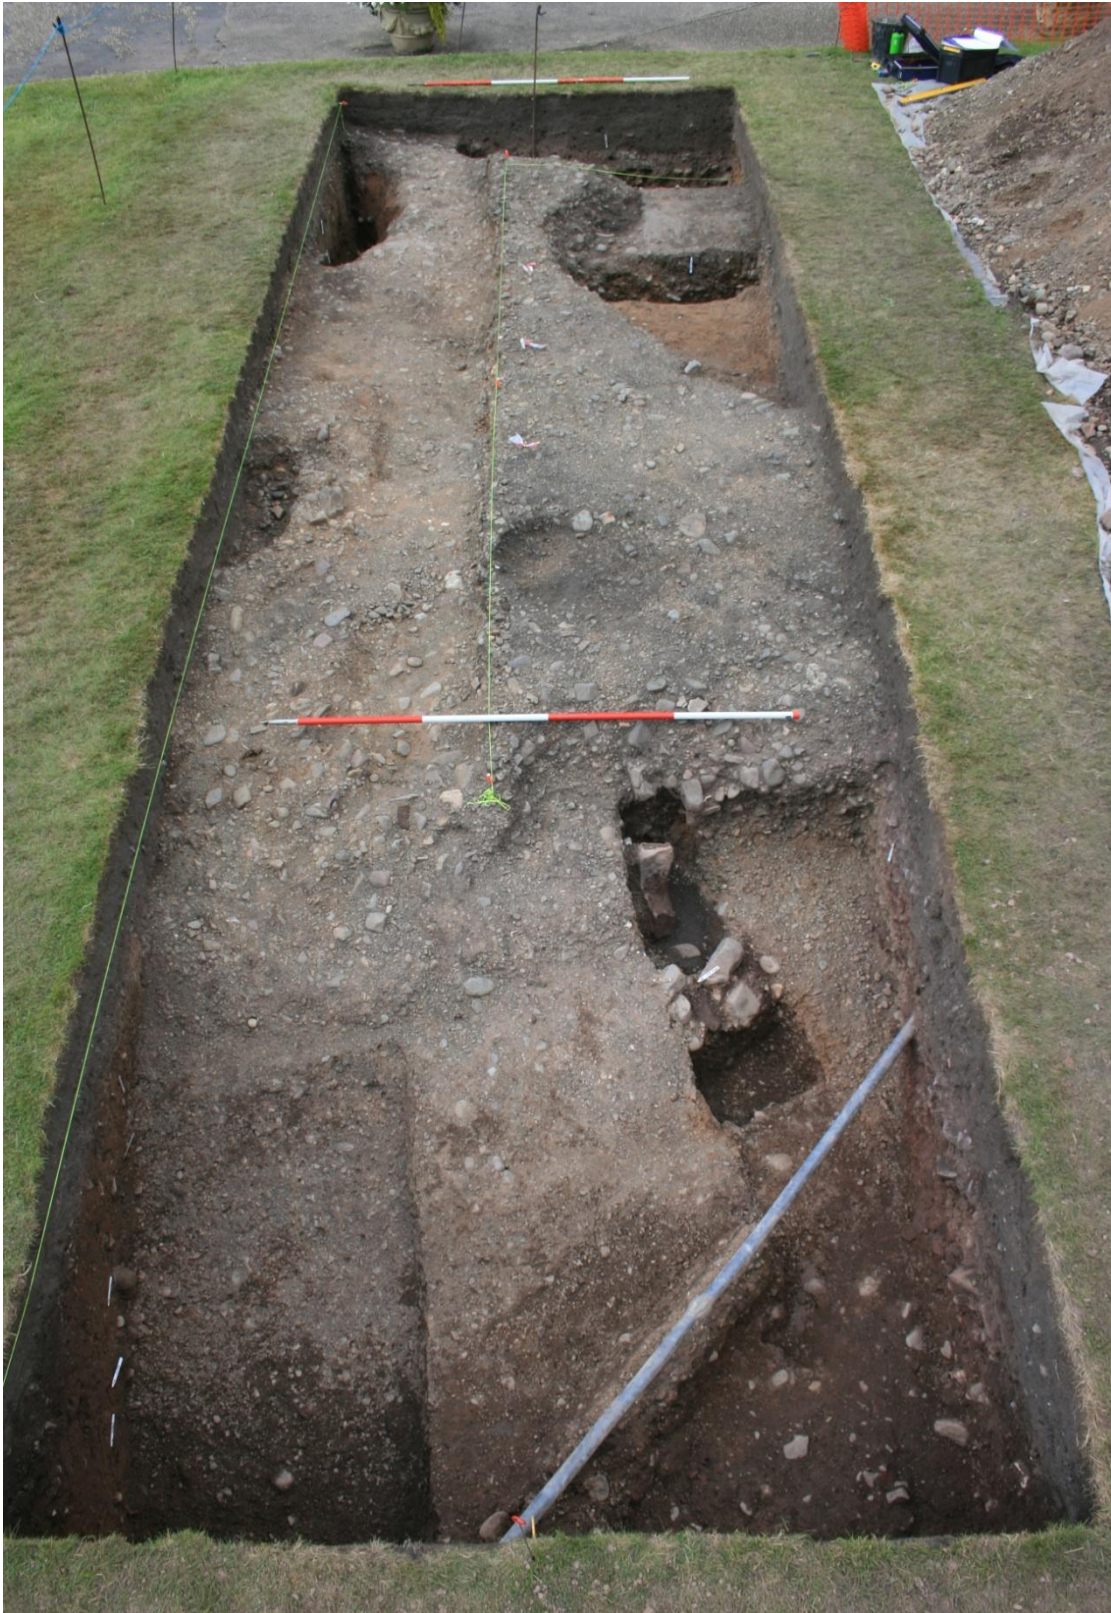
25 Final excavation view looking west, the slope of the motte ditch in the foreground, from the two-metre ranging pole. The ditch-fill deposits have been completely excavated only on the left side (south). Above the diagonal water-pipe are the probable post-hole 025 (excavated) and slot or gully 027 part-excavated in the foreground

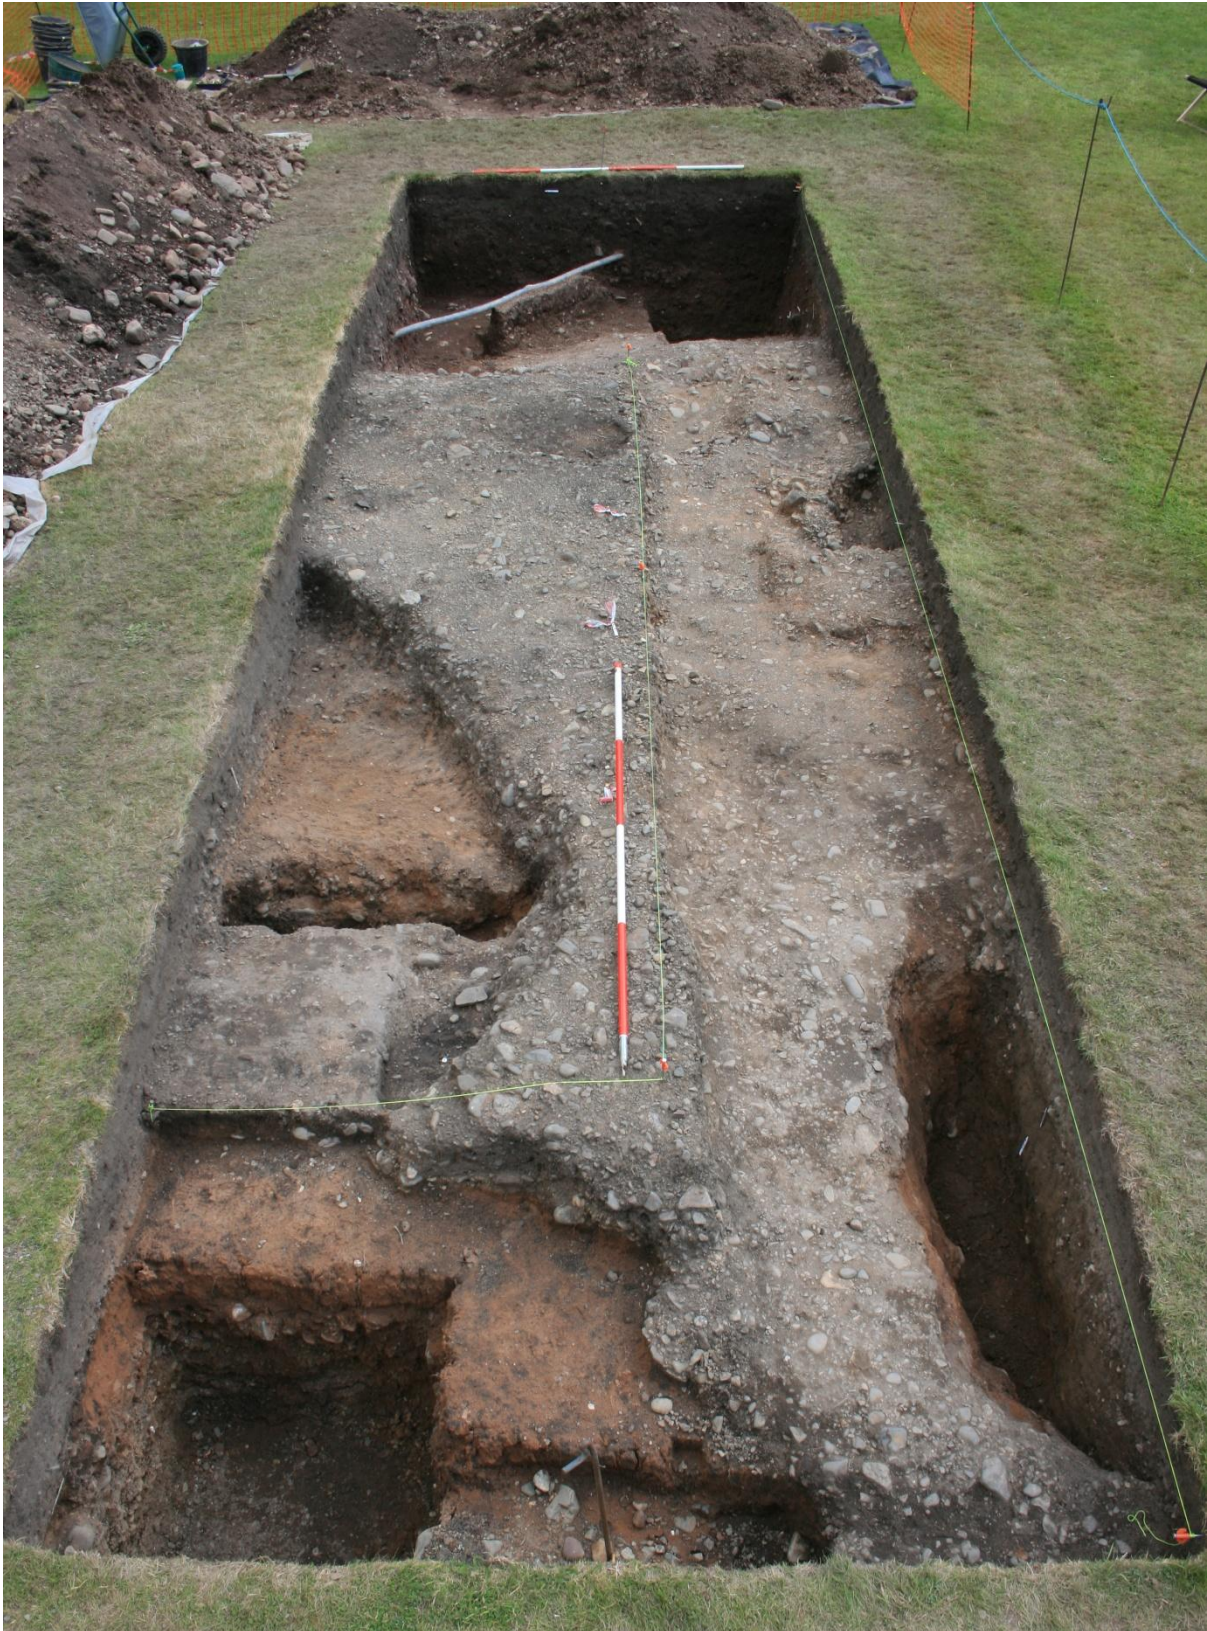
26 Final excavation view, looking east. Gravel surface 003 has been sectioned, and tested with a 1m-square test-pit (bottom left corner). Late Saxon pit 20: right foreground

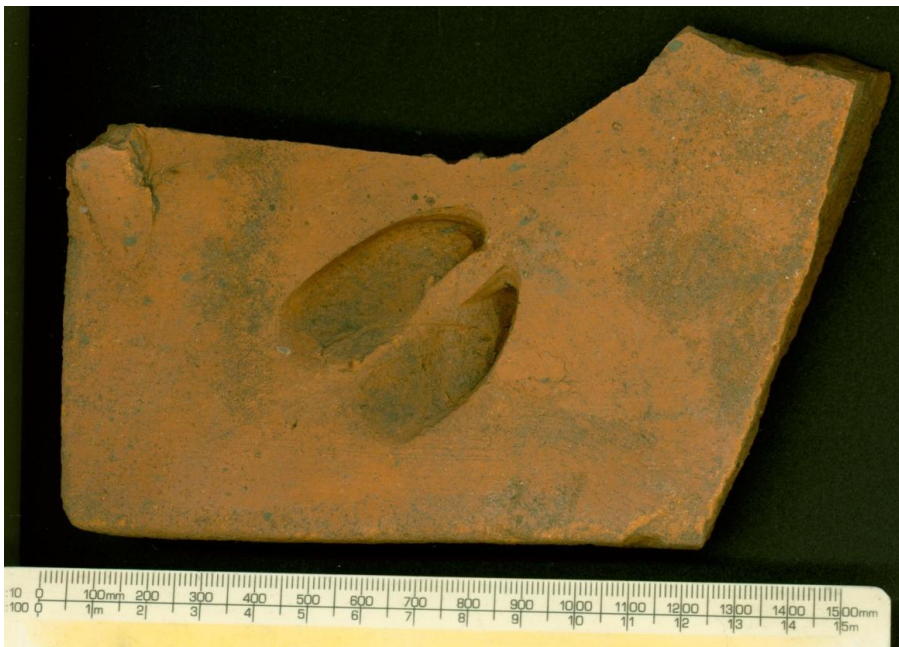
27 Nibbed roof tile with hoof print: context 006

Flat tile fragments 17mm to 24mm in thickness, in a bright red sandy fabric, were recovered from contexts 002, 010 and 017. One nearly complete roof tile from context 006 (the topmost surviving fill of the motte ditch) with a central raised nib on one edge is illustrated: it bears a hoof print, probably from a sheep, goat or possibly deer. Probably medieval.

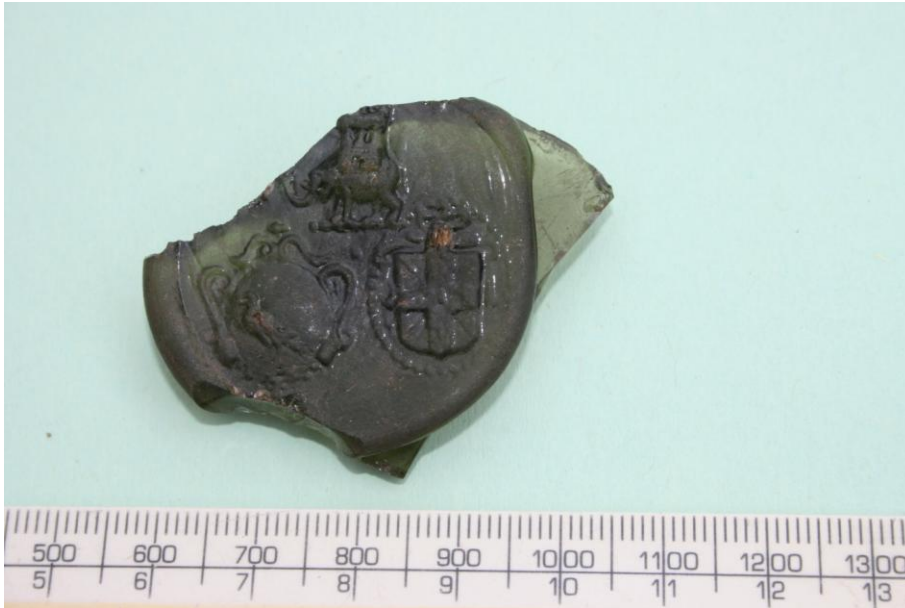
29 Wine bottle glass seal bearing the arms of the Corbett family

The vast majority of the glass recovered was bottle-glass of post-medieval date. The finest individual piece (from context 002) is illustrated: it bears the arms of the Corbett family.

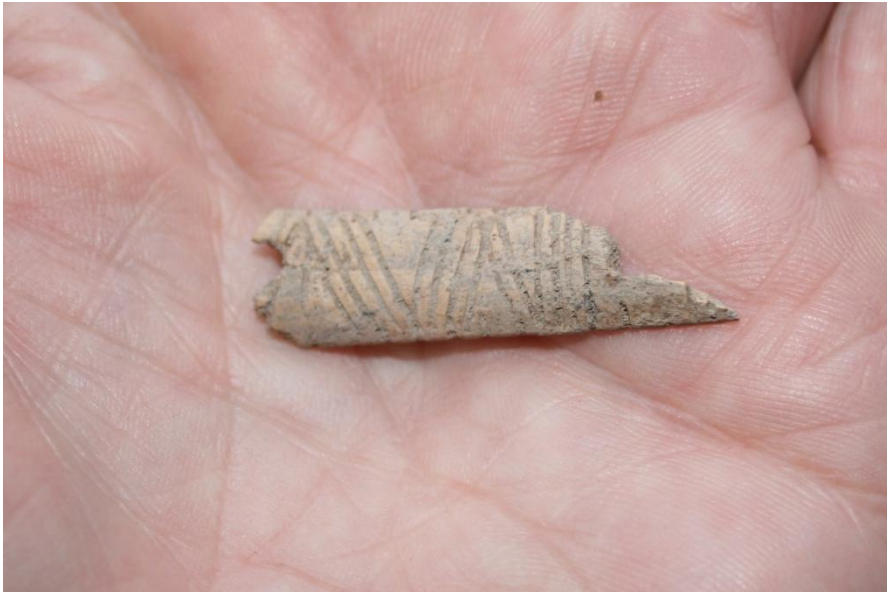
30. Bone knife- or comb handle with incised decoration. ?Late pre-Conquest

A piece of rib bone 3.5cms long with incised cross-hatched decoration. Probably a fragment of a knife handle or comb. Possible early medieval date (from context 022, the lower fill of pit 20).

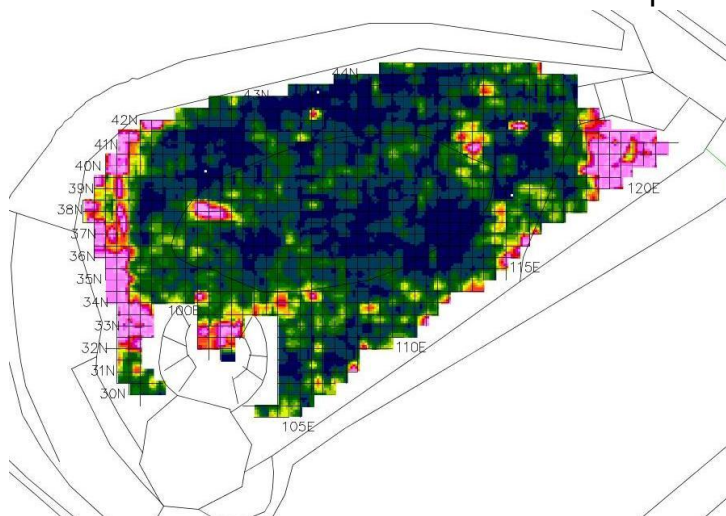
32 Stratascan’s 2000 GPR plot of the motte top: timeslice at 0.95-1.40m showing solid reflective targets (buried foundations) in pink/red

Despite there having been no excavation on the motte top, there is nevertheless sound evidence of buildings up there. The Stratascan GPR survey of 2000, though largely inconclusive, did succeed in identifying an increased thickness to the perimeter retaining walls at the north and south ends of the motte top. Both these locations can be identified as

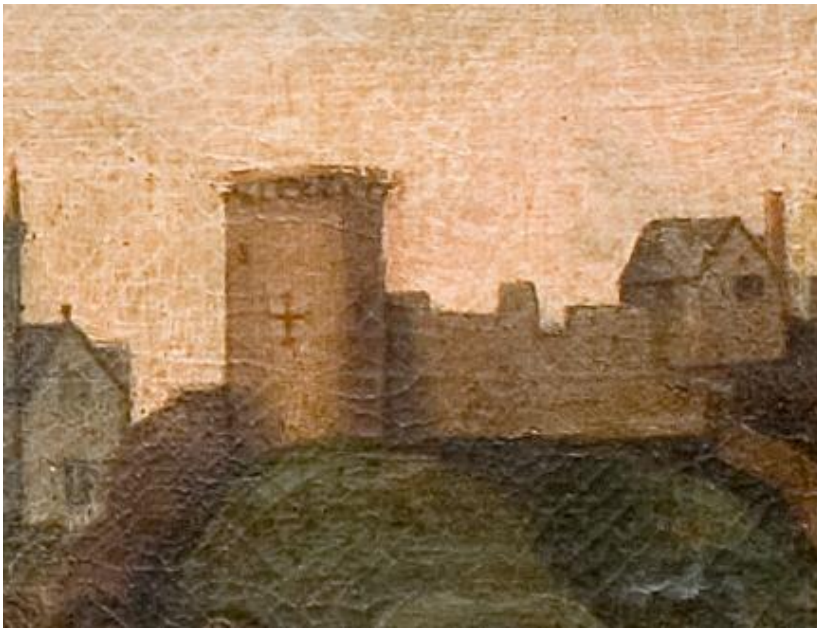
33 Detail from the panorama of Shrewsbury c.1640 from the east showing the remains of motte-top buildings and the late 13<sup>th</sup>-century ‘watch tower’, demolished c.1790

the sites of former buildings from historic illustrations evidence showing former window openings in these two areas. At the north end, this can be seen on the Shrewsbury panorama of c.1640 (fig. 33) which shows not just a ruined window opening in a stretch of masonry, but the overhanging, presumably timber-framed, gable of a building. At the south end, the earliest surviving illustration identified so far – one of 1663 by Sandford in the College of Arms (copy in Shropshire Archives PR/2/655) – shows a roofed building west of Laura’s Tower, and a view of c.1778 by Thomas Pennant (fig.34) shows three ruined window openings on the motte top where now there is just the low parapet wall.

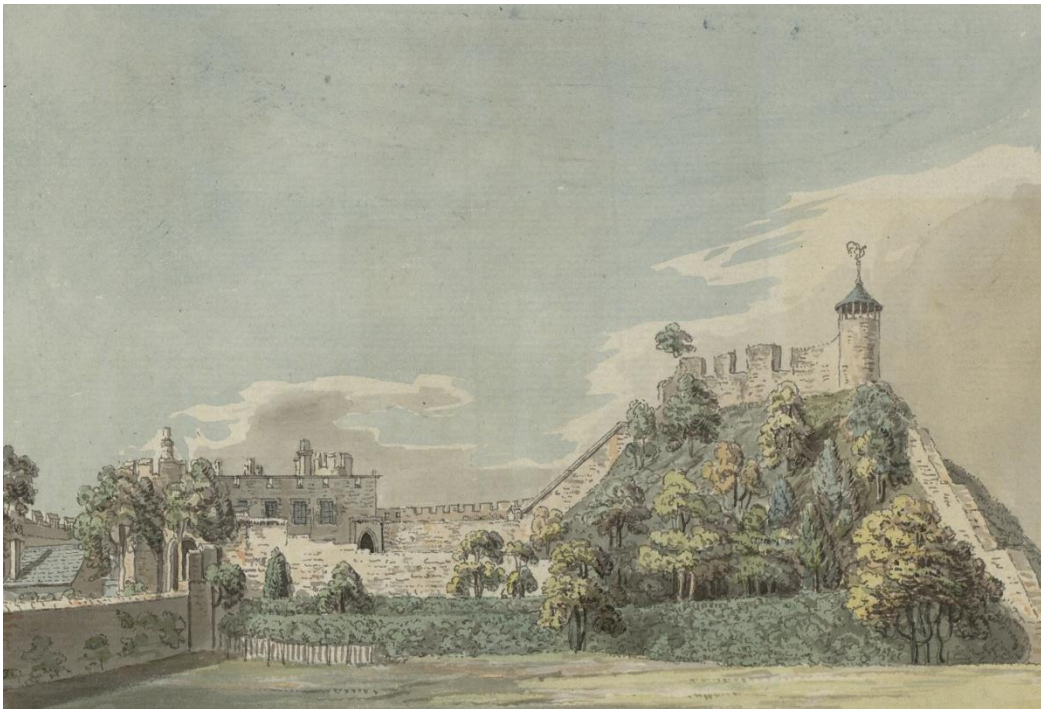
34 View from the south by Thomas Pennant c.1778 from his ‘A Tour in Wales’ (National Library of Wales via Wikipedia)

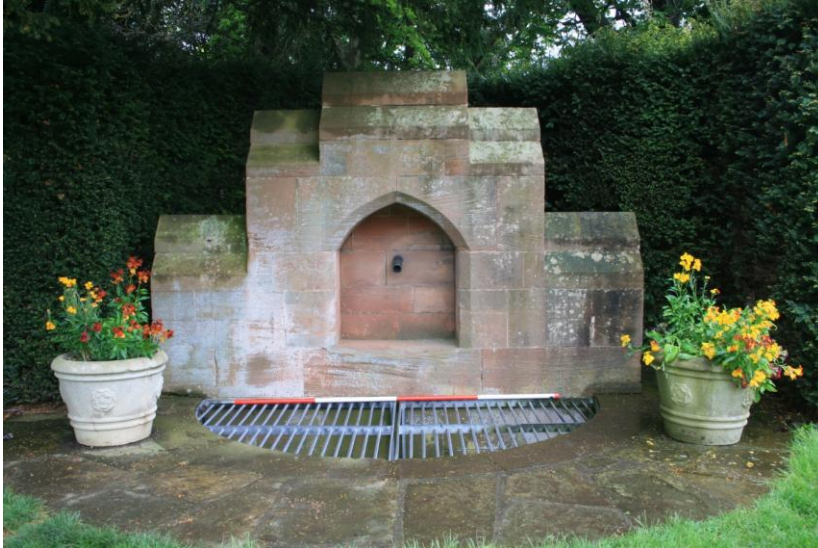
38 The present well head: front

The present castle well above ground is an undistinguished and rather overlooked, not to say dull, garden feature, with a masonry well head with a central niche from which a pipe protrudes to supply water to the semi-circular basin at its foot: this has not contained water for at least the last twenty years. The well sits within a small hedged enclosure, open on the NW side to face into the bailey interior.

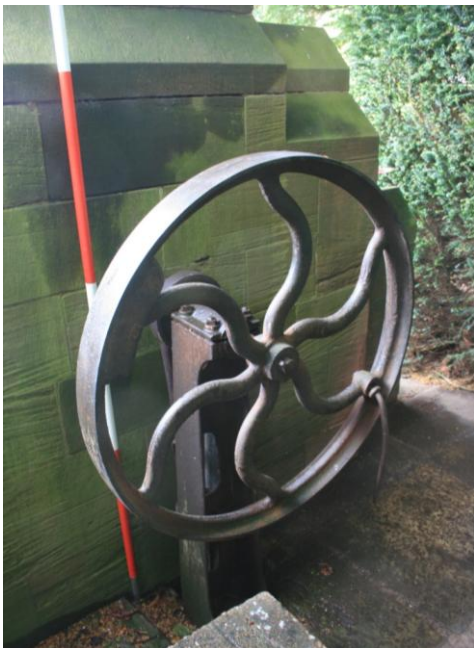
39 The well head, rear: the hand pump flywheel

Behind it is a paved area supporting a large cast-iron hand pump with the remains of a handle on its flywheel. Close by, an inspection cover in the paving gives access to an underground inspection chamber reached by iron rungs embedded in the brickwork of early/mid 20<sup>th</sup>-century character. The chamber floor is 2.15m below ground level; at 0.99m by 0.66m, it is not roomy. Its NW side is open to the well shaft.

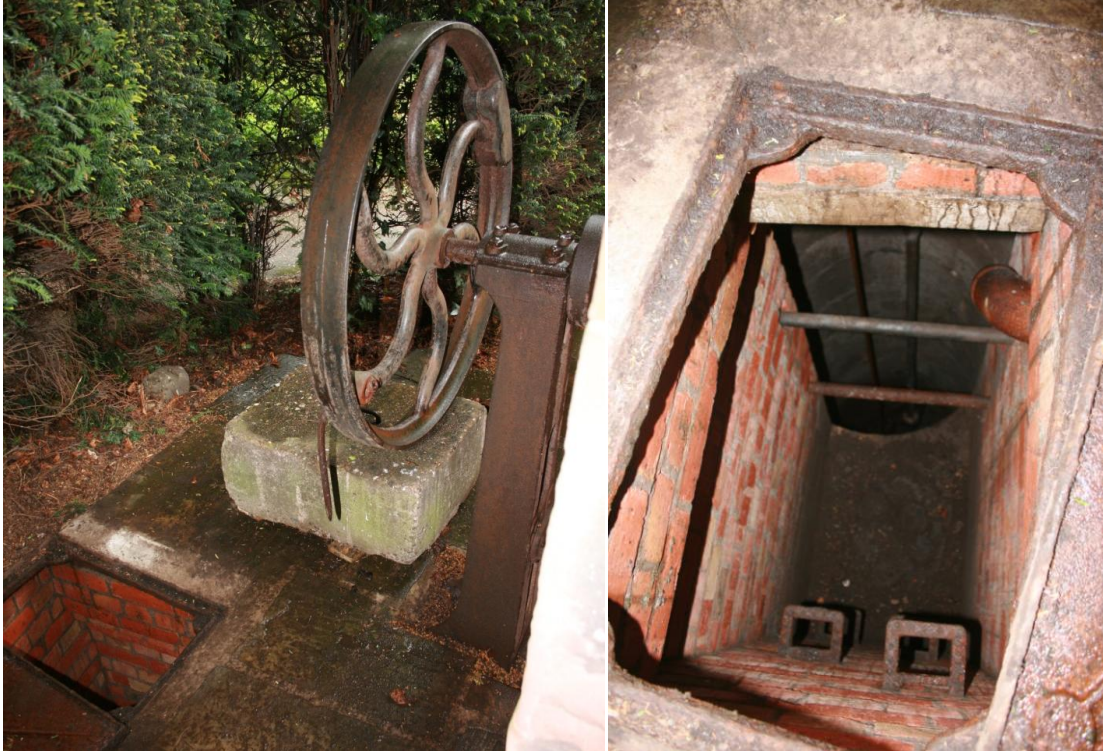
Left: 40 The pump in relation to the inspection chamber (the concrete block has just been moved off the inspection chamber cover); right: 41 The inspection chamber and well shaft
