# An excavation in the inner bailey of Shrewsbury Castle

Nigel Baker BA PhD FSA MCIfA

*A report to the Castle Studies Trust*

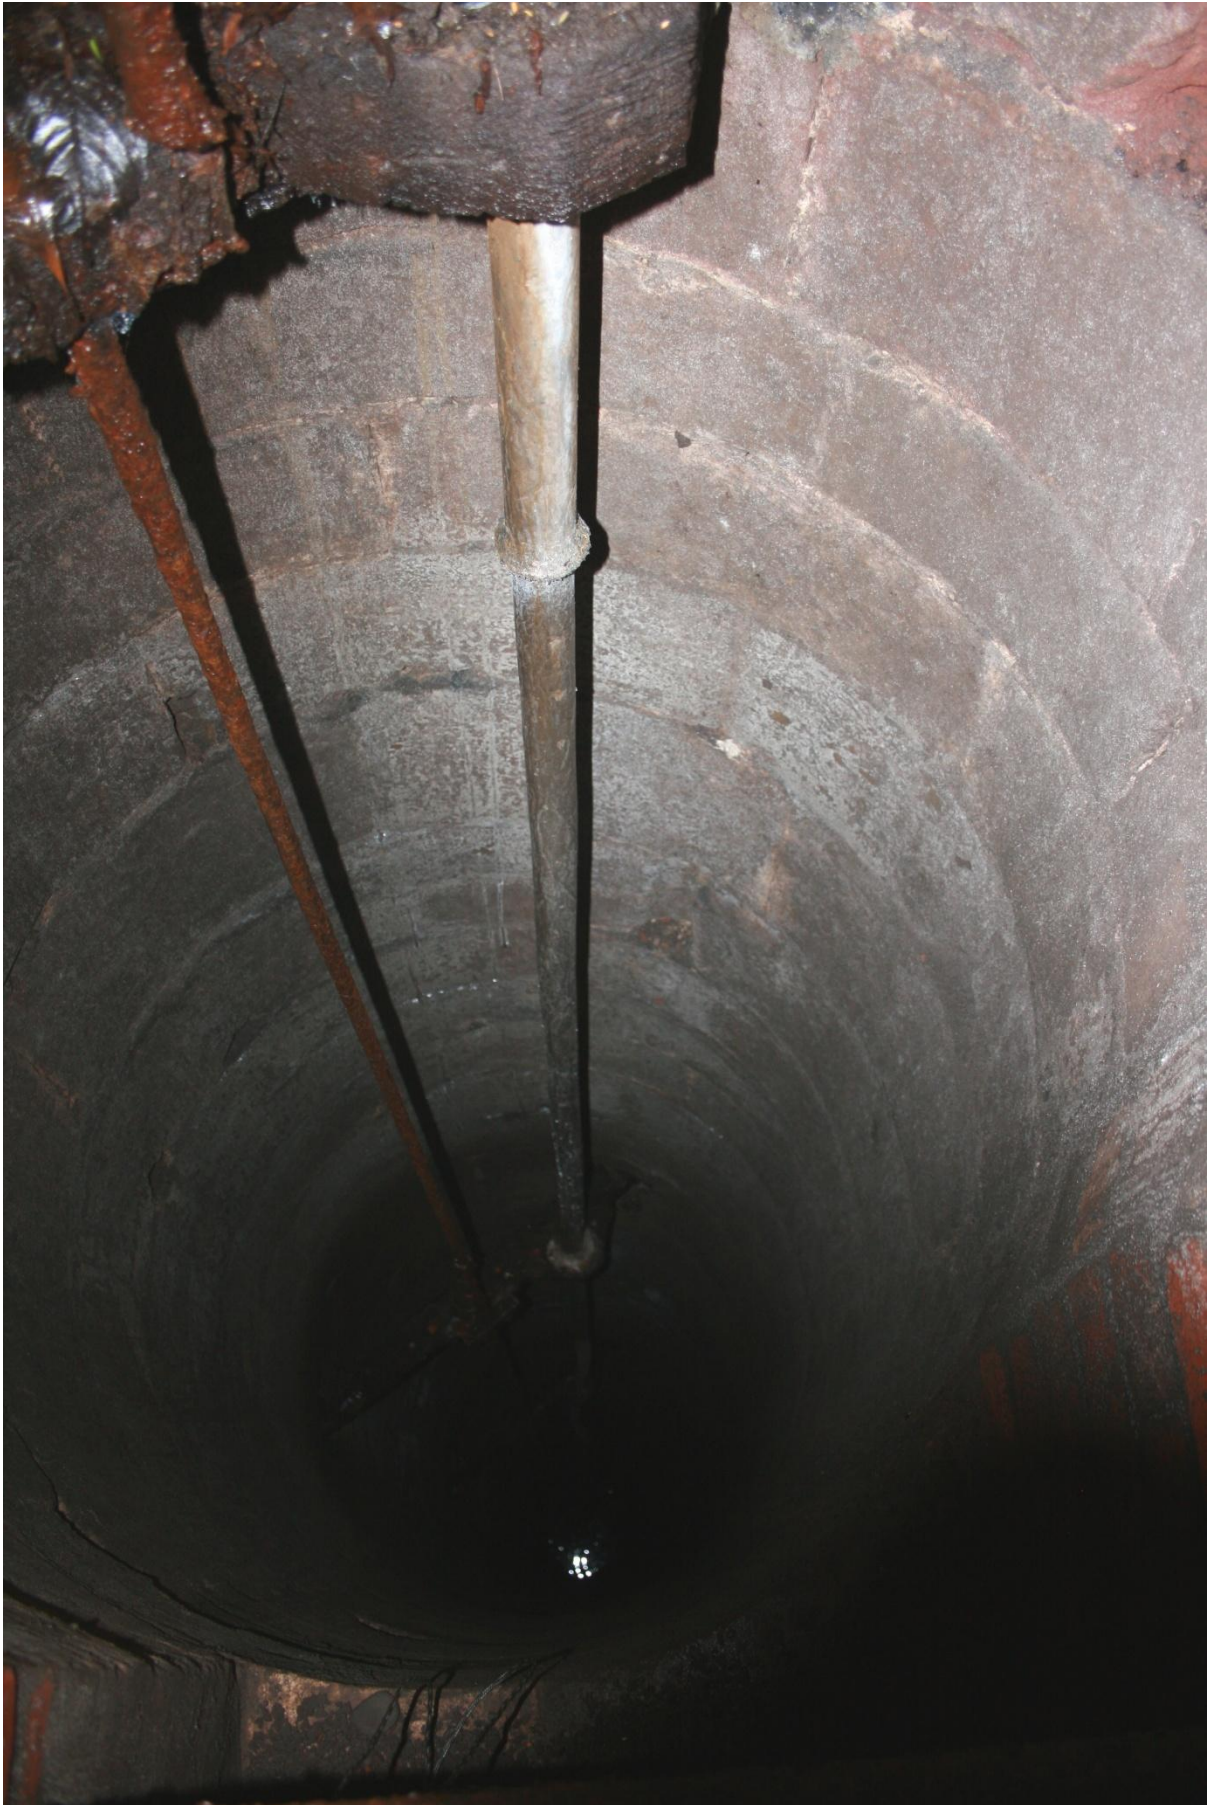
42 The well shaft. The light is reflecting off the surface of the water 21 metres down

A pipe and an unidentified iron rod descend the shaft from the pump at ground level, retained in place by wooden beams inserted across the shaft at intervals.

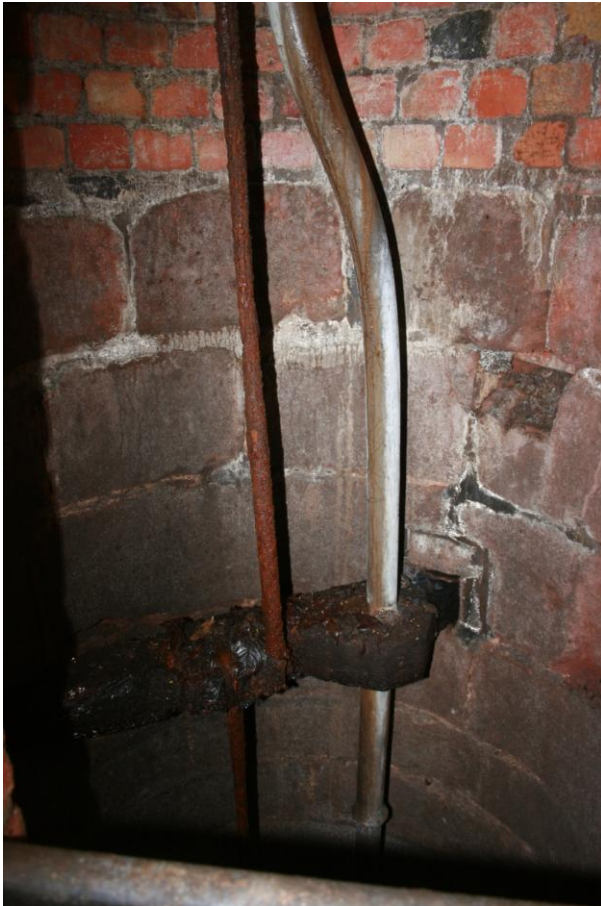
43 The shaft at inspection-chamber level showing the top brick courses and the pipe and unidentified iron rod retained by the uppermost wooden beam inserted into the stonework

The character of the sandstone masonry lining of the well shaft suggests that it is likely to be of late medieval or early modern date, but fairly certainly built when the castle was still in its military phase, before it became a private residence. The location of the well – within the infilled motte ditch – confirms that it was not built during the earliest life of the castle. The condition of the stonework suggests the shaft has never been open to the elements but has always been under cover, whether within a building (maybe that on the Burghley Map), under a well-head roof, or just slabbed over. This issue needs (like so much in Shrewsbury Castle) further research on primary source materials. J A Morris, a local man, writing his paper on Shrewsbury Castle published in 1938, described the well as being 'in the centre of the inner ward', which makes one wonder whether he had actually seen it, though he accurately recorded its depth as 74 feet.

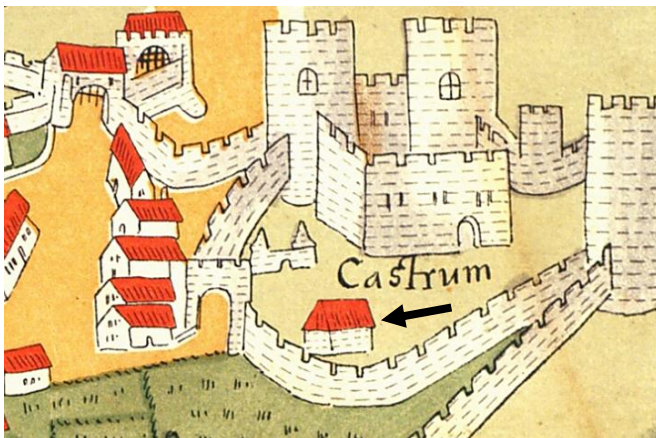
44 Extract from the Burghley Map, c.1575 showing a single building still roofed, in the area of the present well

The earliest reference (from secondary sources) found to a well at the castle is to its refurbishment, with a new pitch-covered rope, by Royalist forces in July 1643 (Worton 2012, 106). The existing well is not shown on a map until as late as 1882 (see fig.45), but it is interesting that the only roofed building within the bailey on the Burghley Map is in this area. It is not shown at all on John Rocque's map of Shrewsbury of 1746 (fig.37).

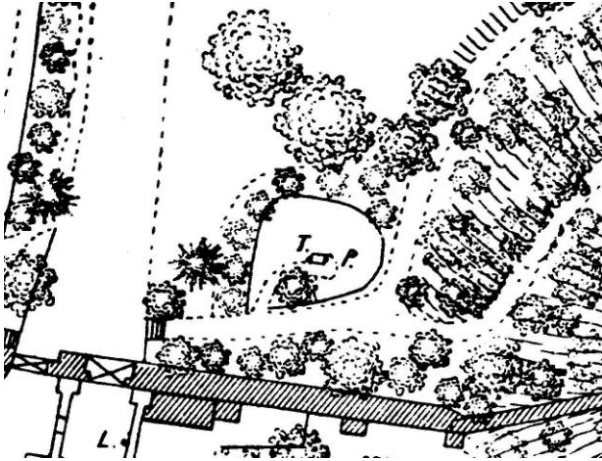
45 Enlarged detail from the O.S. 1:500 plan showing the well as it was in 1882. The little enclosure is close to the footprint of the present one, though here it opens on to the path to the south. The well itself is not visible; the 'T' for tank and 'P' for pump suggests it was a working feature, perhaps mainly for garden use
