Excavations on the motte and the north curtain wall at Shrewsbury Castle, 2022

A report to the Castle Studies Trust

Summary

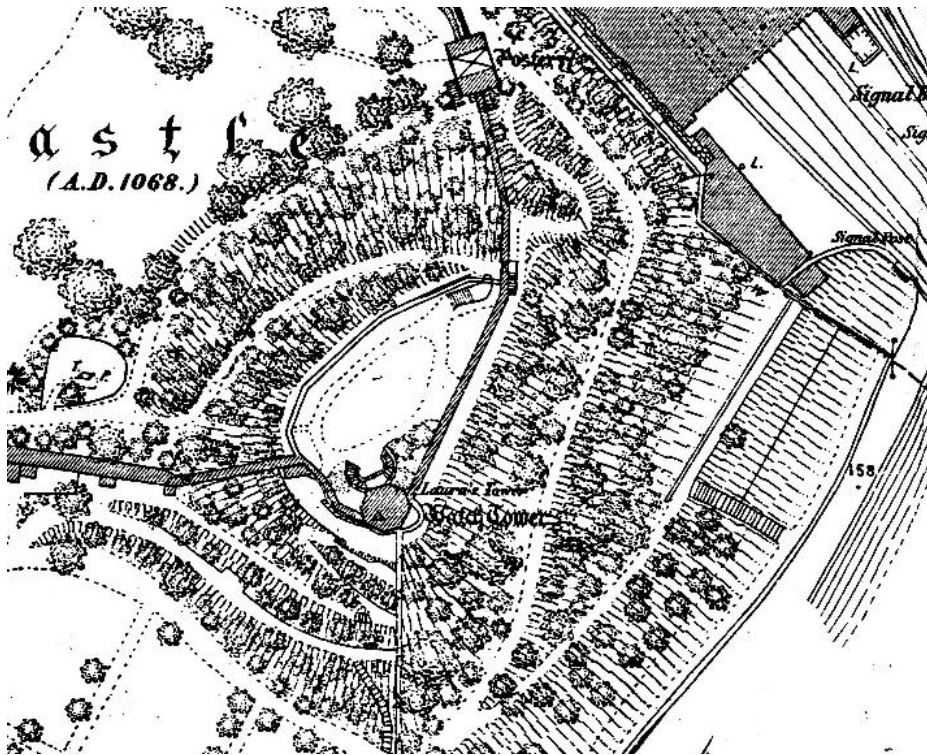
6. The motte as surveyed in 1879, from the Ordnance Survey 1882 1st edition 1:500. The garden on the motte summit is clearly depicted, with lawns, paths and shrubbery either side of Laura's Tower

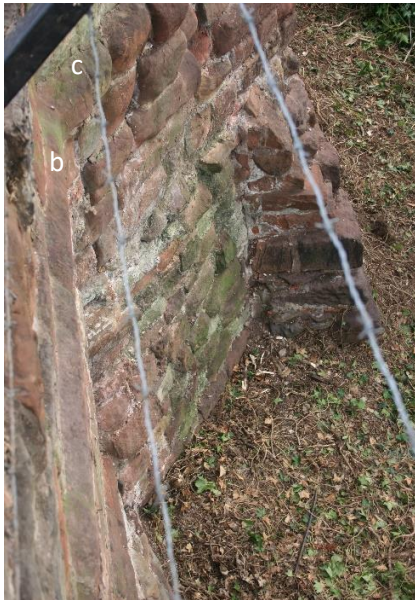
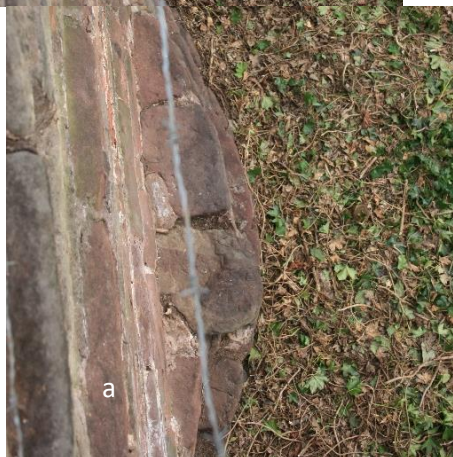
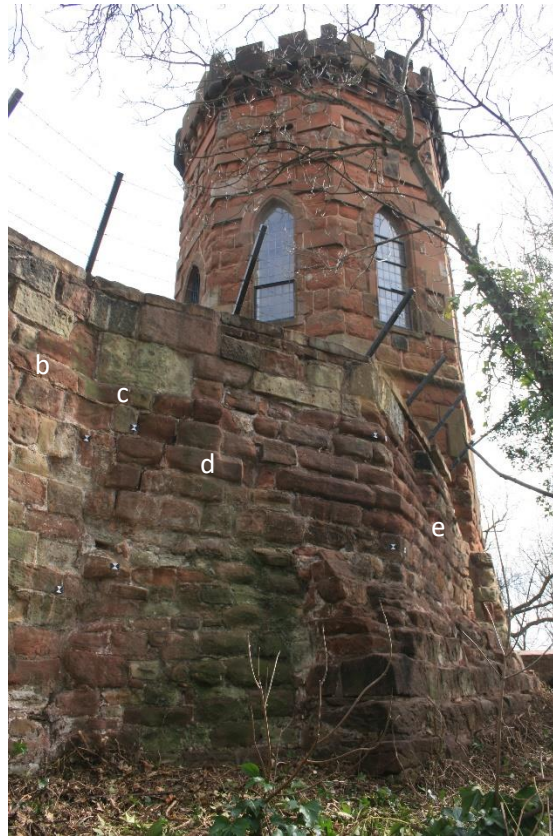
7. (left) Composite vertical view off the south motte-top parapet wall looking down onto the arc of masonry that may represent part of a circular tower base. It also looks down to the top of the plinth course (a-b-c) higher up the wall face that carries on across the angled masonry face to the east (top of picture)

8. (right) view looking east towards the stepped masonry base under angled wall with high plinth course. In this view the plinth course can be seen stepping down from four courses below the parapet to seven/eight courses below (at 'd') and continuing horizontally around the angle beyond ('e')

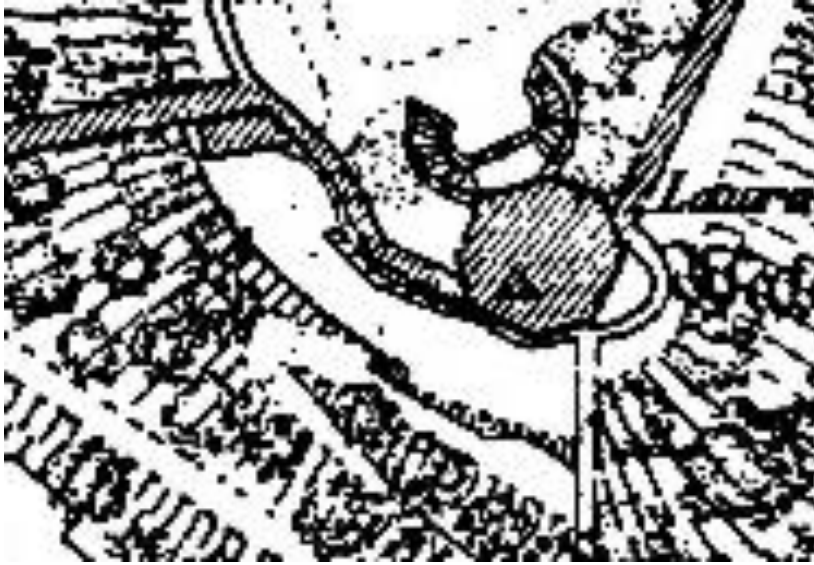
9. Enlarged extract from the 1882 O.S. showing the south side of the motte, the projecting stepped masonry footing and the outline of the watch-tower base under Laura's Tower

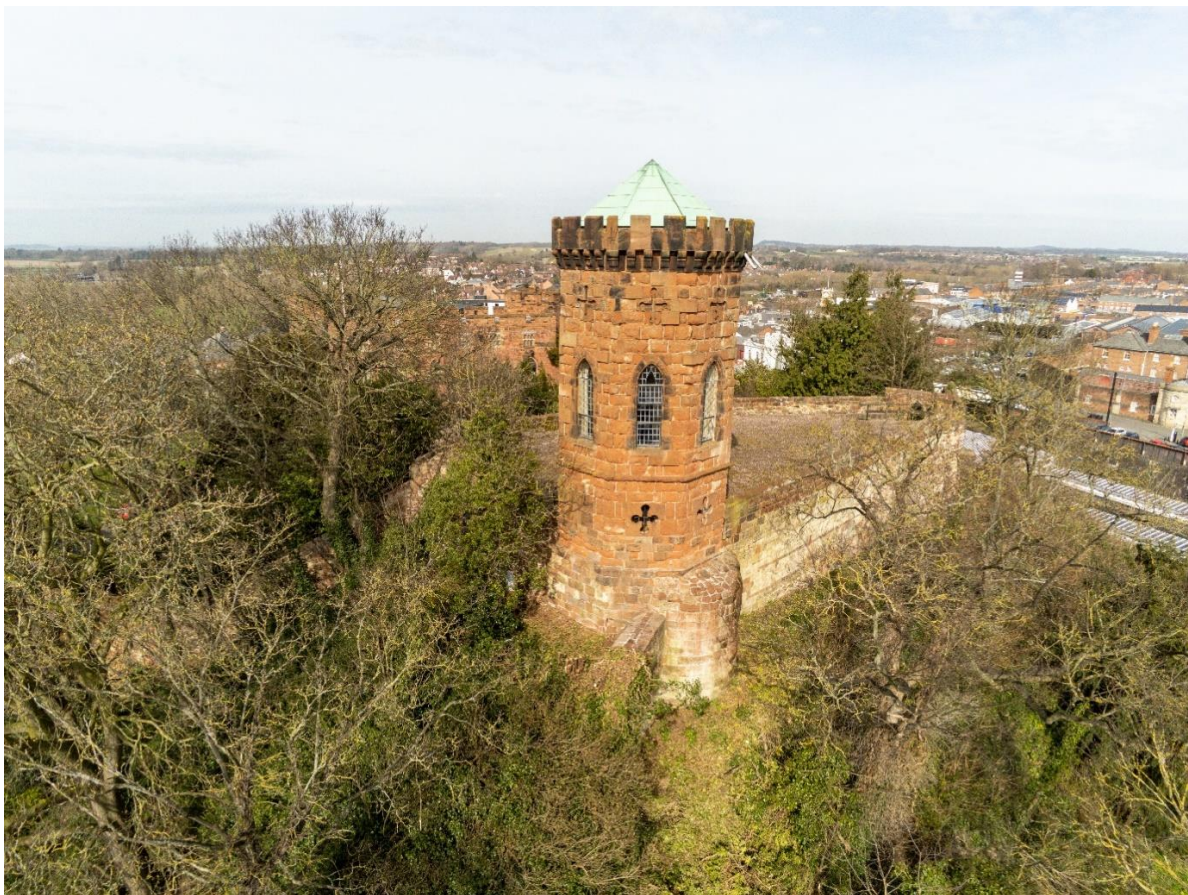
10. Drone shot of the motte from the south-east (James Brennan Associates). The watch tower base can be seen under Laura's Tower with the striped retaining wall beyond marking the making good of the collapsed side of the motte from the late 13th century (James Brennan Associates)

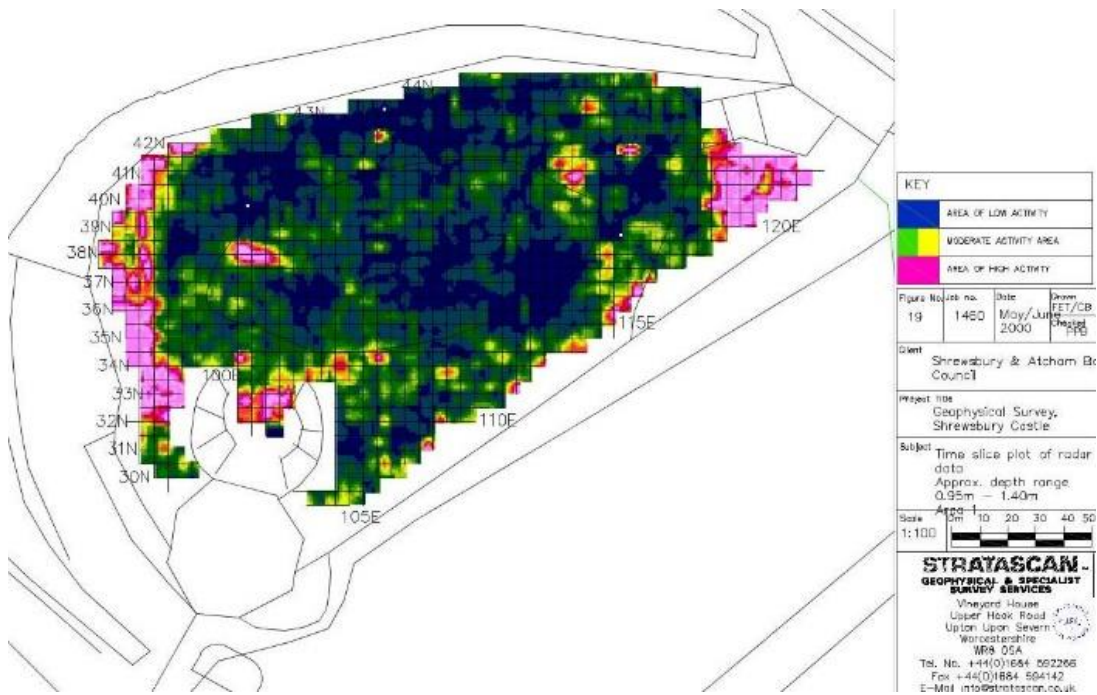
11. Motte top geophysics GPR timeslice @ 0.95m-1.40m. (Stratascan Ltd, 2000)

The only other archaeological research known on the motte top is a geophysical survey undertaken by Stratascan Ltd in 2000, using ground-penetrating radar. The results were less than conclusive, showing clear evidence of deep and solid masonry around much of the perimeter and at the north end, and some activity in the centre, mostly in the 0.45m – 0.95m depth range (GPR timeslices), possibly indicative of buildings. While these results were contemporaneously celebrated as showing 'clear indications of foundation trenches up

to 2 metres in width and similar depth, forming parts of at least one large rectilinear structure' they have always appeared to this writer to be deeply ambiguous – and excavation has now shown that they bear little or no relation to the actual character of the archaeology (Stokes 2000, Stratascan Ltd, 2000).

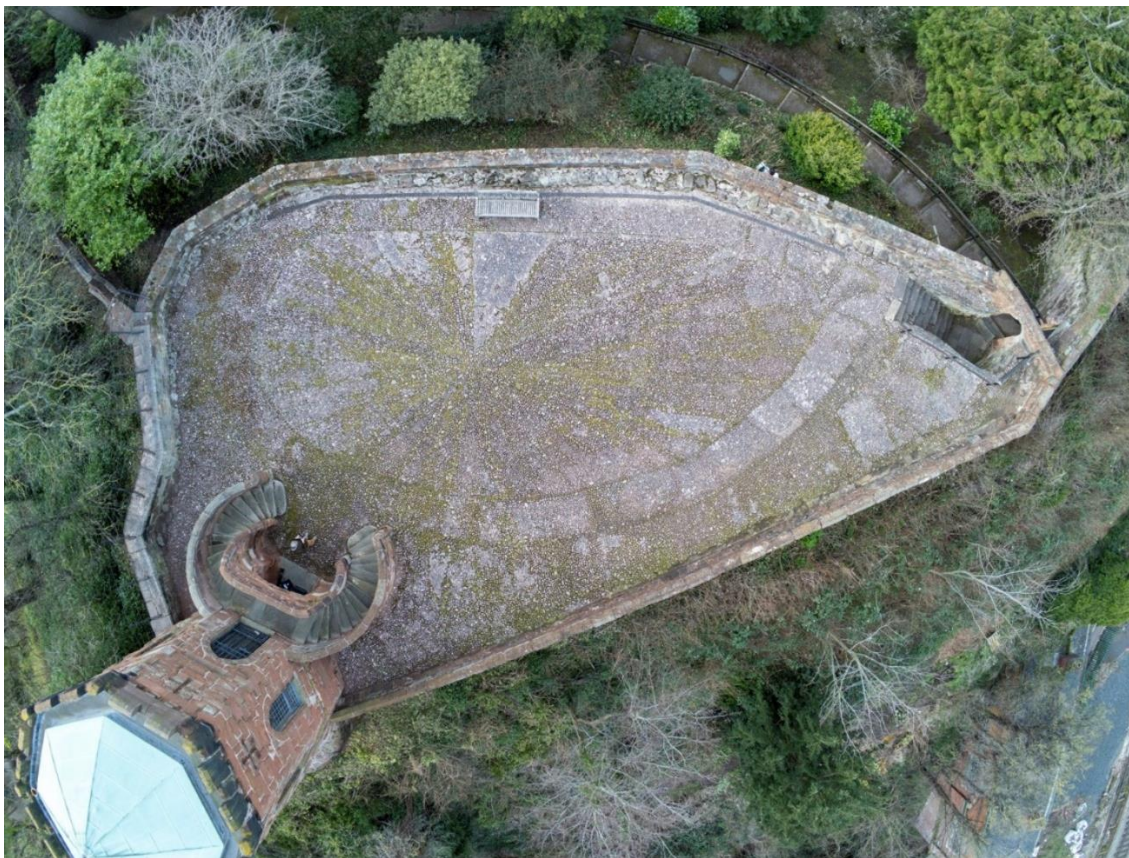
13. Drone photograph (James Brennan Associates) of the motte top in 2022 (north to right). The cobbled surface of the 1990s slopes down to the west (top) to shed water into the French drain running within the west perimeter wall and cutting through it at the SW angle. Telford's path to Laura's Tower is marked out in the cobbling

Excavation began by breaking out the 1990s cobbles set in hard cement to a depth of 10-13cms (context 301). The cobbles were found to have been laid on a bed of compacted grey roadstone or ballast (context 302) 4cms deep on the west side of the motte, 11cms deep on the east side, the difference helping to create a surface that sloped down to the west, to shed water into a French drain. Also, on the east side (area 1), similar roadstone-type material (context 304) was deposited to make good a depression 11cms deep on the line of the oval path, created by Telford's workmen in 1786-90 to give access to Laura's Tower from the doorway and steps at the north end of the motte, and commemorated in the 1990s by stones set on edge within the cobbles (fig.13, below). In the central area (Area 2) alone, a blue plastic membrane was found underneath the roadstone layer. The installation of the French drain seems not to have been recorded archaeologically at the time; neither, so far as is known at present, was the cut made for it through the thickness of the west side motte-top perimeter wall.

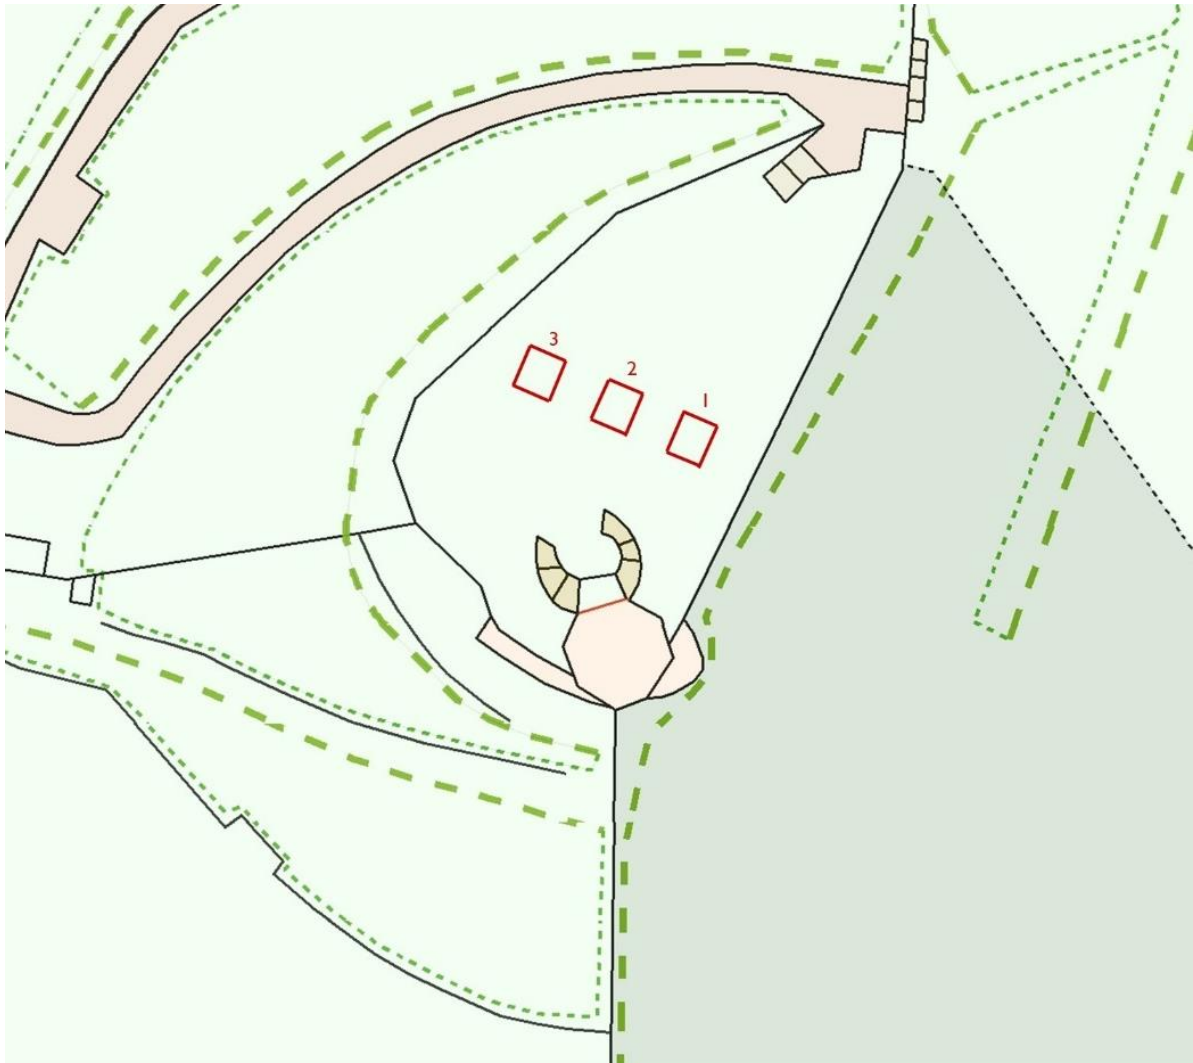
14. Plan of the motte showing the location of Trench 3, areas 1, 2 and 3 on the motte top

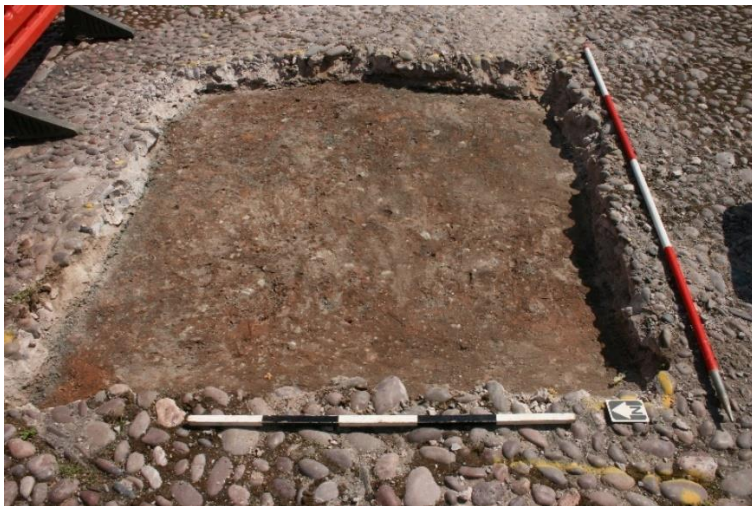
18. Area 3, top of 303 after removal of cobble sub-base layer

In Area 3 (west), removal of the cobble sub-base revealed a layer of solid red-brown clay (303) containing small pieces of cbm (brick or tile), small pieces of green sandstone, degraded red sandstone and patches of dark red clay.

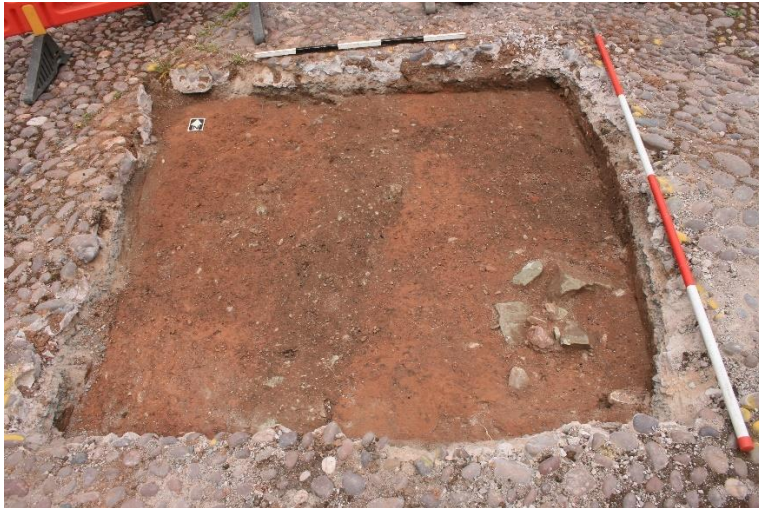
25. Area 3 (north to top), first exposure of motte material 312 cut by negative features: slot 313 is visible pre-excitation running centrally north-south, post-hole 315 is represented at this level by the cluster of green sandstone pieces, bottom right

In **Area 3**, a shallow fairly straight-sided cut feature (313/314) was first identified running north-south, its fill of grey-brown clayey silty soil contrasting with the surrounding motte material. Excavation showed this to be a shallow flat-bottomed feature, possibly a foundation slot for a horizontal timber or possibly the very bottom of a truncated, formerly deeper, linear cut, with a very slight westwards curve, possibly dug in two separate lengths end-to-end. In the top of its fill were some small brick pieces and one clay pipe fragment suggesting either that it was of post-medieval date or that later material had been introduced into the top of its fill from later contexts immediately above and the levelling-down operations on this side of the motte.

This north-south slot was found to have cut across an earlier east-west slot 332/333, flat bottomed, with a fill of medium-brown silty-clayey soil. This was in turn found to have cut what is interpreted as a post pad, 314, a green sandstone slab forming a flat base within a slight cut into the underlying motte material. Neither the east-west slot nor the post-pad contained any artefacts, so, strictly speaking, are undated.

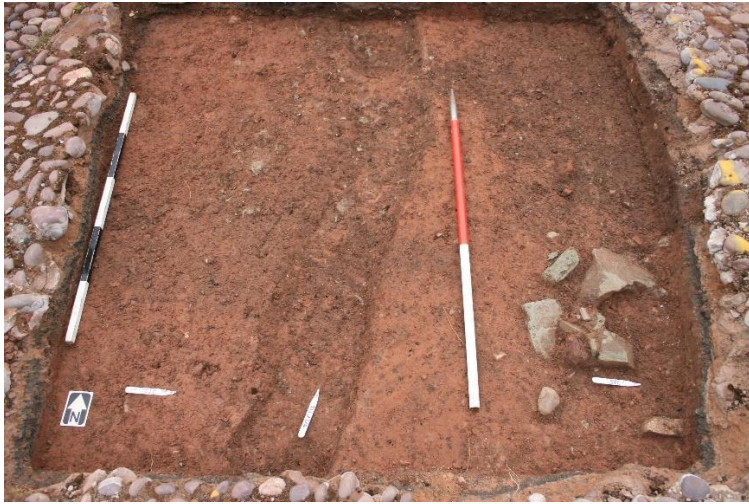
26. Area 3, N-S slot 313 under excavation

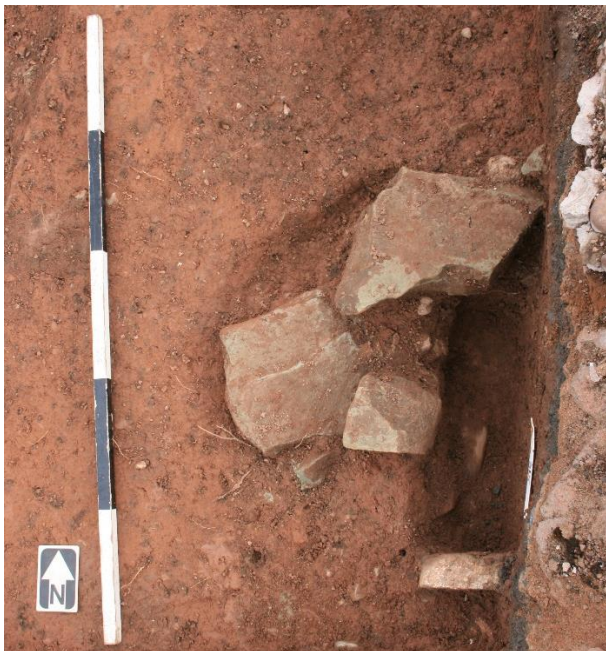
27. Area 3, post-hole 315 after excavation

In the south-east corner of Area 3, a cluster of pieces of green sandstone rubble was found by excavation to be a probable post-hole, 315, with the sandstone remaining from packing around a central post. This too produced no dateable artefacts. In the north-east corner of Area 3 a steep-sided flat-bottomed small pit or post-hole 330/331 was filled with a sterile medium brown silty-clayey soil with small stones.

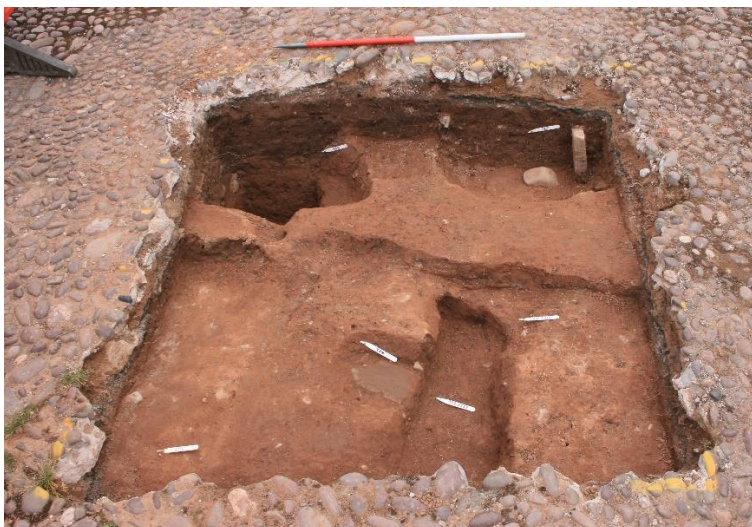
29. Area 3 at the end of the excavation (north to left). Post-pad 334 is in the centre foreground cut by slot 332. A 50cm-square test sondage has been sunk through the base of pit 330 (top left)

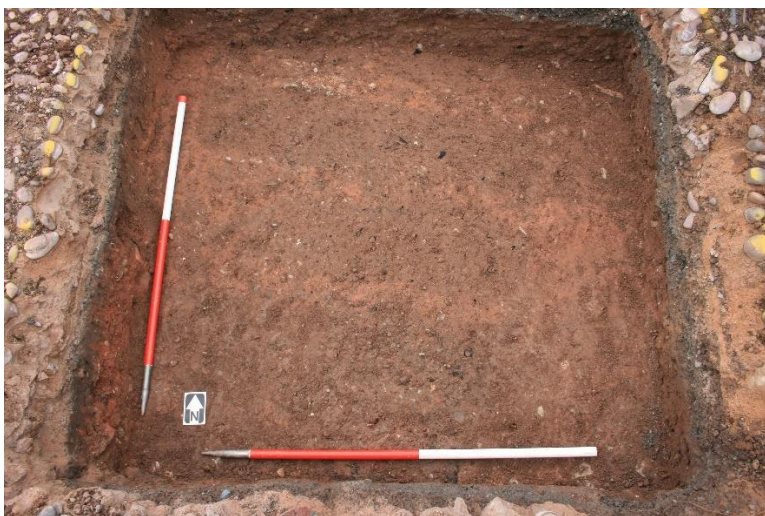
30. Area I, east-west slots cutting motte material 339, first definition. Three linear features are visible, framed by the 1m scales, top to bottom: 317, 318, 319. A later intrusive feature 320 has not yet been identified and defined (centre, bottom)

On the north side, an east-west slot 317 was found to be flat bottomed and up to c.21cm deep; it contained only early medieval (12th-13th-century) pottery. At its east end it appeared to cut an earlier negative feature 336 in the north-east corner of the area, filled with a medium brown gritty, gravelly soil 337; this was not excavated, though cleaning of its surface produced a sherd of medieval cooking pot. To the north of slot 317, right at the base of the section, another east-west-running edge was seen; this was suspected to be a further parallel slot, numbered 338, but was left unexcavated. Between this and slot 317 was a patch of mortar with pieces of sandstone, 321, cut by both 338 and 317.

South of slot 317 was another, 318, which was found to butt-end towards the east side of the excavated area while fading out to the west. In its surface was a piece of 17th-18th-century slipware, though this could have been introduced from one of the intrusive contexts immediately above it. Along the south side of the excavation was another east-west linear feature, 319, though little of this was seen as it was found to have been largely cut away by the late post-medieval post-hole 320.

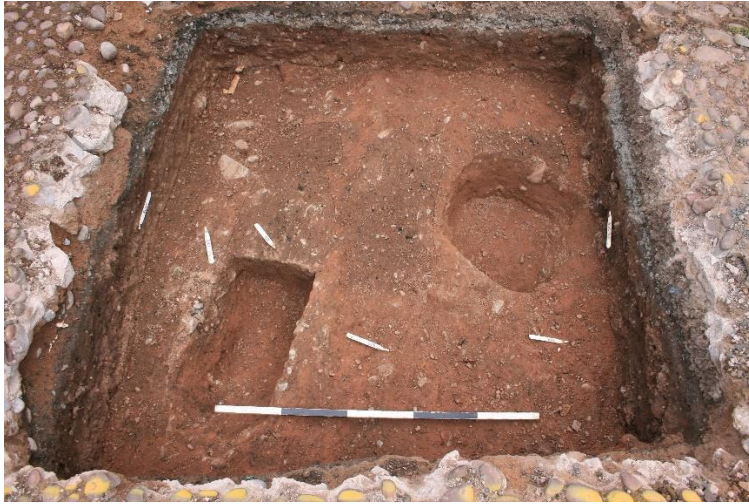
31. Area 1, looking east (north to left) on the conclusion of the excavation. Left to right: mortar patch 321, cut by unexcavated feature 338 on the left, and slot 317 (half-sectioned) on its right, slot 318 diminishing in depth in centre foreground, later pit 320 cutting another slot 319

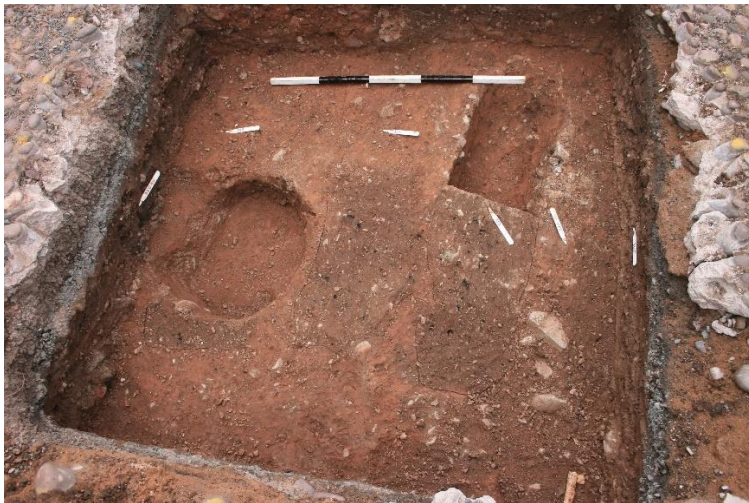
32. Area 1, looking west (north to right). Left: pit 320 cutting the remains of slot 319 (foreground), slot 318, largely unexcavated, slot 317 half-sectioned, mortar patch 321 to its right/north, cut on its right by unexcavated slot 338; the darker area bottom right resolved into (unexcavated) feature 336/7

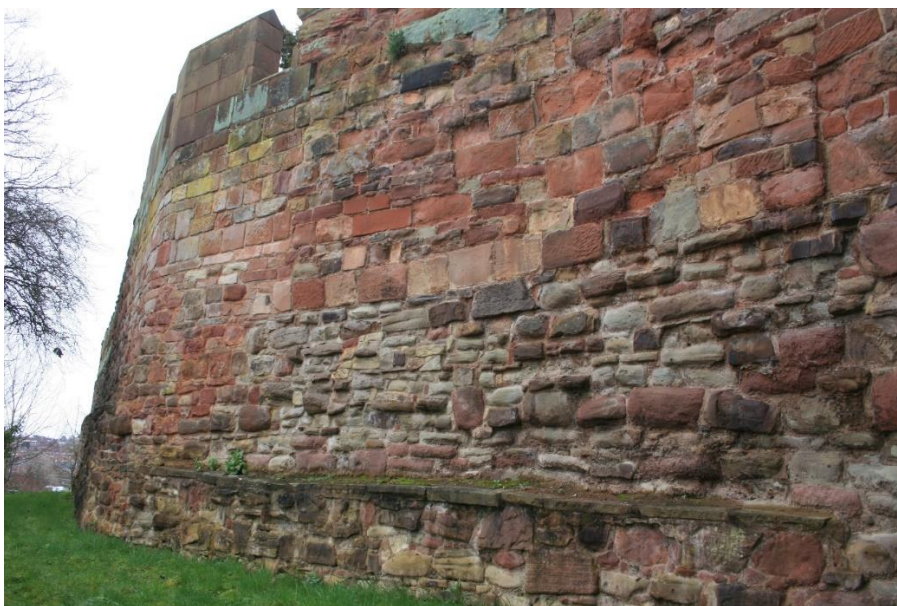
37. The north-west end of the north curtain wall, showing multiply rebuilt masonry above probable primary Green Coed-yr-Allt Beds sandstone slabby rubble

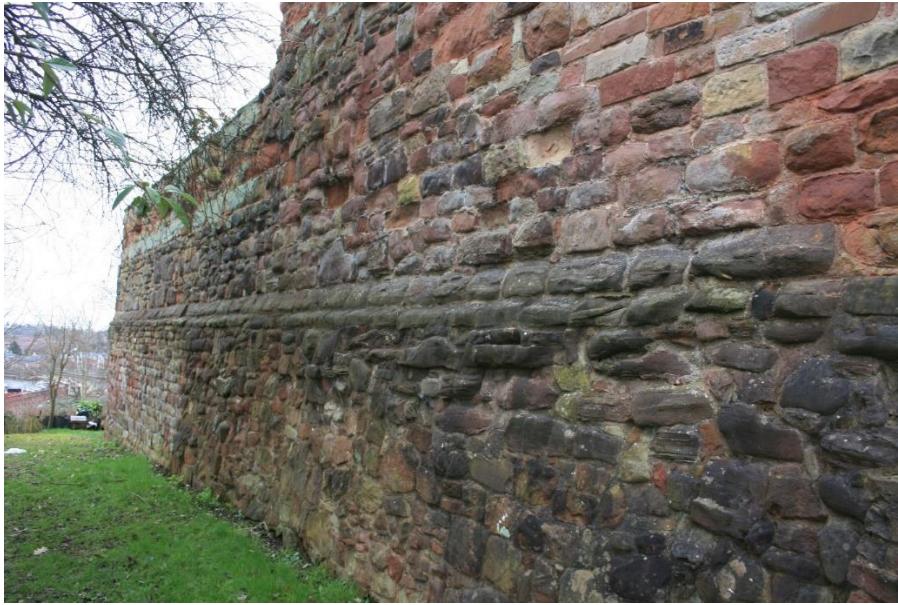
38. The central section of the north curtain wall. This marks the commencement of the sandstone rubble section with high plinth courses examined in Trench 4

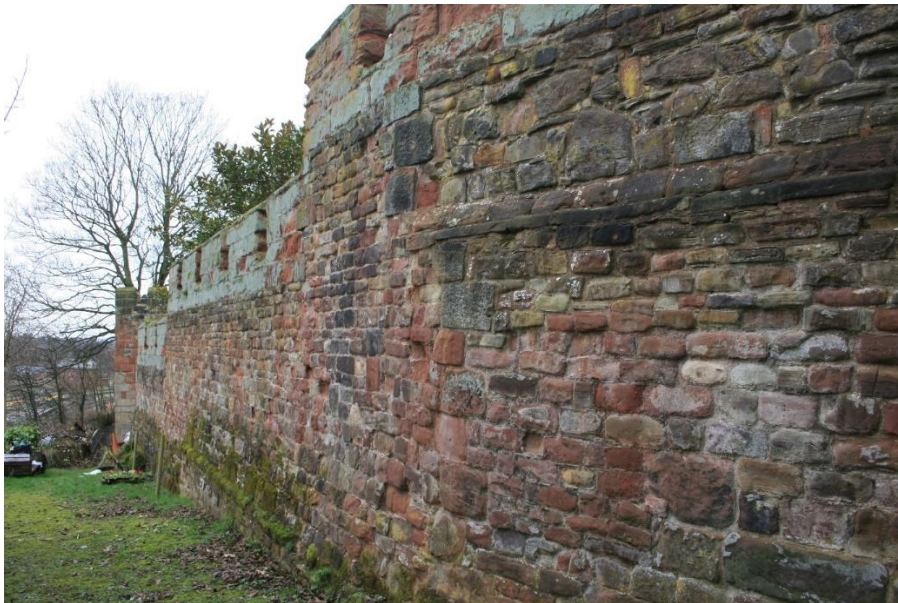
39. The east section of the north curtain running down-slope (the motte ditch profile) to the Postern Gate. Trench 4 examined this section

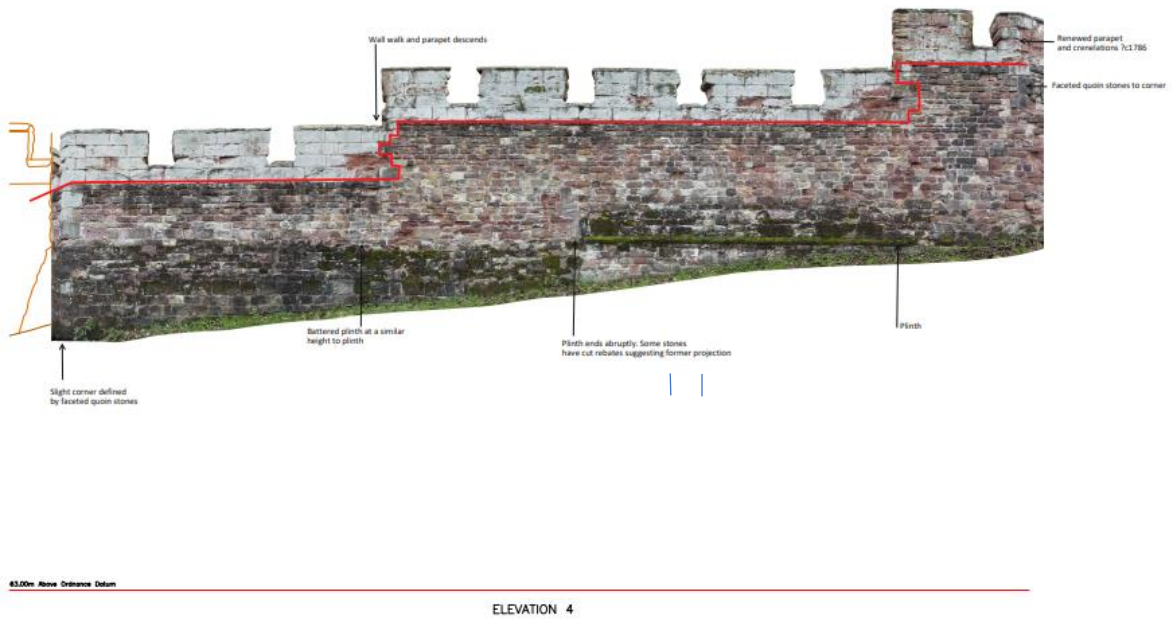
40. Photogrammetric elevation of the north curtain wall east section from the conservation management plan (survey: James Brennan Associates; CMP interpretation: Vicky Hunns)

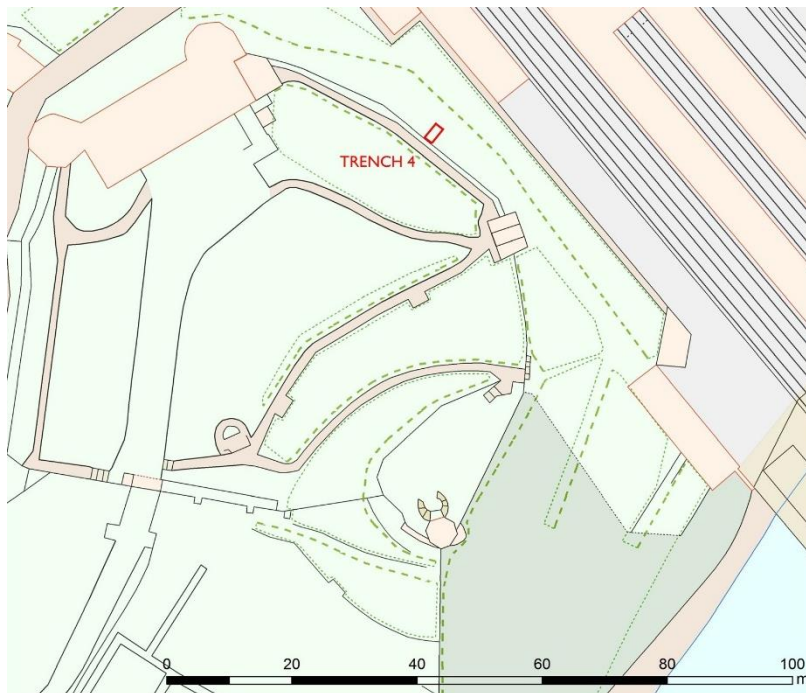
41. Trench 4 location plan

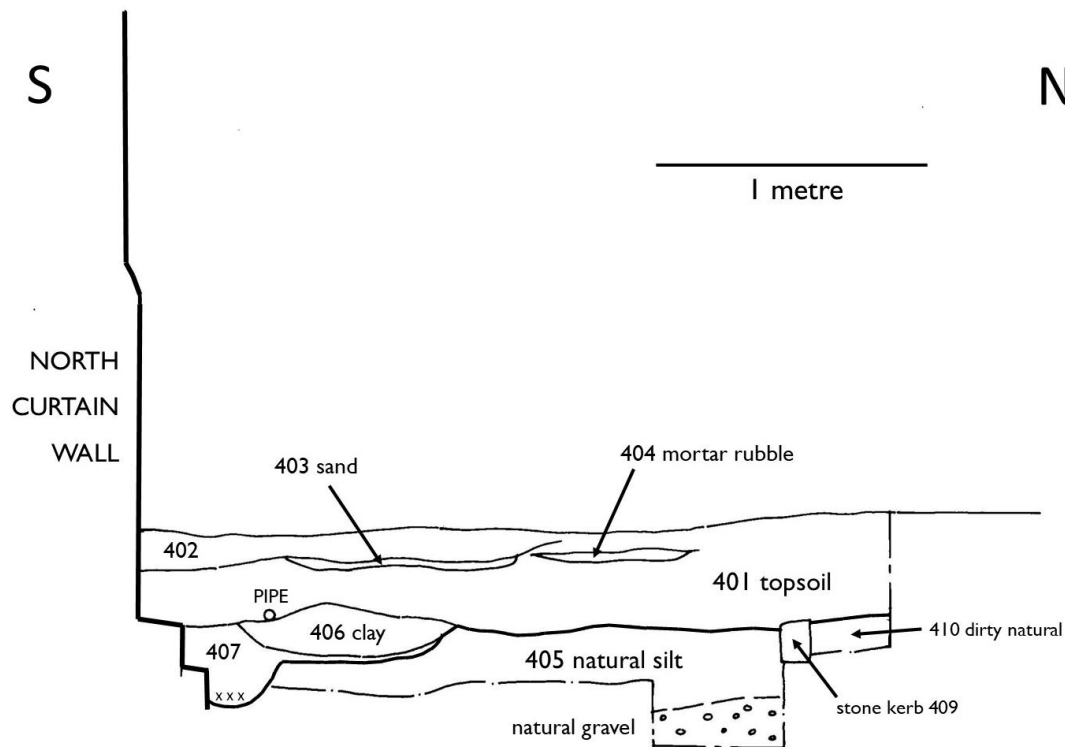
42. Trench 4, extramural section

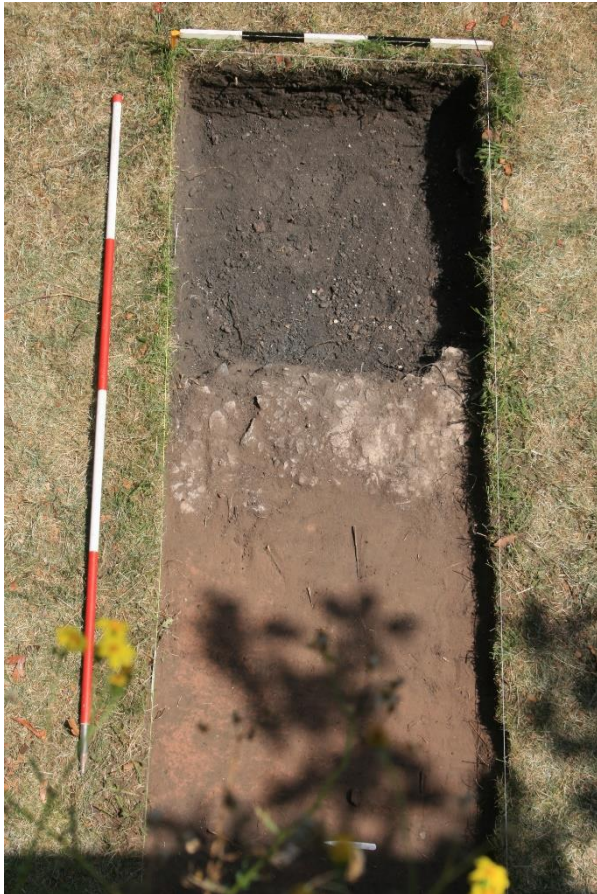
43. Trench 4, vertical view at an early stage of excavation showing, from bottom to top (west to east) sandy layers 402 and 403 bounded by the mortar strip 404, with black gritty topsoil 401 outside/beyond it. All are 19th- or 20th-century contexts

Beyond (east of) the mortar strip 404 and immediately under the turf was a much more substantial layer of dark grey-brown gritty soil (401) containing clinker and small pieces of brick, mortar and small stones, with 19th-century pottery sherds. On removal of 403 and 404 it was found to occupy the whole length of the trench, in which it was the principal topsoil equivalent. It was found to be covering a c.1-inch diameter iron pipe, running parallel to the wall, which, it was thought (pers. comm Ian Pritchard), probably contained a disused electricity cable formerly providing power to Laura's Tower on the motte. The mortar strip 404 is unexplained, though it may have formed a path or other feature bounding a flower-bed represented by the sandy soils 402/403.

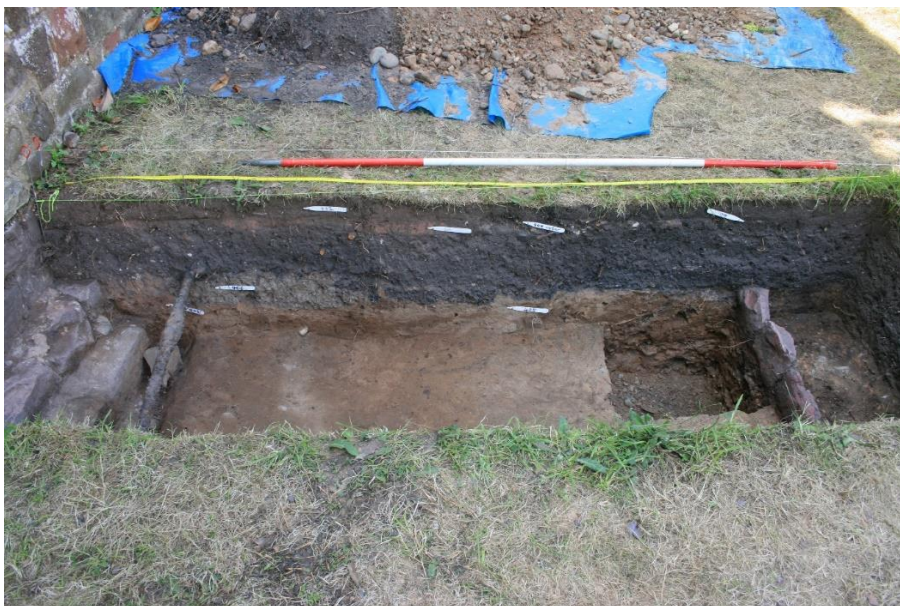
44. Trench 4, view of the completed trench looking north-west, showing the principal (dark) topsoil layer 401 covering (l-r) 405 natural clay silt, 50cm sondage through 405, sandstone edging 409 and 'dirty natural' 410

Closer to the curtain wall, removal of the black gritty topsoil revealed a deposit (406) of grey to khaki clayey soil which lay up against the topmost foundation course of the curtain wall. Removal of 406 revealed a light-brown to yellow-orange silty clay or clayey silt (407) which appeared to be a disturbed, slightly dirtier, version of the underlying 405 natural clayey soil. Excavation of 407 revealed a linear edge against the underlying 405, fairly certainly the (or a) foundation cut for the footings of the curtain wall, containing sandstone rubble and mortar (408, unexcavated). 407 was interpreted as 'builders' trample' filling and spilling out over the natural surface from the cut for the curtain wall foundations.

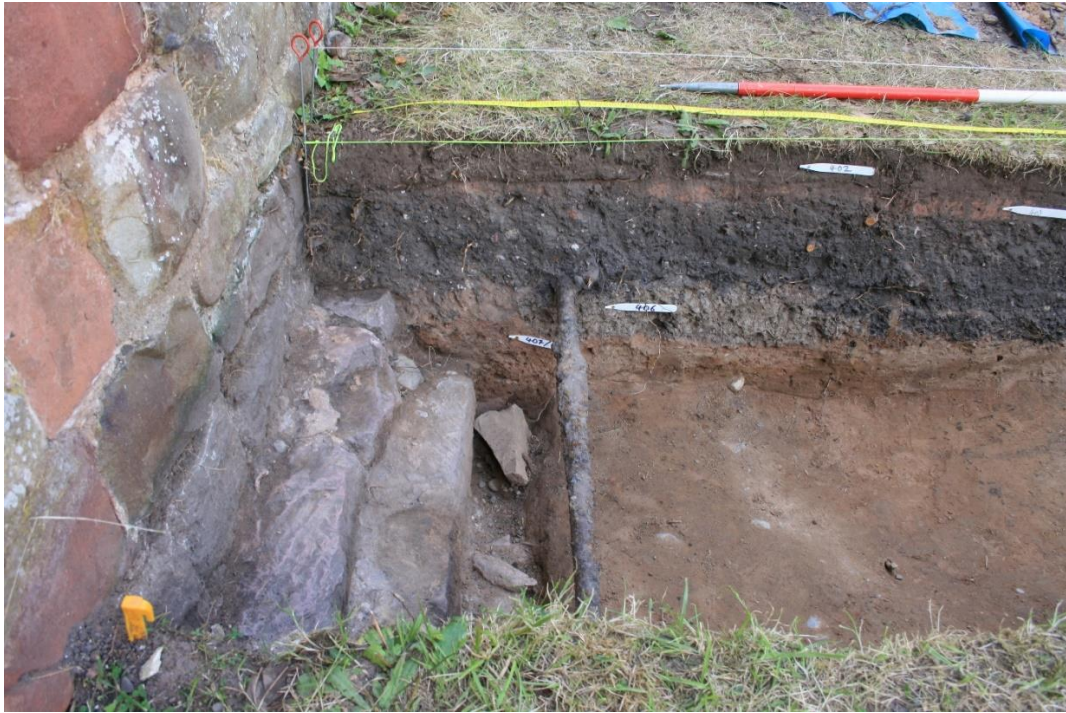
45. Trench 4, close-up of the stratigraphy overlying the curtain wall footings

These were found to be of the simplest type: from the level of the foundation trench, the thickness of the wall was stepped back twice to the main plane of the superstructure up to a plinth course about 0.7m above present ground level, 1.1m above the footings. This is

somewhat different to the usual early medieval practice in Shrewsbury (such as St Mary's Church, Shrewsbury Abbey church, the town wall), where the plinth course marks the transition from rough footings to ashlar superstructure and therefore is always to be found just above ground level.

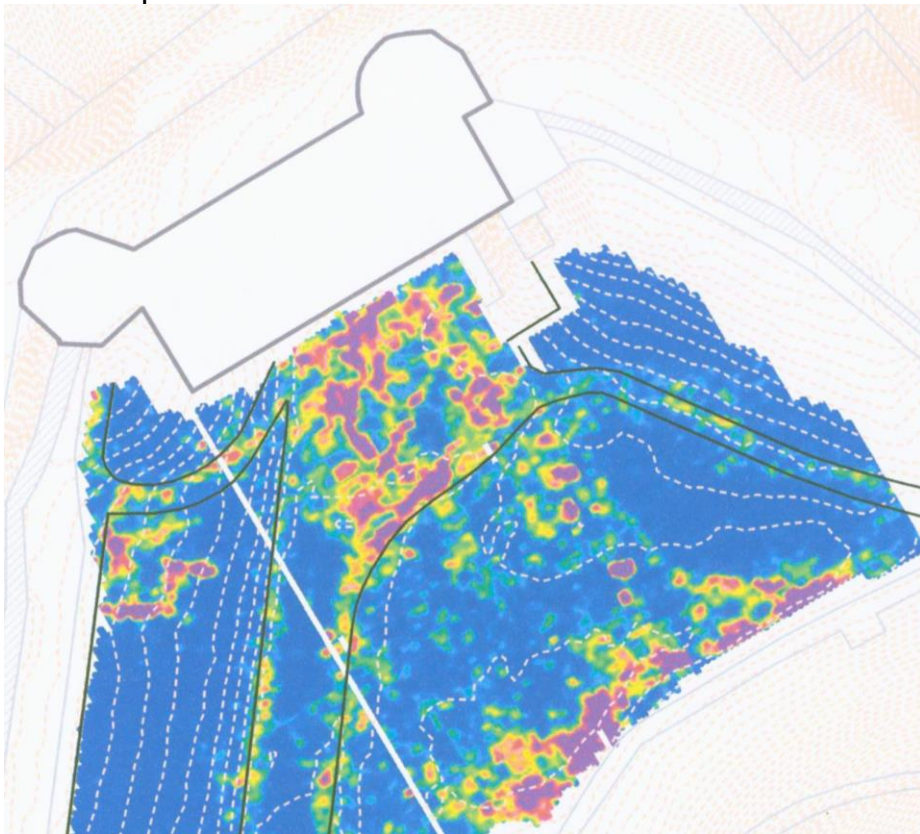
48. GPR plot by Tiger Geo (2019) showing (1) a line of hard reflective targets running across the bailey south, perpendicular to the hall, towards the motte, possibly indicative of a flying bridge and (2) hard reflective targets around the base of the motte

Finally, two elements of the motte fabric have not been investigated but would be susceptible to excavation. How the motte top was accessed is unknown, though the 2019 CST-sponsored geophysical investigation of the inner bailey by TigerGeo did find a line of individual hard reflective targets across the bailey heading south from the present door at the north/low end of the hall that could be indicative of deep – maybe even Telford-proof –

footings for a flying bridge up the side of the motte. GPR also indicated substantial buried foundations around the base of the motte, very probably indicative of a substantial perimeter wall around the base of the motte forming the inner edge of the ditch. This is, perhaps, the most fruitful area for archaeological investigation in future generations. It presents another deep and therefore probably Telford-proof target, though one which would come with all the costs associated with the need to secure a potentially very deep excavation, and deal with the processing and conservation costs of a much larger body of artefacts, potentially with organic preservation, than the castle has so far yielded.
